— SIMMONDS —

**EXTERIOR BUILDING STUDY**  
**for**  
**CULKIN HALL, MAHAR HALL & WILBER HALL**  
**SUNY OSWEGO CAMPUS**  
**OSWEGO, NEW YORK**

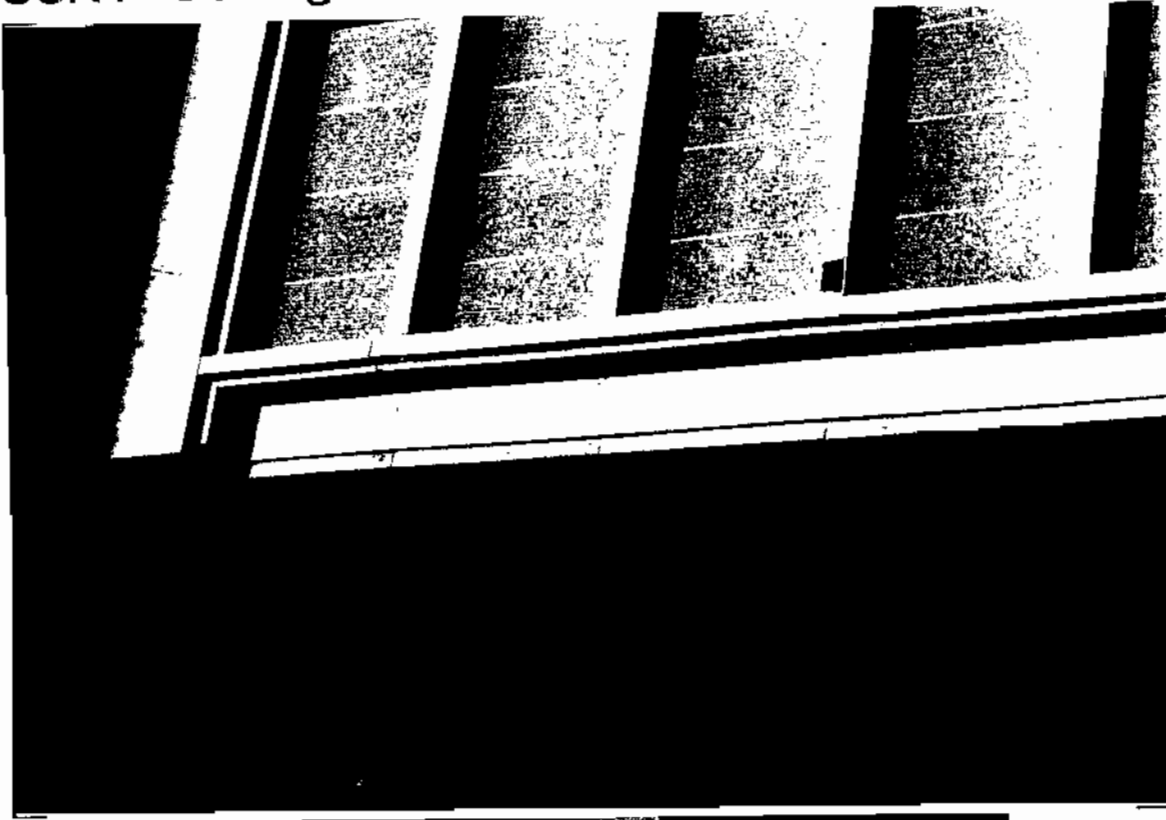
PHOTO C-2: SOUTHEAST BLDG. CORNER. NOTE SPALLED-OFF CEMENTITIOUS COATING AT 8th FL. LEVEL; AND SPALLED OFF CONC. COVER AT EMBEDDED STL. PLATE, AT 6th FL. LEVEL

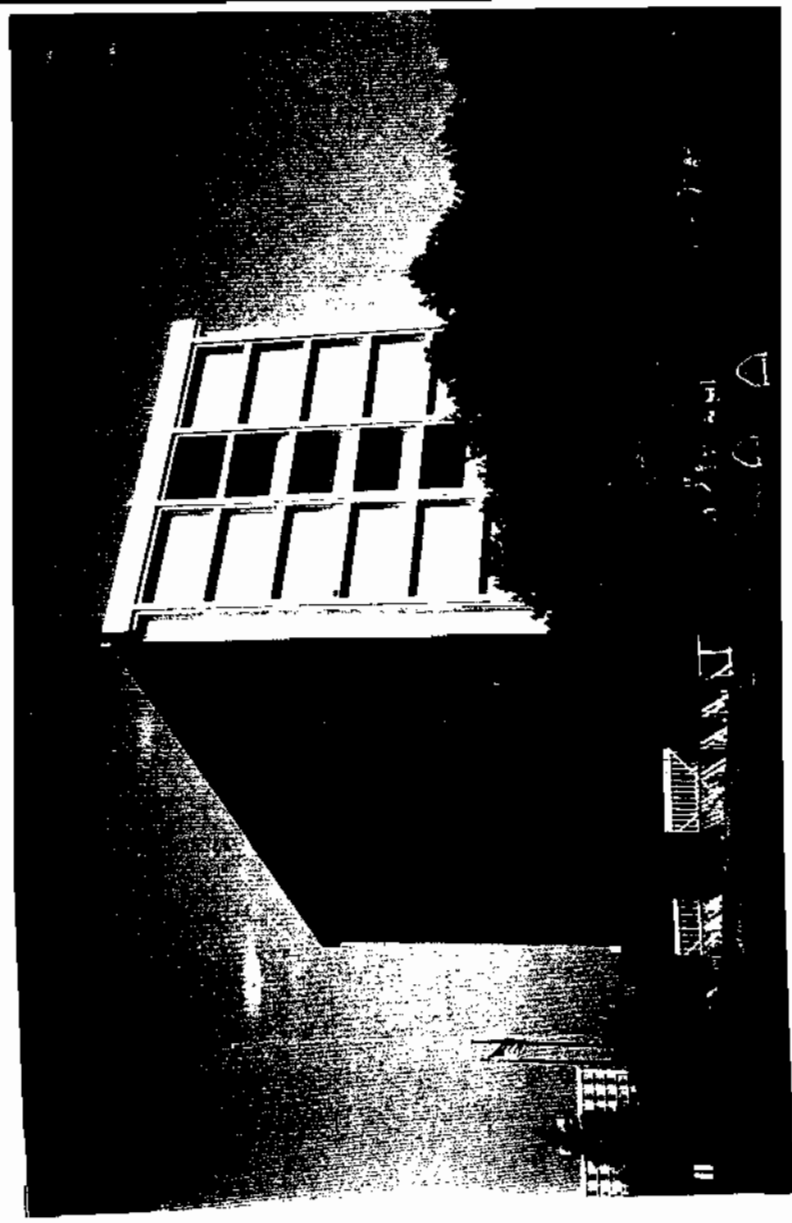
PHOTO C-1: SOUTH (LEFT) AND EAST (RIGHT) BUILDING FACADES.

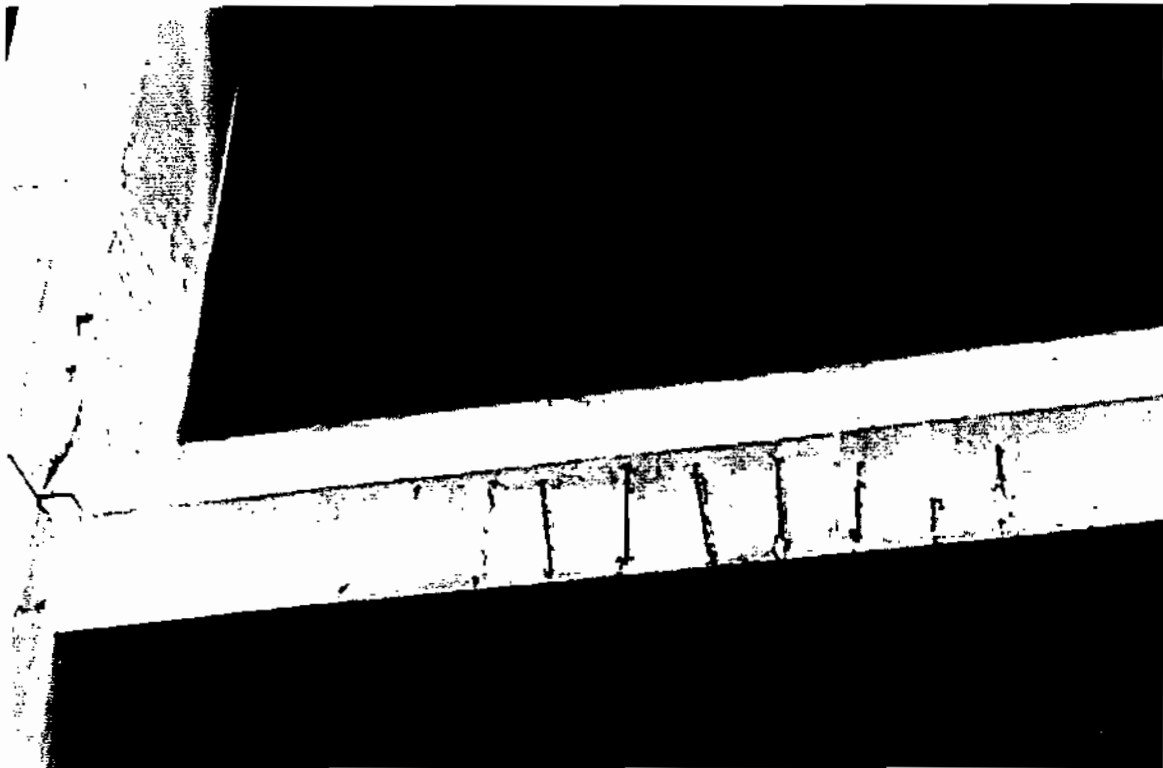
PHOTO M-2: CONCRETE SPALLS AT SPANDREL TIES, IN BUILDING SOUTH FACADE, 3rd FL. LEVEL, BETWEEN COLUMN LINES 2-5.

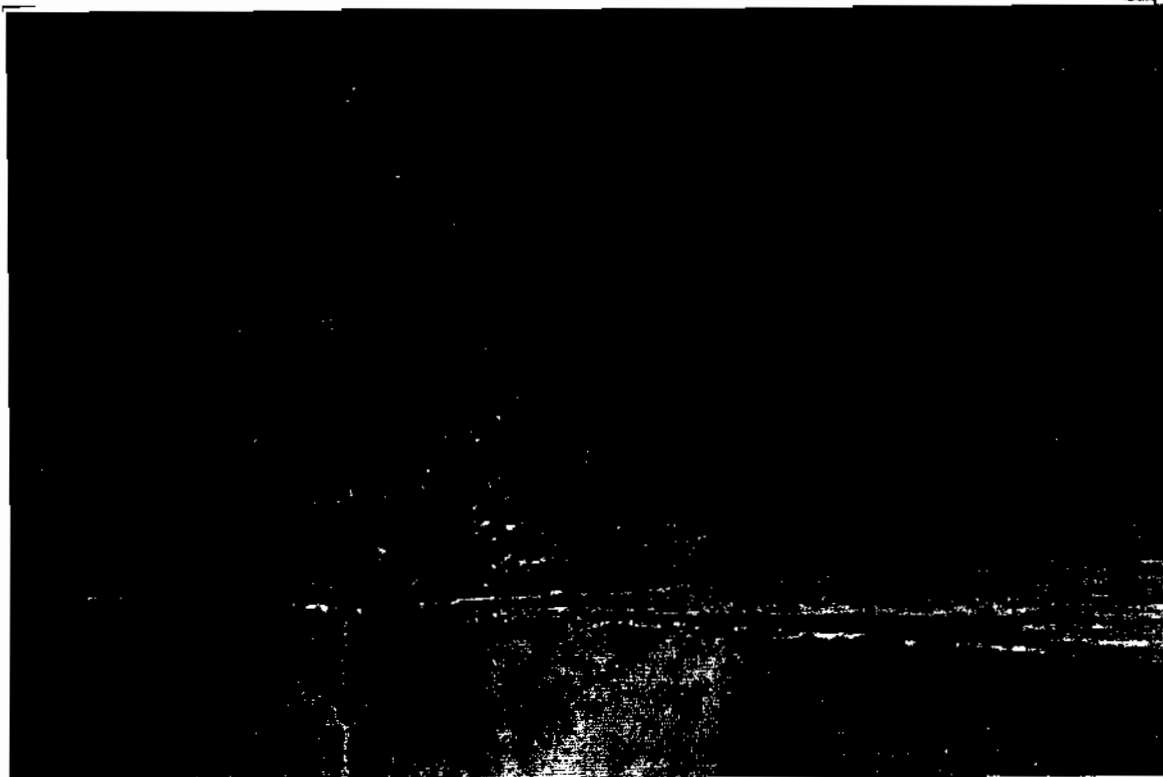
PHOTO M-3: CONCRETE SPALL AND DELAMINATION AT COLUMN D/1,  
1st. FL. LEVEL, BUILDING WEST FACADE.

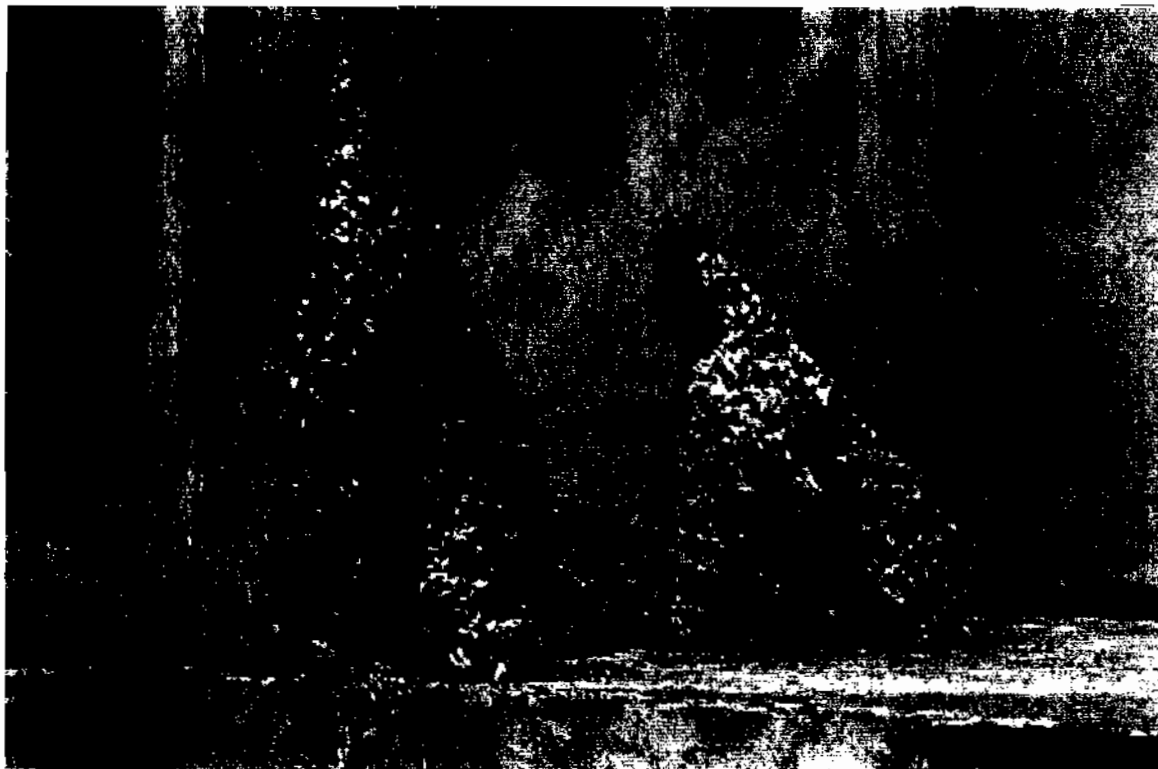
PHOTO M-4: REMOVAL OF DELAMINATED CONCRETE AT COLUMN D/1  
1st. FL. LEVEL, BUILDING WEST FACADE.

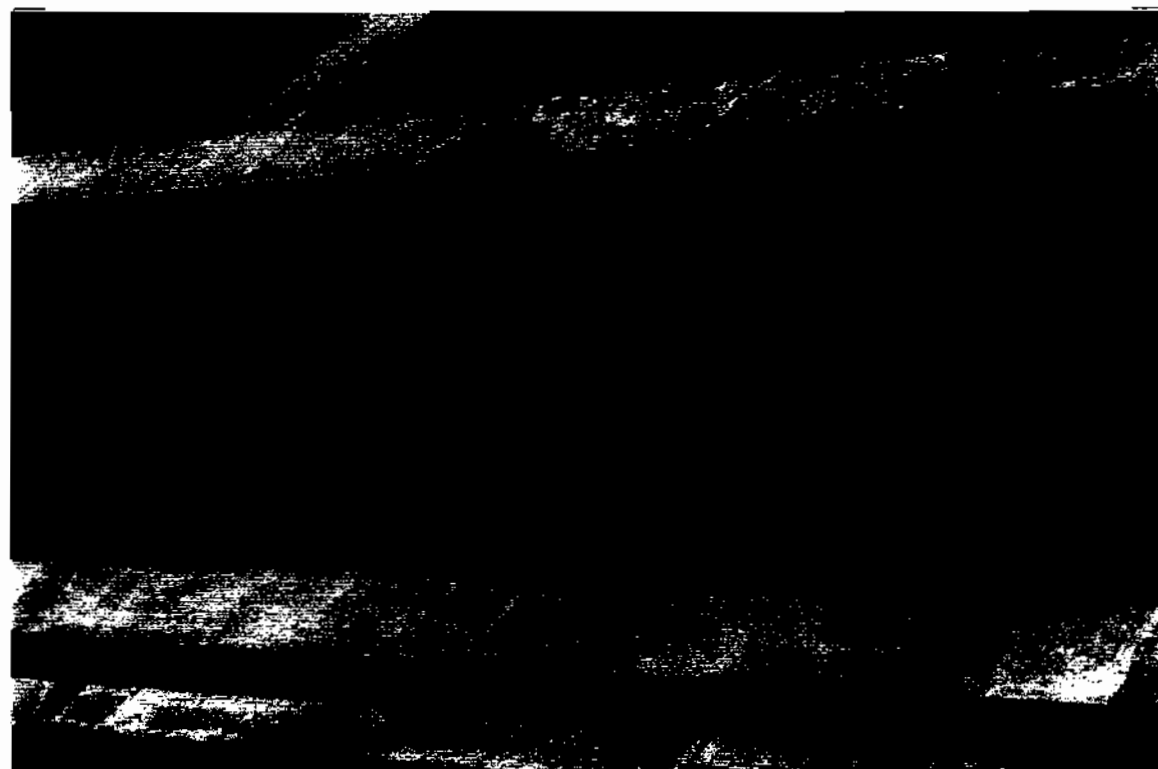
PHOTO M-5: CONCRETE SPALL AT NORTHWEST CORNER COLUMN H/1, 2nd FL. LEVEL, BUILDING WEST FACADE.

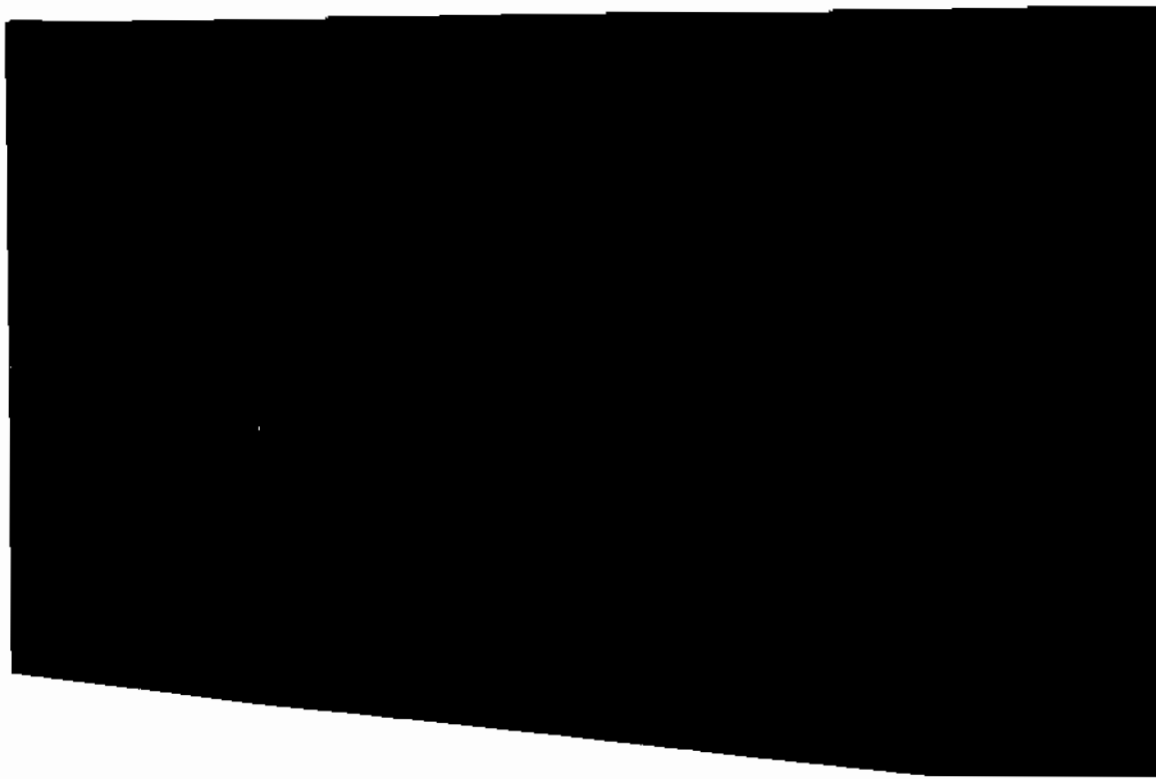
PHOTO M-6: CONCRETE SPALLS AT COLUMN TIES & SPANDREL REINF. BAR, AT NORTHEAST CORNER COLUMN H/6, BETWEEN 2nd & 3rd. FL., BUILDING NORTH FACADE.

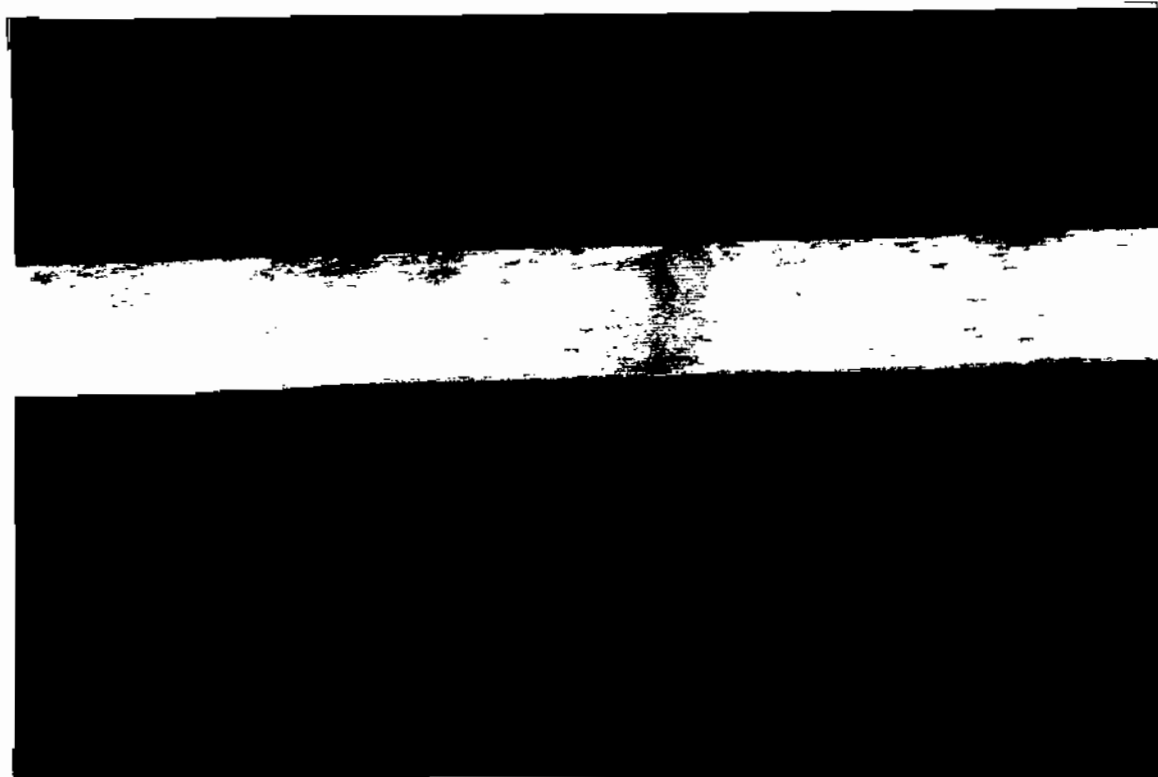
PHOTO M-7: CONCRETE DELAMINATION AT SPANDREL'S BOTTOM HORIZONTAL REINFORCING BAR, IN BUILDING NORTH FACADE.

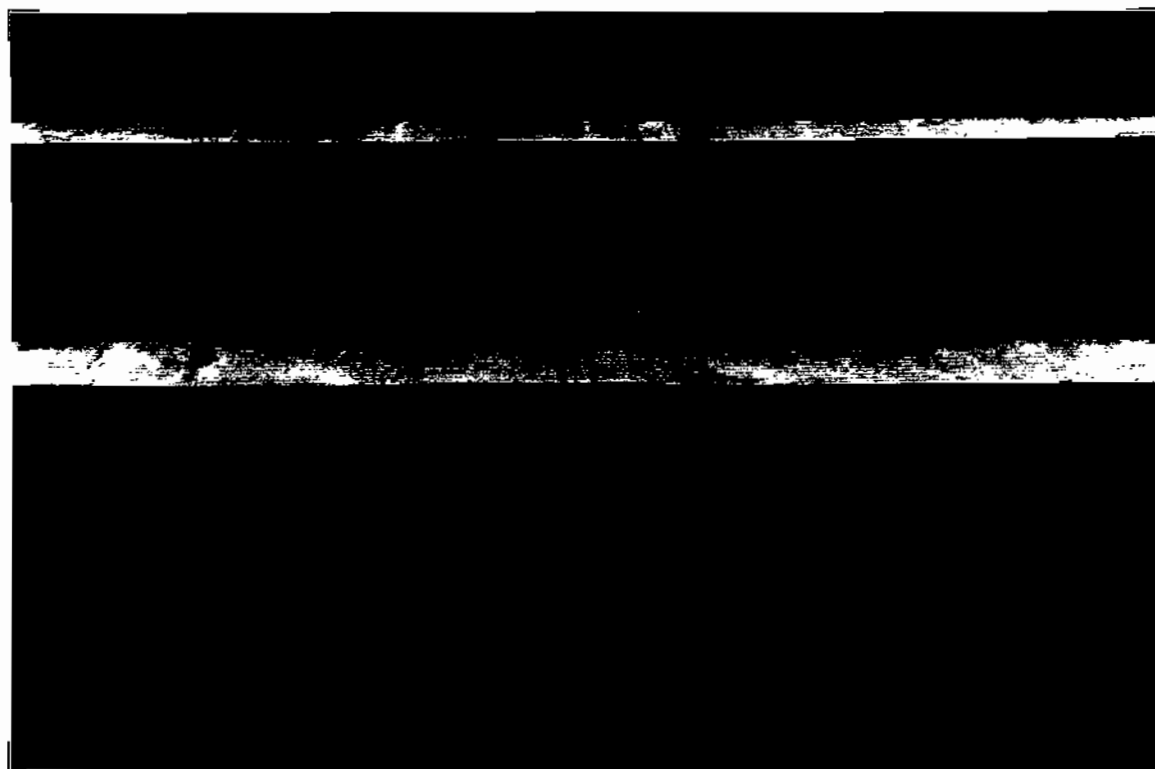
PHOTO M-8: CONCRETE SPALL AT SPANDREL'S BOTTOM REINFORCING BARS, IN BUILDING NORTH FACADE.

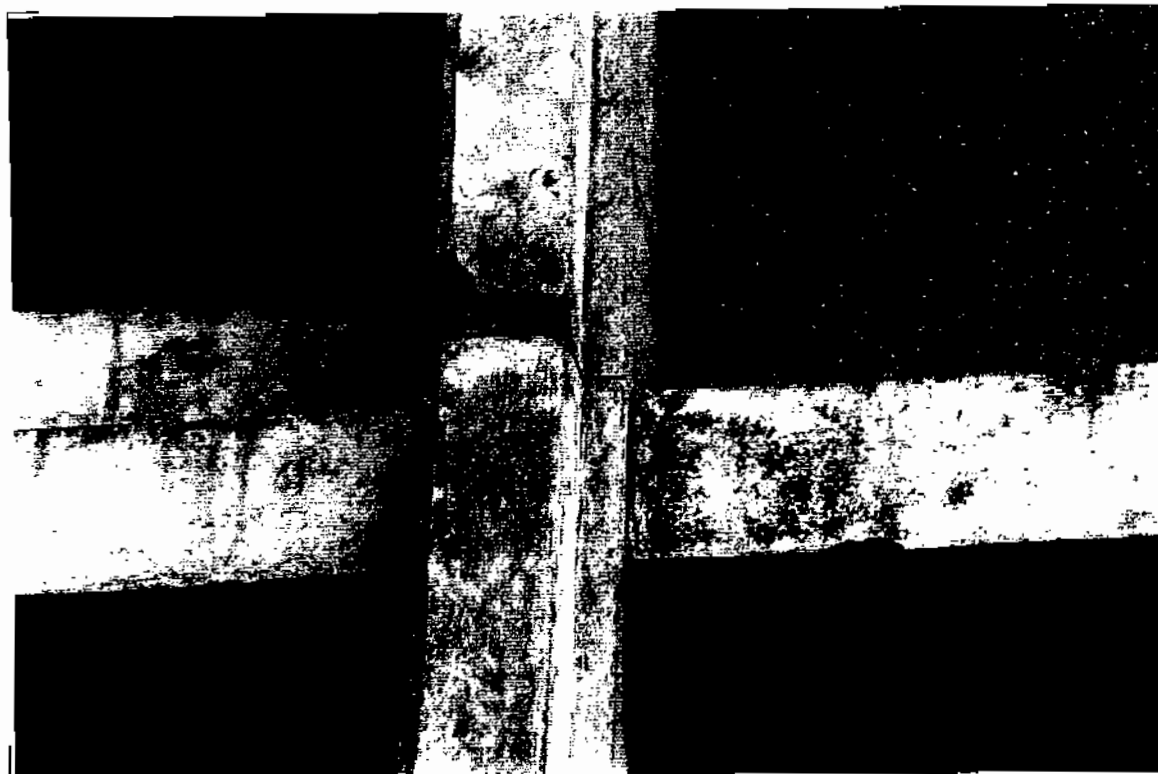
PHOTO M-9: CONCRETE SPALLS IN COLUMN H/2 & 2nd FL. SPANDREL,  
AND SHRINKAGE CRACK IN CONCRETE WALL UNDER WINDOWS,  
IN BUILDING NORTH FACADE.

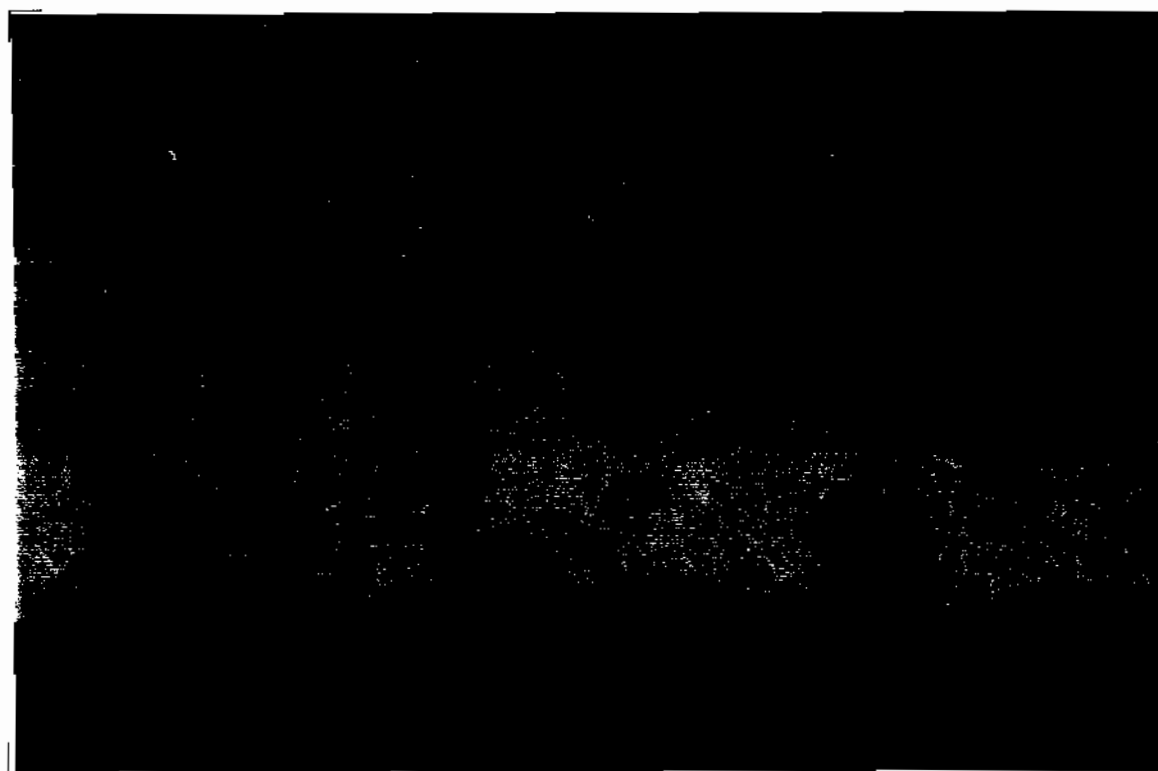
PHOTO M-10: CRACK IN 1st FL. SPANDREL BETWEEN COLUMN LINES  
1-2, IN BUILDING NORTH FACADE.

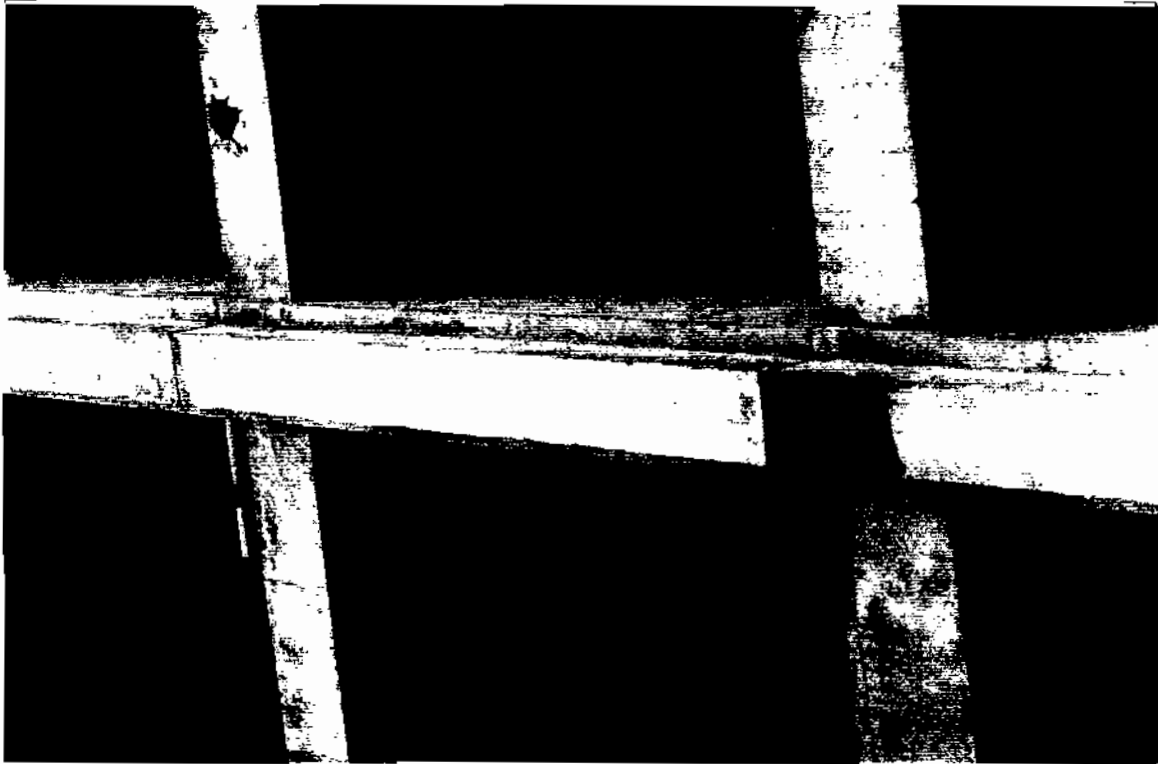
PHOTO M-11: SPALLED-OFF CONC. COVER AT EMBEDDED STEEL PLATES IN COL. H/2, AT 3rd FL. LEVEL, AND IN 4th FL. SPANDREL BETWEEN COL. LINES 1-2 IN BUILDING NORTH FACADE

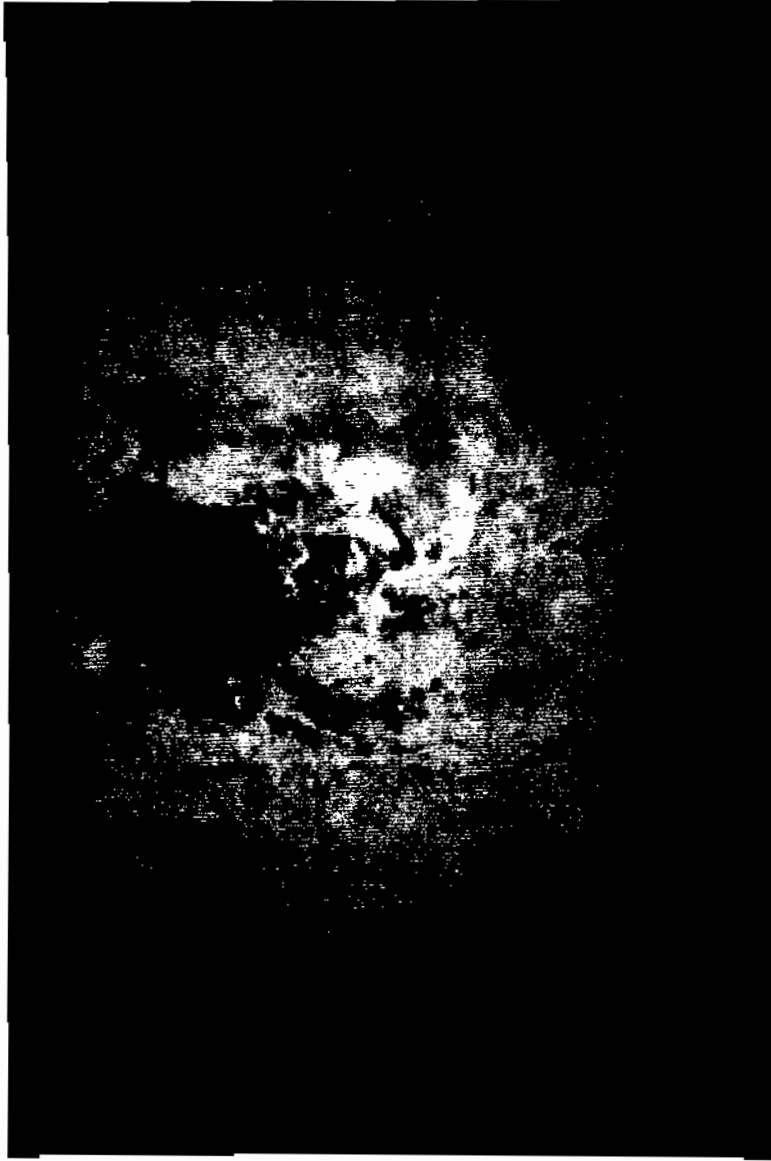
PHOTO M-12: SPALLED-OFF CONCRETE COVER AT EMBEDDED STEEL PLATE IN 4th FL. SPANDREL BETWEEN COL. LINES 1-2, IN BUILDING NORTH FACADE.

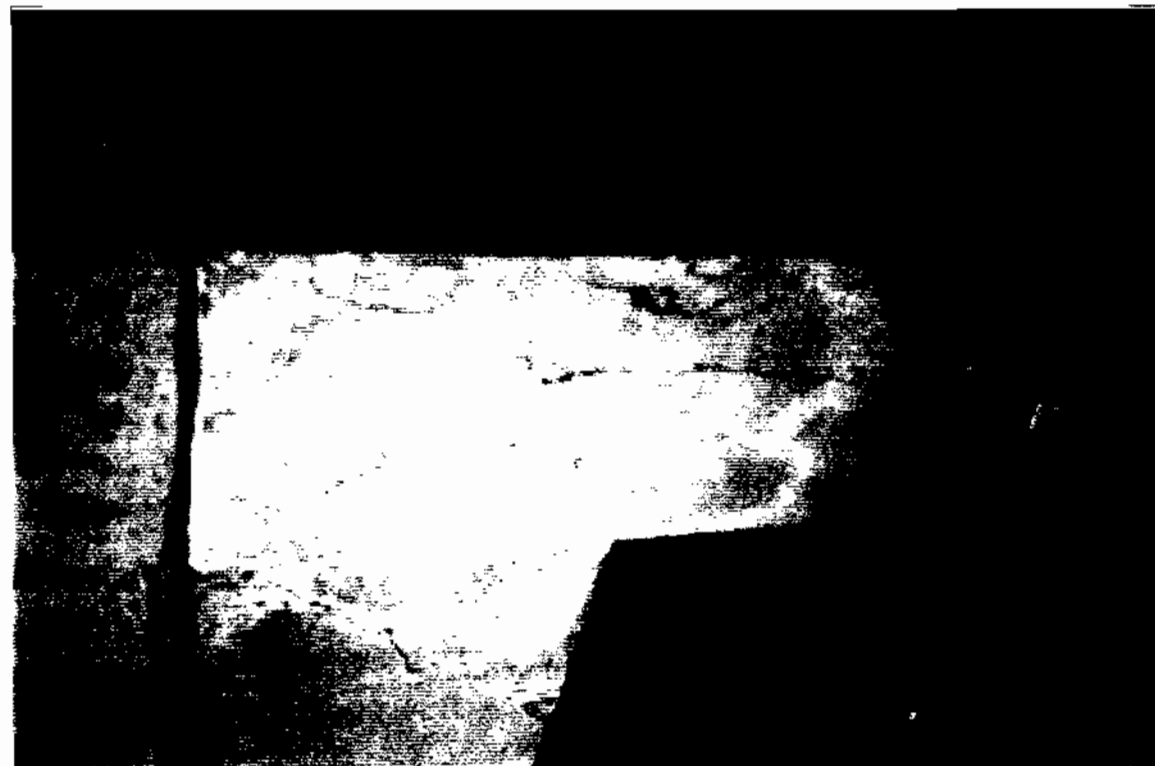
PHOTO M-13: CONC. DELAMINATION IN COL. H/2, AT 4th FL. LEVEL, IN BUILDING NORTH FACADE. NOTE: DELAMINATION IS AT EMBEDDED STEEL PLATE.

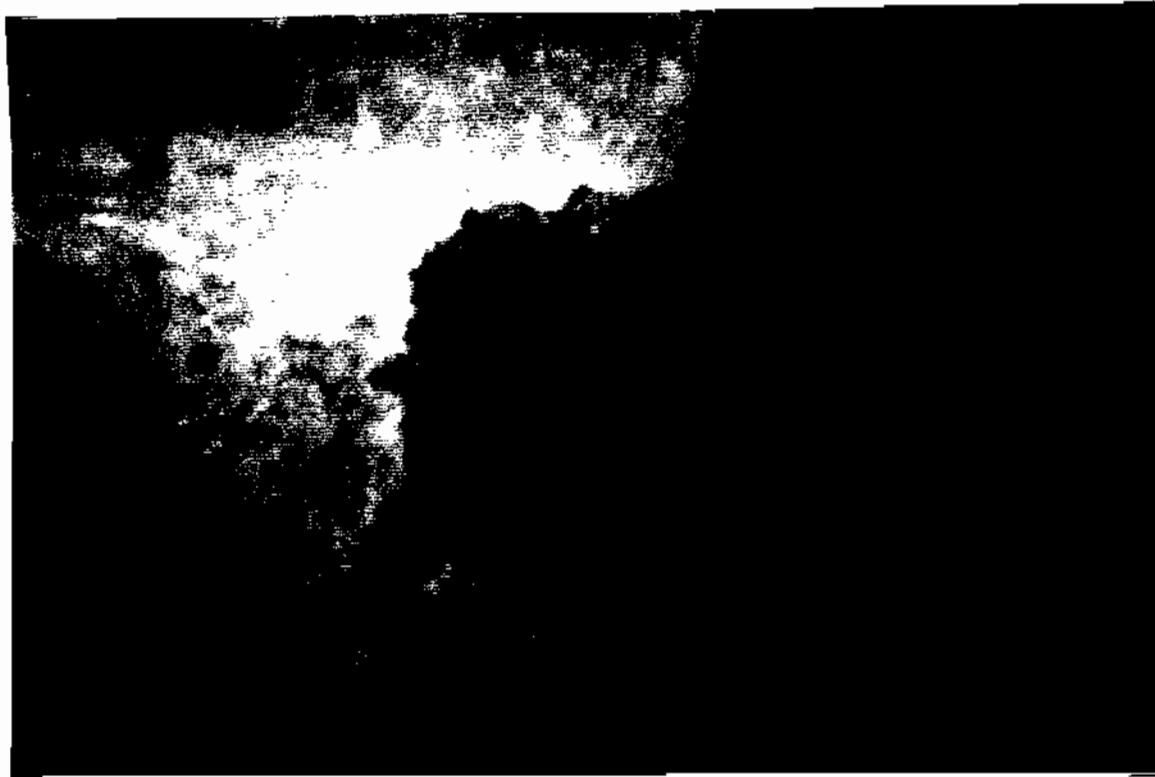
PHOTO M-14: SPALLED-OFF CONCRETE COVER AT EMBEDDED STEEL PLATE IN COL. H/5, AT ROOF LEVEL, IN BUILDING NORTH FACADE.

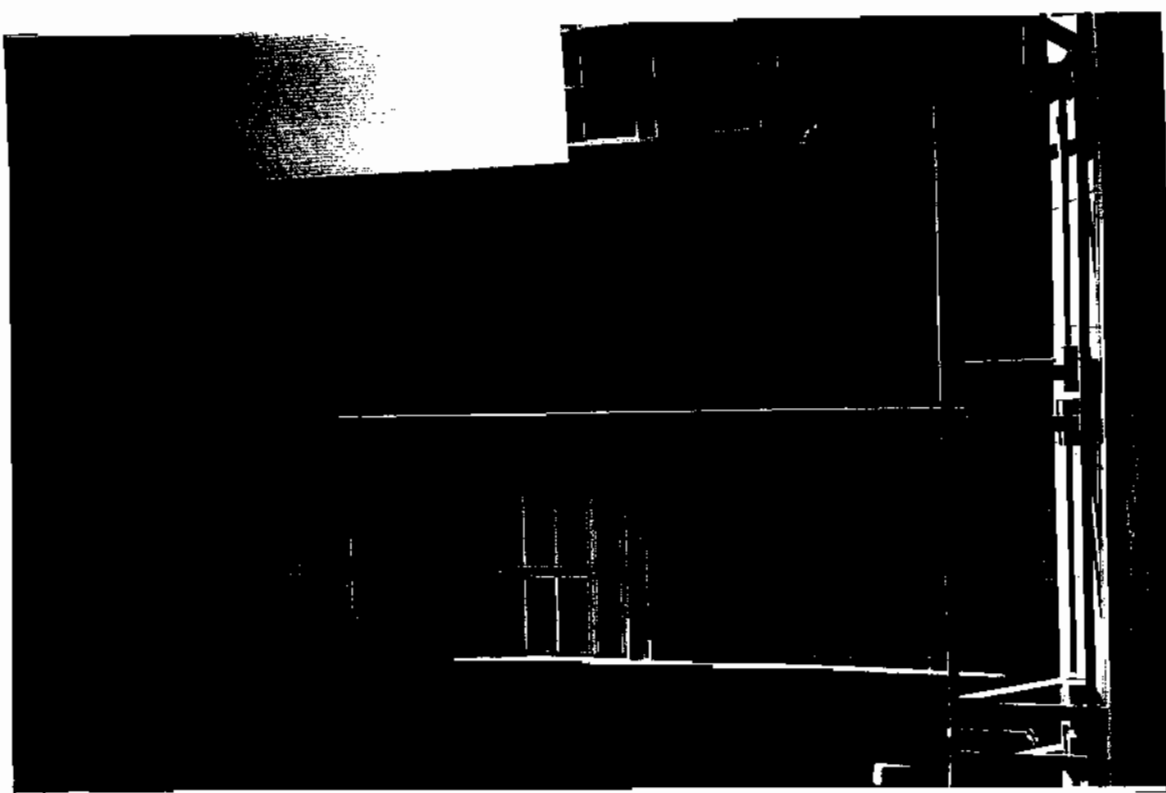
PHOTO W-2: CRACKED BRICK PILASTER, EAST OF COLUMN LINE 3, IN BUILDING SOUTH FACADE.

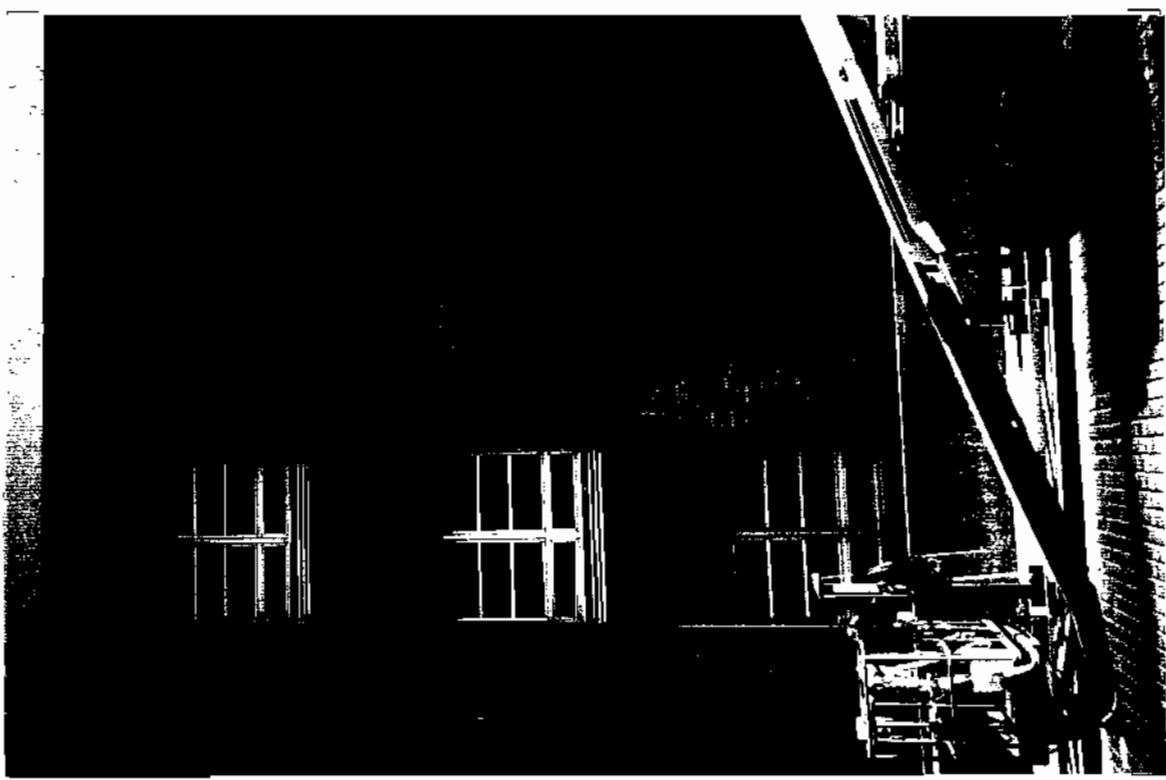
PHOTO W-1: CRACKED BRICK PILASTER, EAST OF COLUMN LINE 5, IN BUILDING SOUTH FACADE.

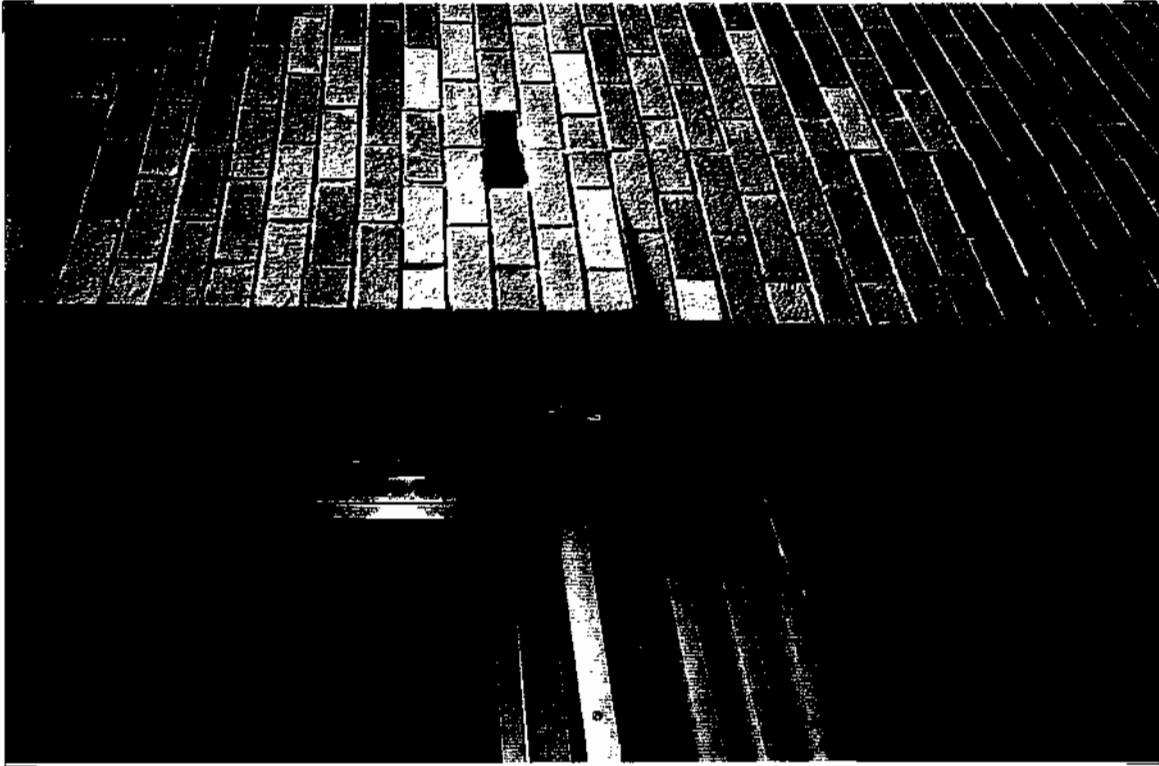
PHOTO W-3: CRACKED BRICK PILASTER (WITH TEST HOLE #2), EAST OF COL. LINE 5, IN BUILDING SOUTH FACADE, 3rd FLR. LEVEL.

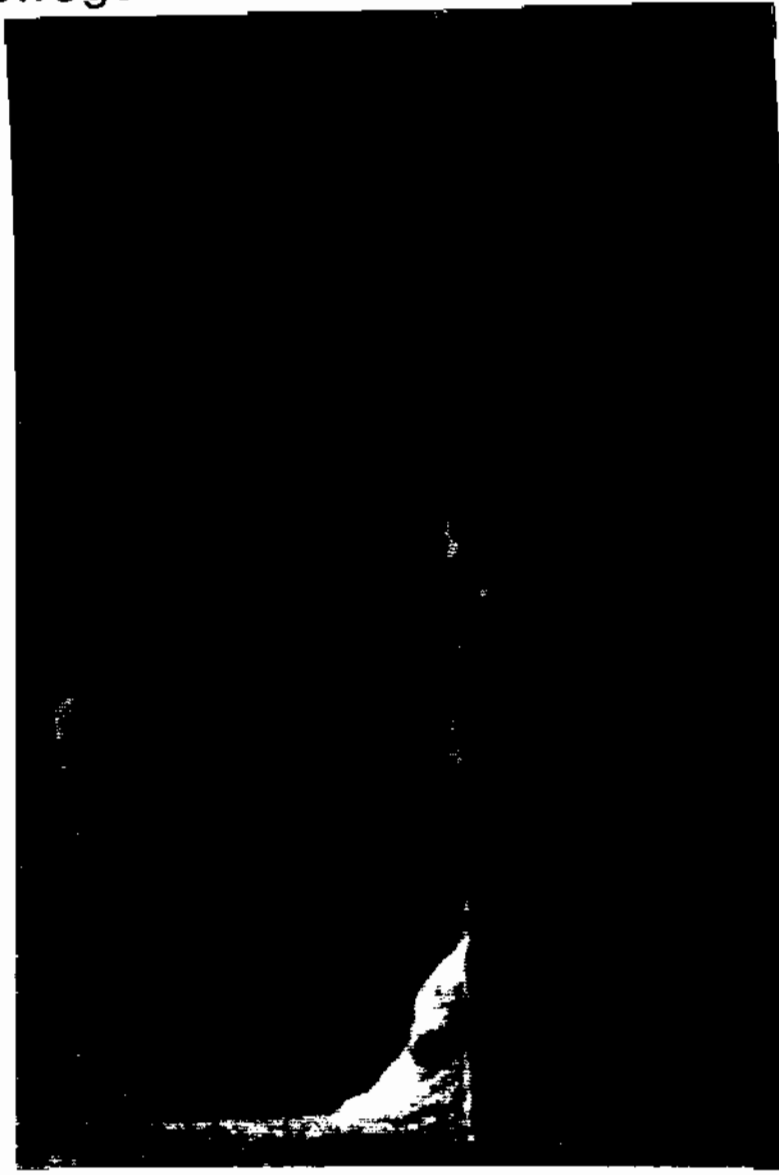
PHOTO W-4: TEST HOLE #2 IN BRICK PILASTER. NOTE ROOF DRAIN CONDUCTOR PIPE, WRAPPED WITH INSULATION.

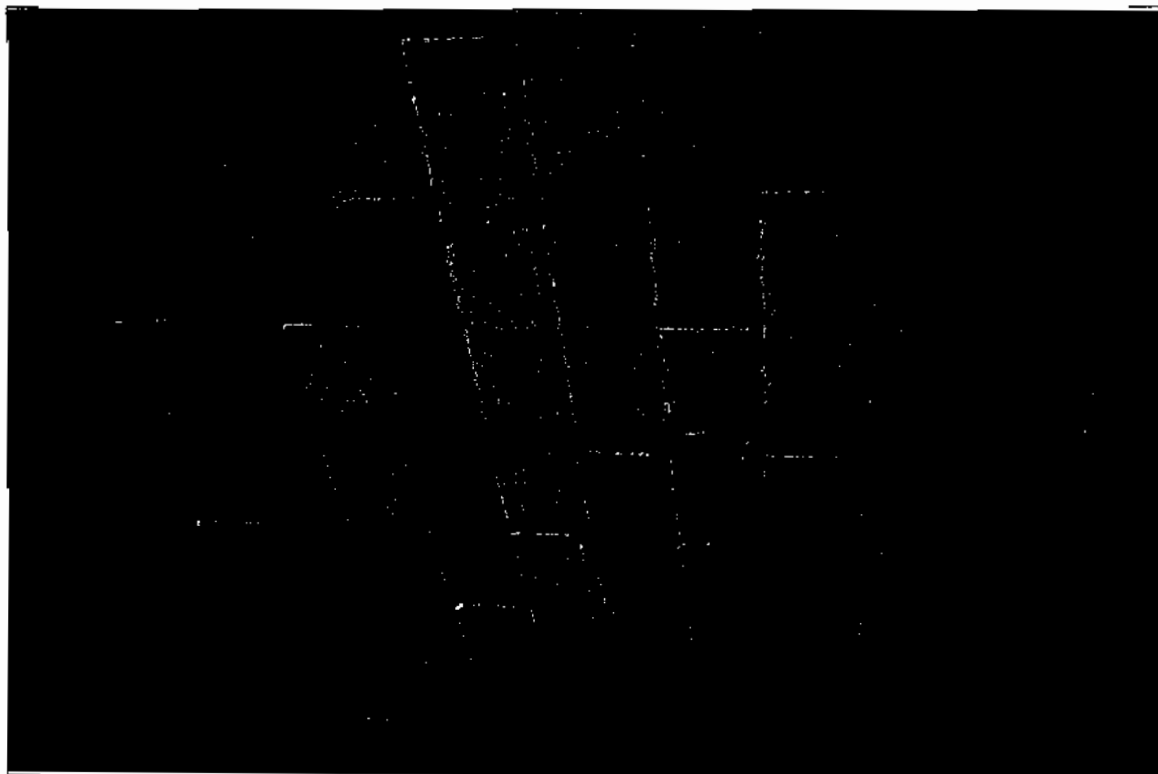
PHOTO W-6: VERTICAL CRACK IN BRICK PILASTER, EAST OF COL. LINE 5, IN BUILDING SOUTH FACADE, BETWEEN 2nd & 3rd. FLR. LEVELS

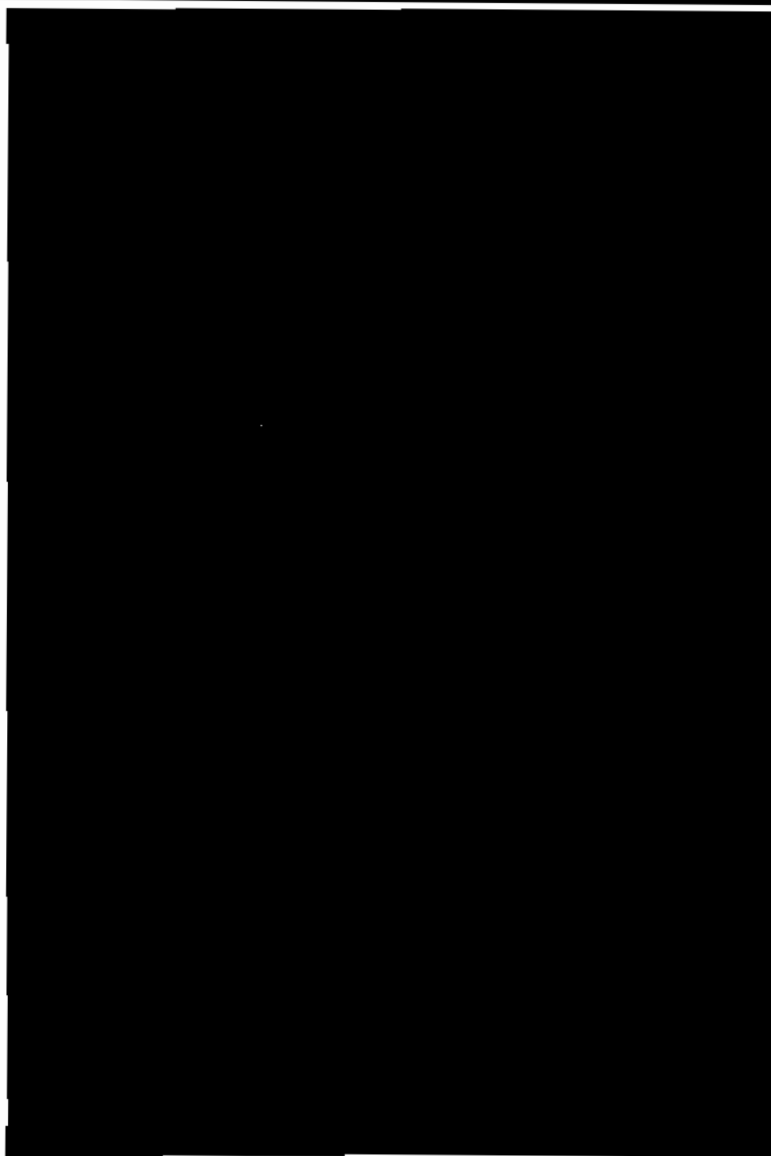
PHOTO W-5: CRACKS IN TOP OF BRICK PILASTER, EAST OF COL. LINE 5, IN BUILDING SOUTH FACADE.

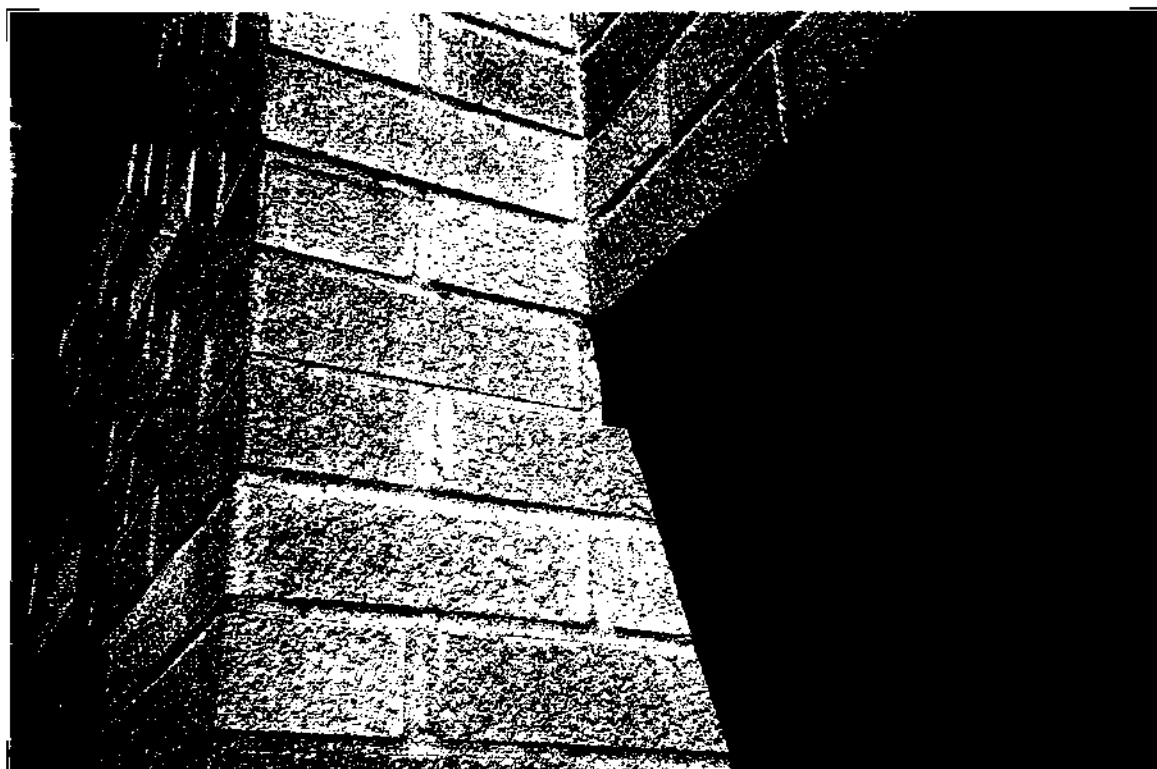
PHOTO W-8: SPALLED BRICK UNDER BRICK SHELF ANGLE AT BRICK PILASTER ON COL. LINE 5, AT 1st. FLOOR WINDOW IN BUILDING SOUTH FACADE.

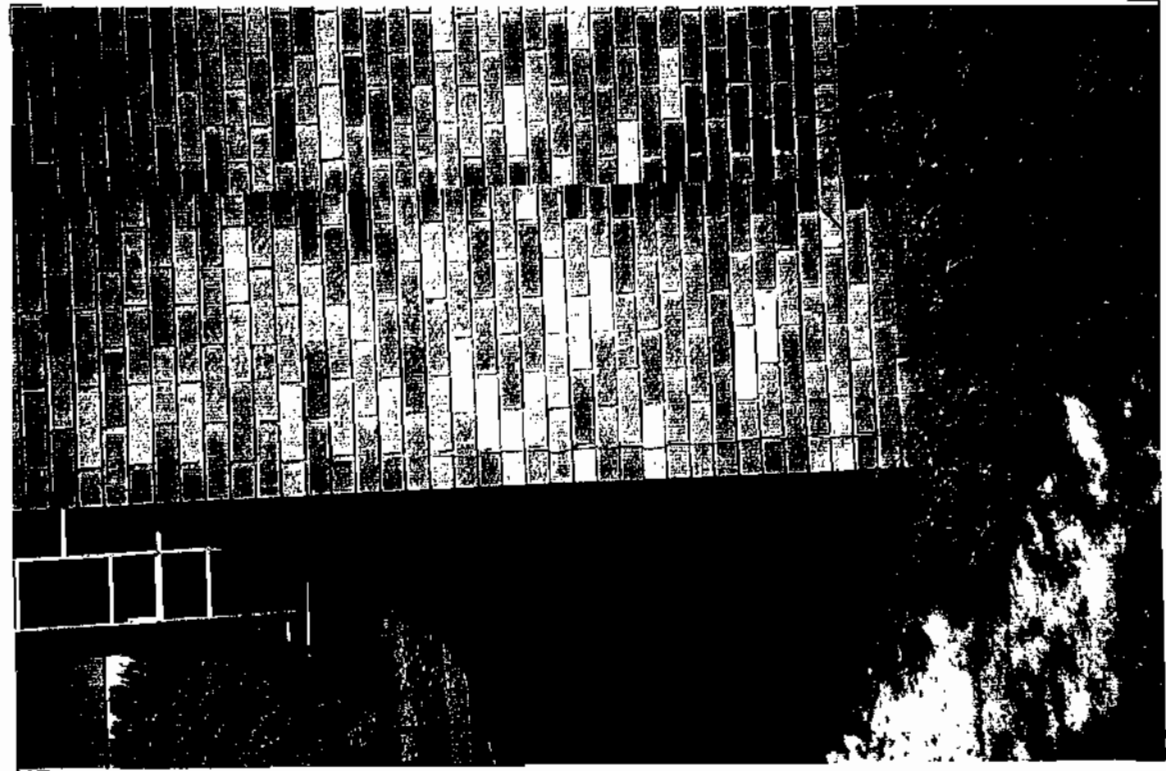
PHOTO W-9: VERTICAL CRACK IN BRICK PILASTER AT NORTHWEST CORNER OF 3-STORY.

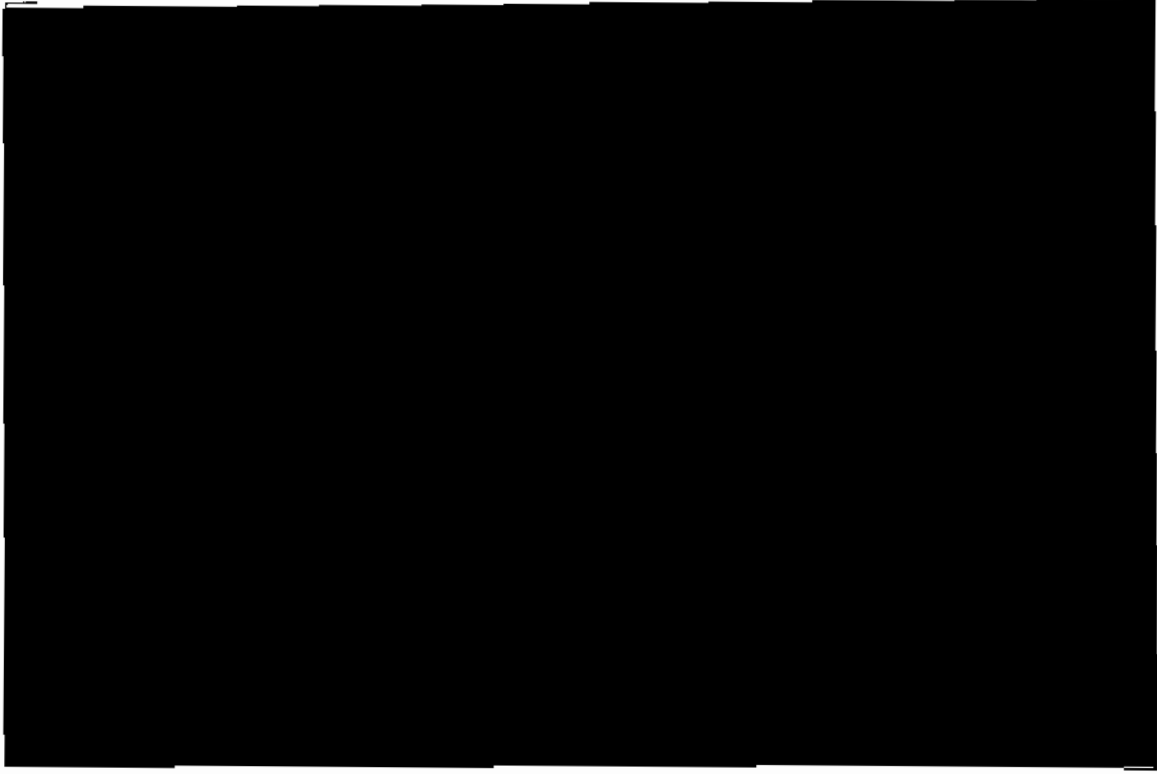
PHOTO W-12: CRACKED BRICK MASONRY IN  
EAST FACADE OF 1-STORY  
BUILDING WING.

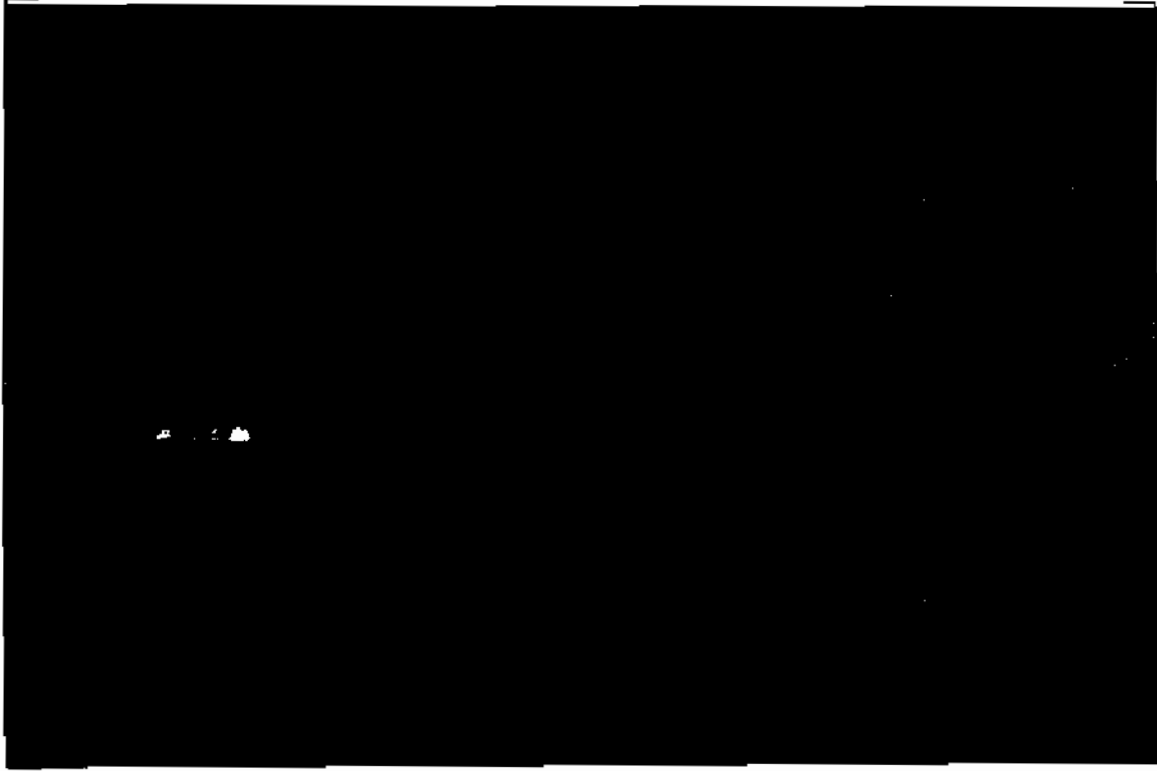
PHOTO W-11: CRACKED BRICK MASONRY IN  
EAST FACADE OF 1-STORY  
BUILDING WING.
