— SIMMONDS —

**EXTERIOR BUILDING STUDY**  
**for**  
**CULKIN HALL, MAHAR HALL & WILBER HALL**  
**SUNY OSWEGO CAMPUS**  
**OSWEGO, NEW YORK**

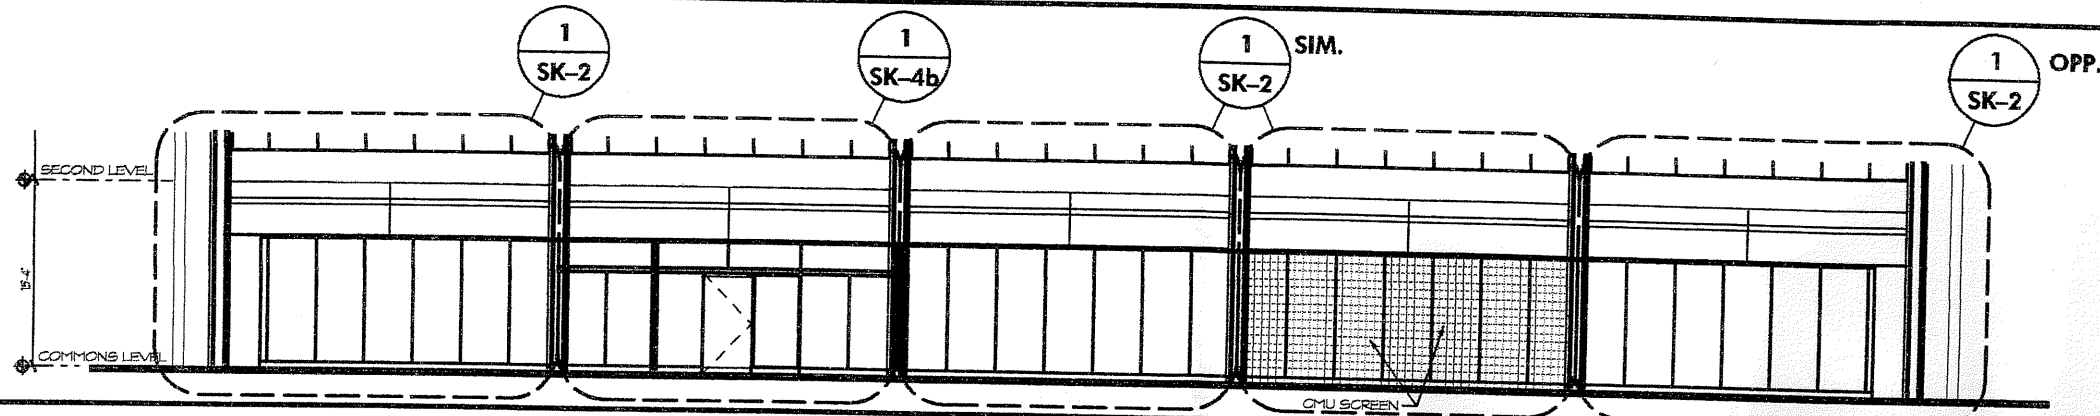
4 SK-1 FIRST FLOOR NORTH PARTIAL ELEVATION

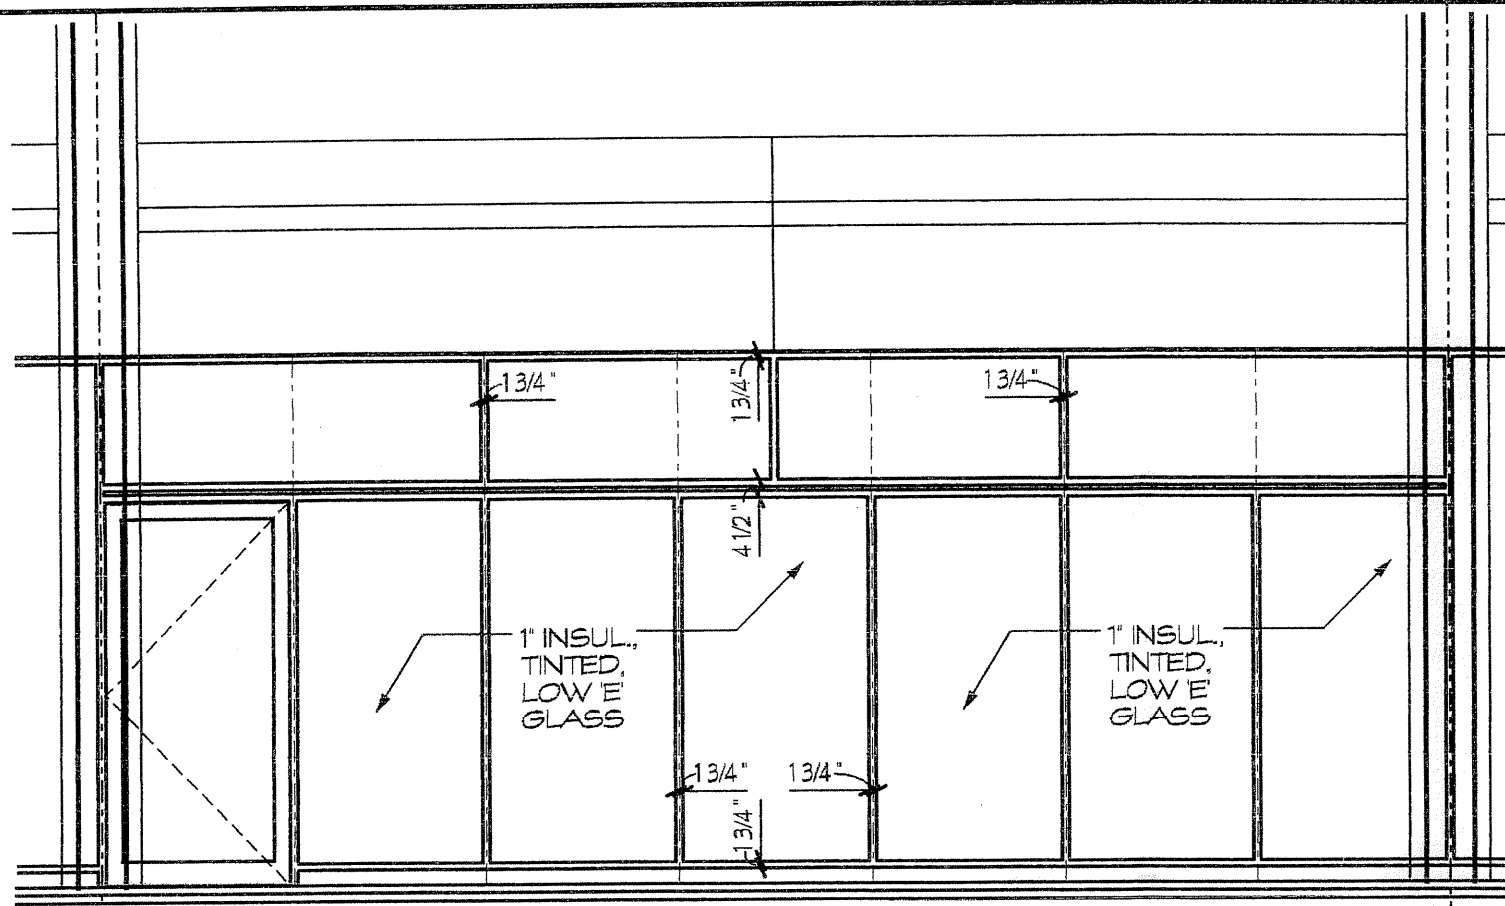
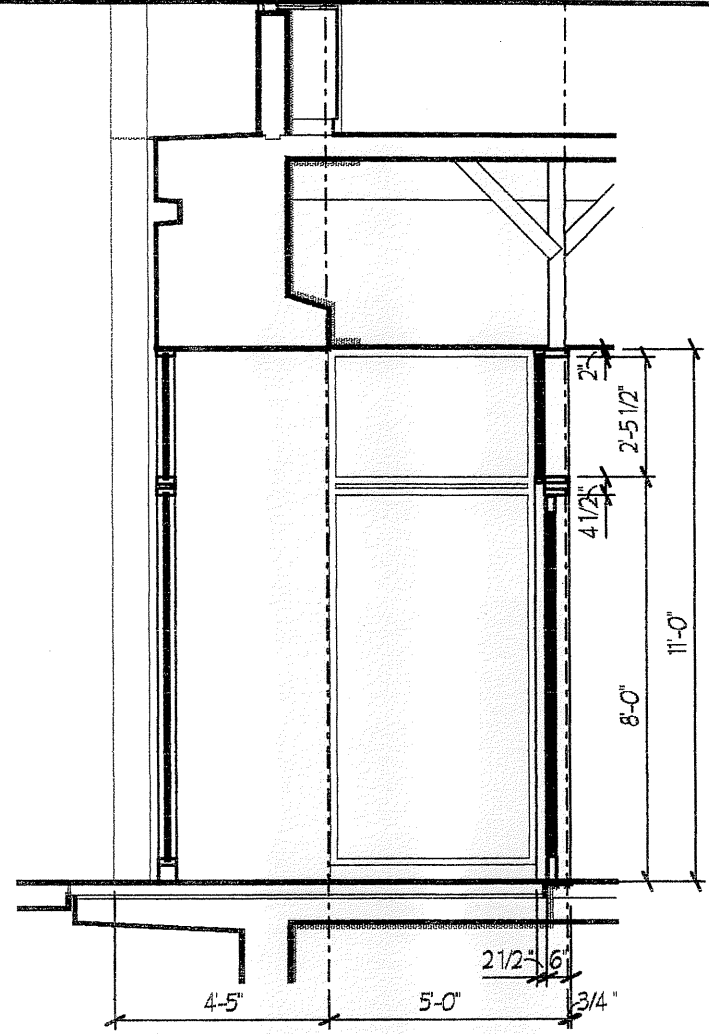
**A** ENTRANCE ELEVATION BAYS  
SK-4a

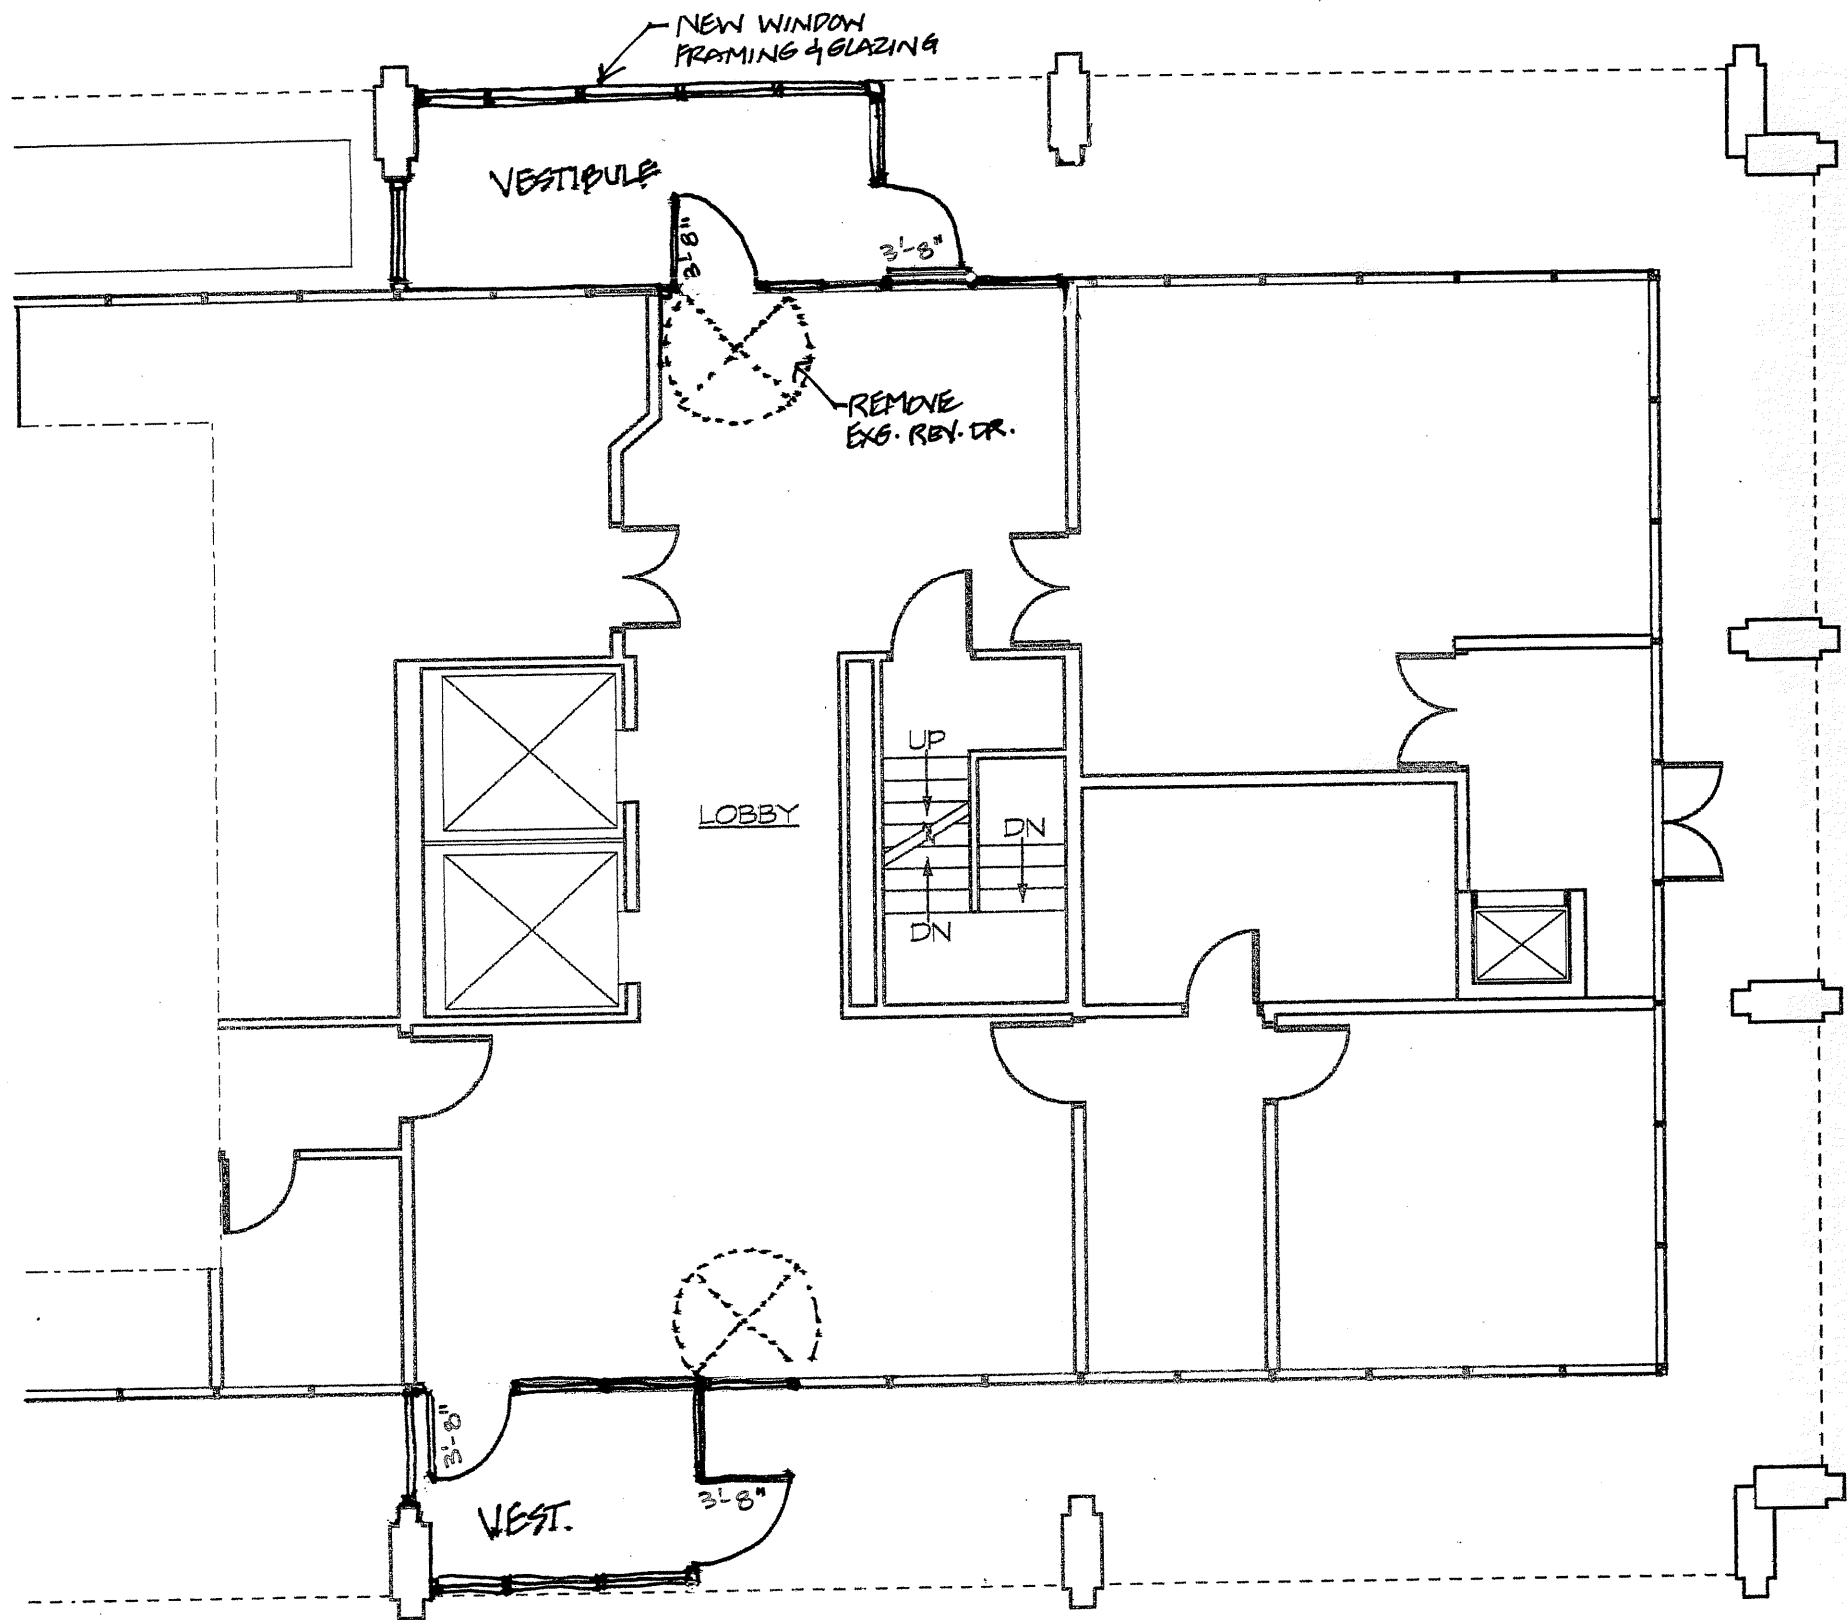
JCM ARCHITECTURAL ASSOCIATES  
300 HAWLEY AVENUE  
SYRACUSE, NEW YORK 13203  
315-424-0141 FAX 315-478-8053

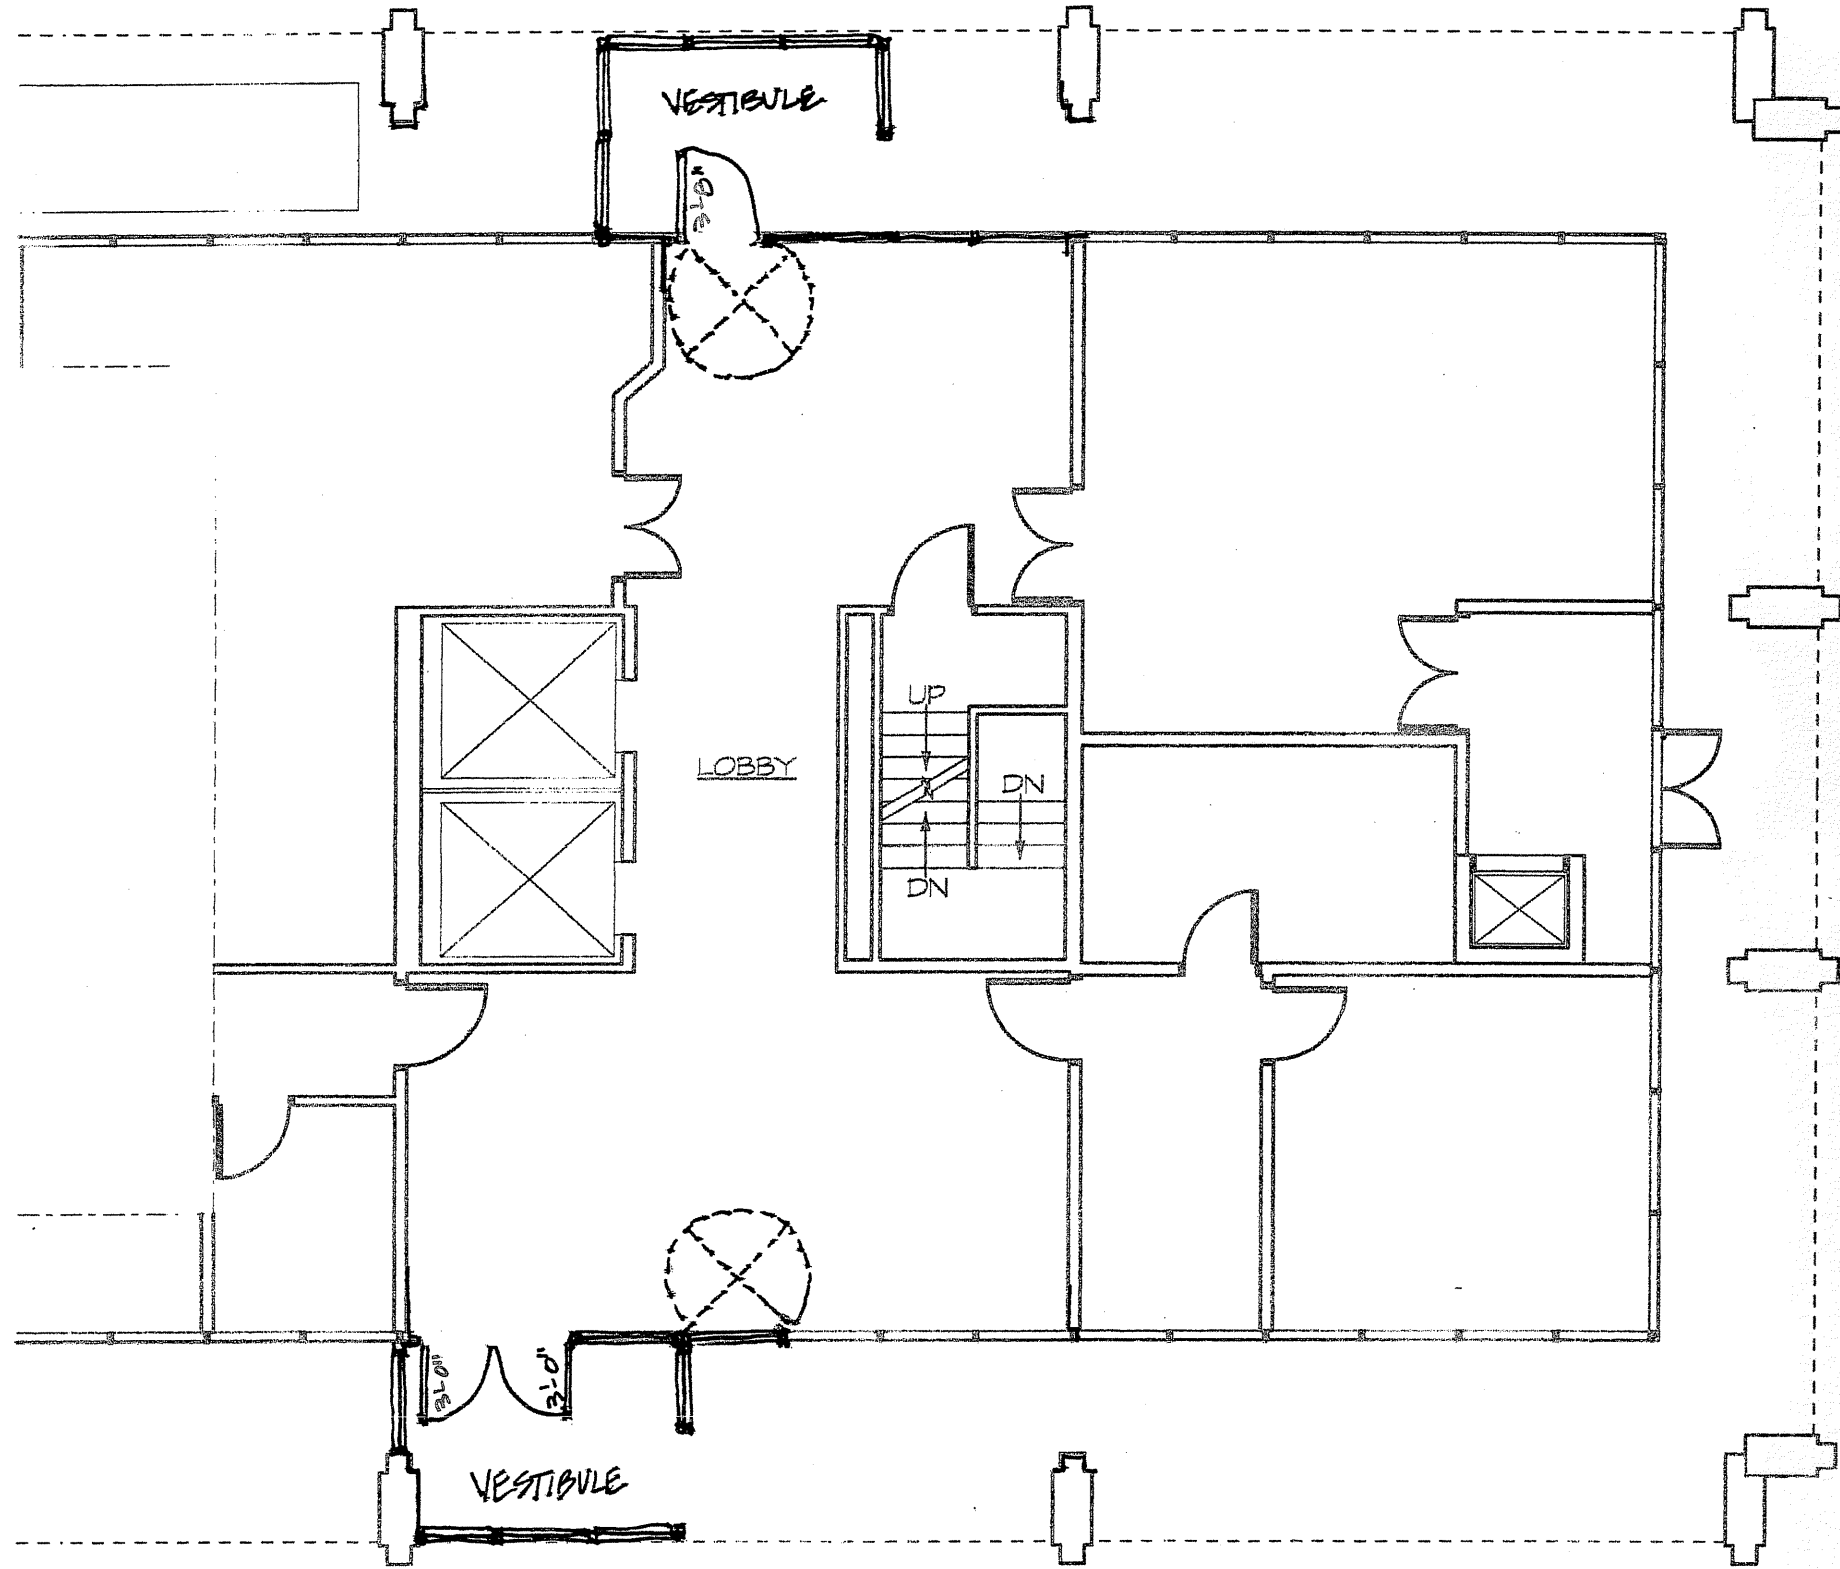
SHEET NUMBER <b>SK-7a</b>	
DATE JUNE 30, 1999	SCALE AS NOTED
JOB NUMBER 98-053	
S. U. N. Y. @ OSWEGO <b>SUNNY OSWEGO</b> EXTERIOR BUILDING STUDY Oswego New York DRAWING DESCRIPTION	
JCM ARCHITECTURAL ASSOCIATES 300 HAWLEY AVENUE SYRACUSE, NEW YORK 13203 315-424-0141 FAX 315-478-8053

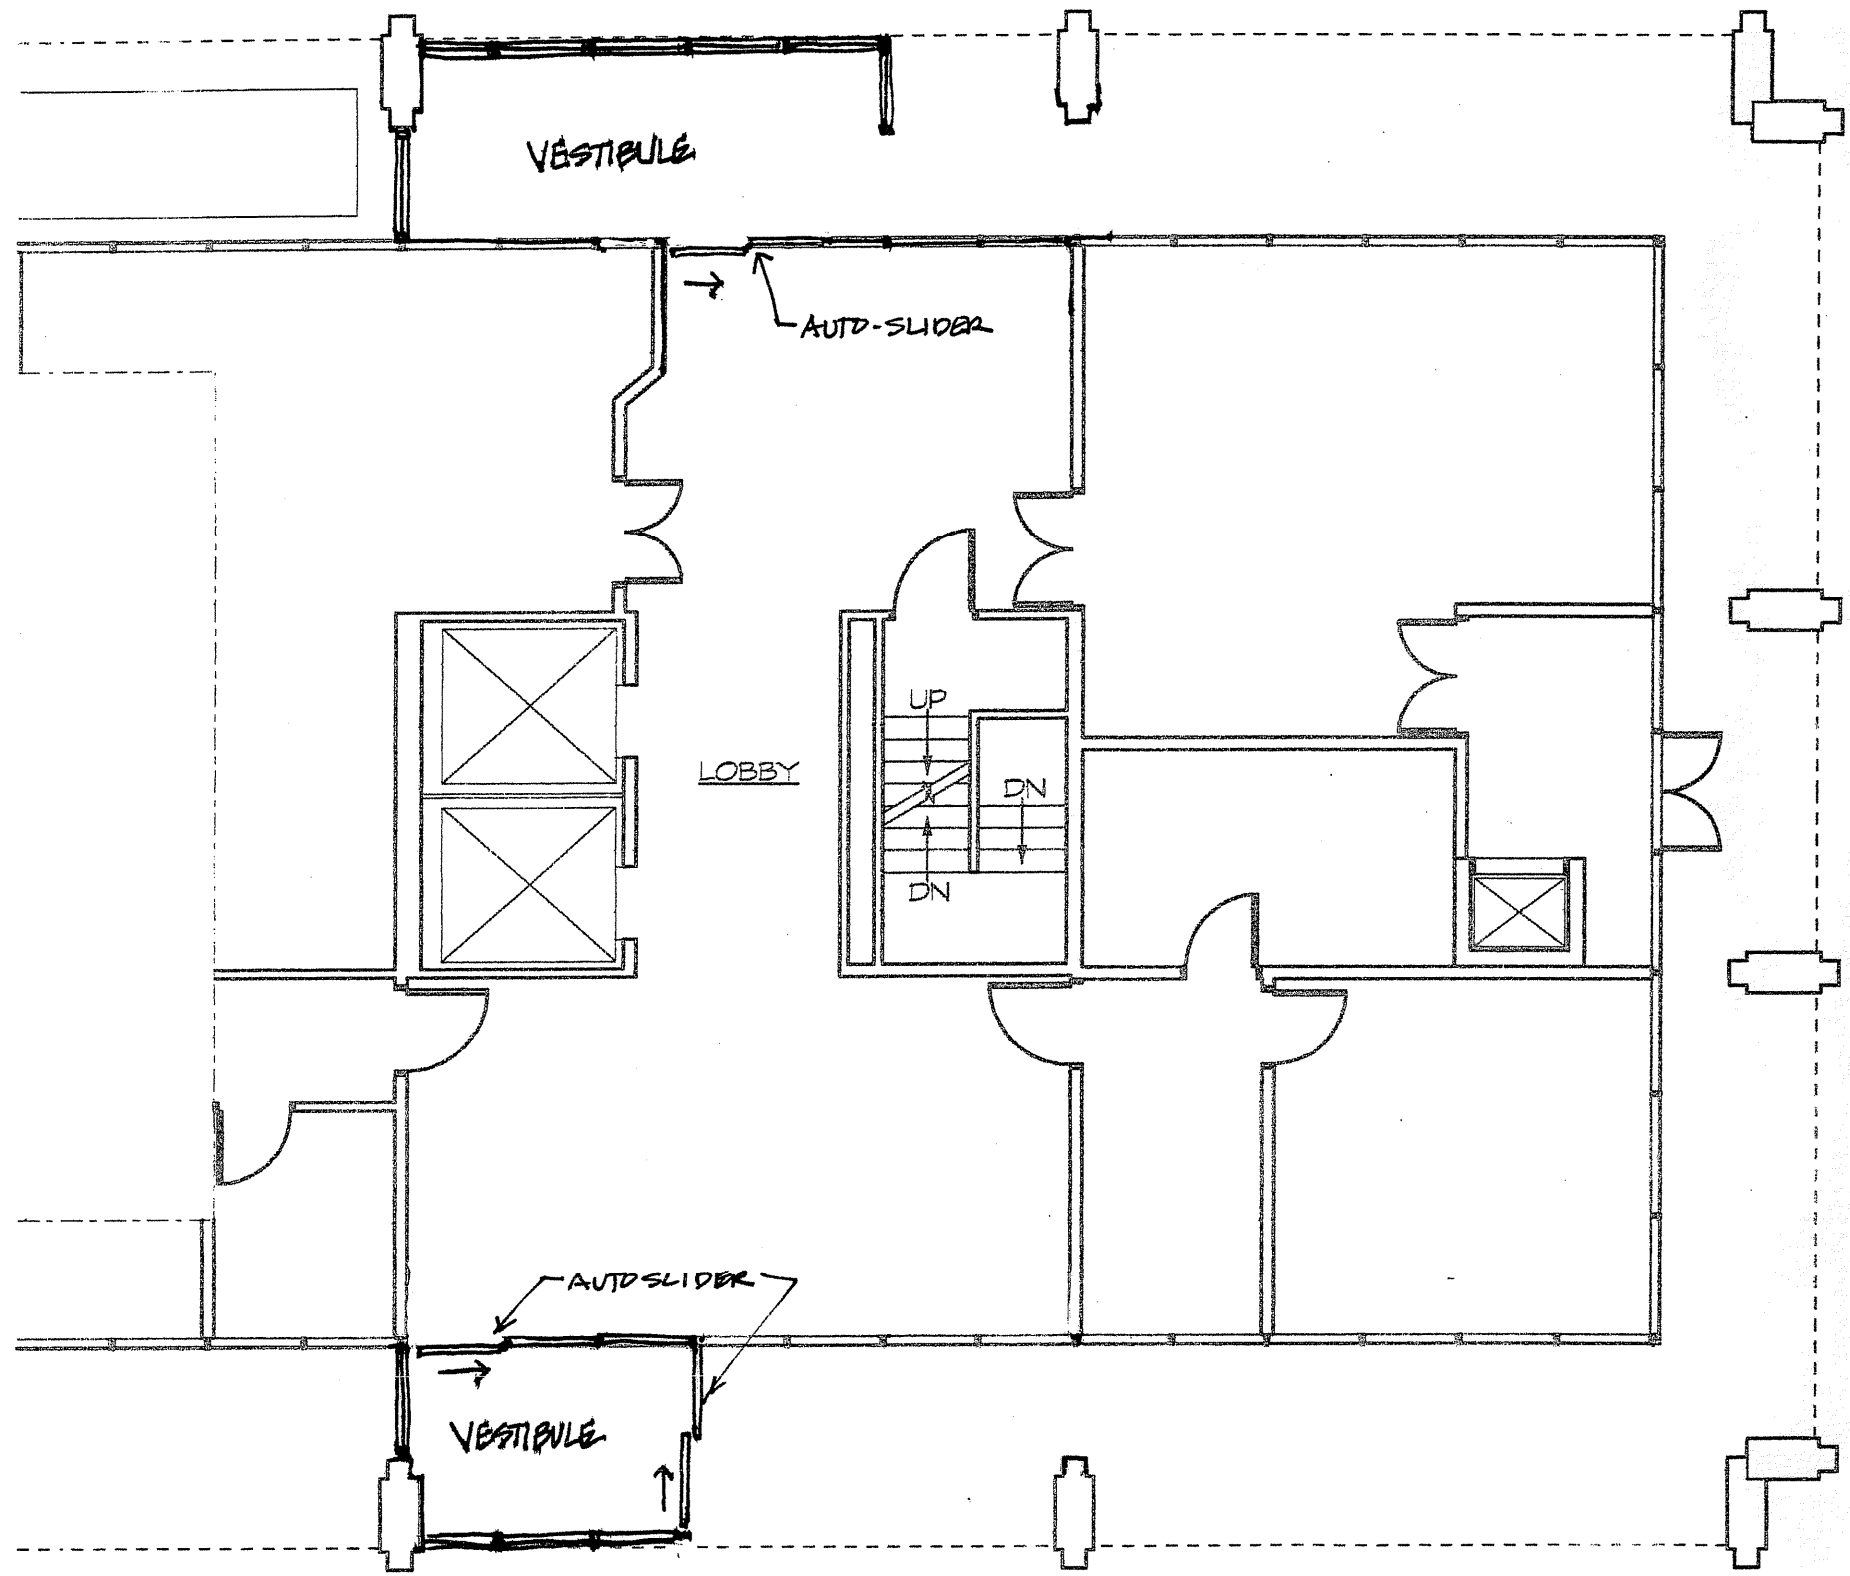
JCM ARCHITECTURAL ASSOCIATES  
300 HAWLEY AVENUE  
SYRACUSE, NEW YORK 13203  
315-424-0141 FAX 315-478-8053

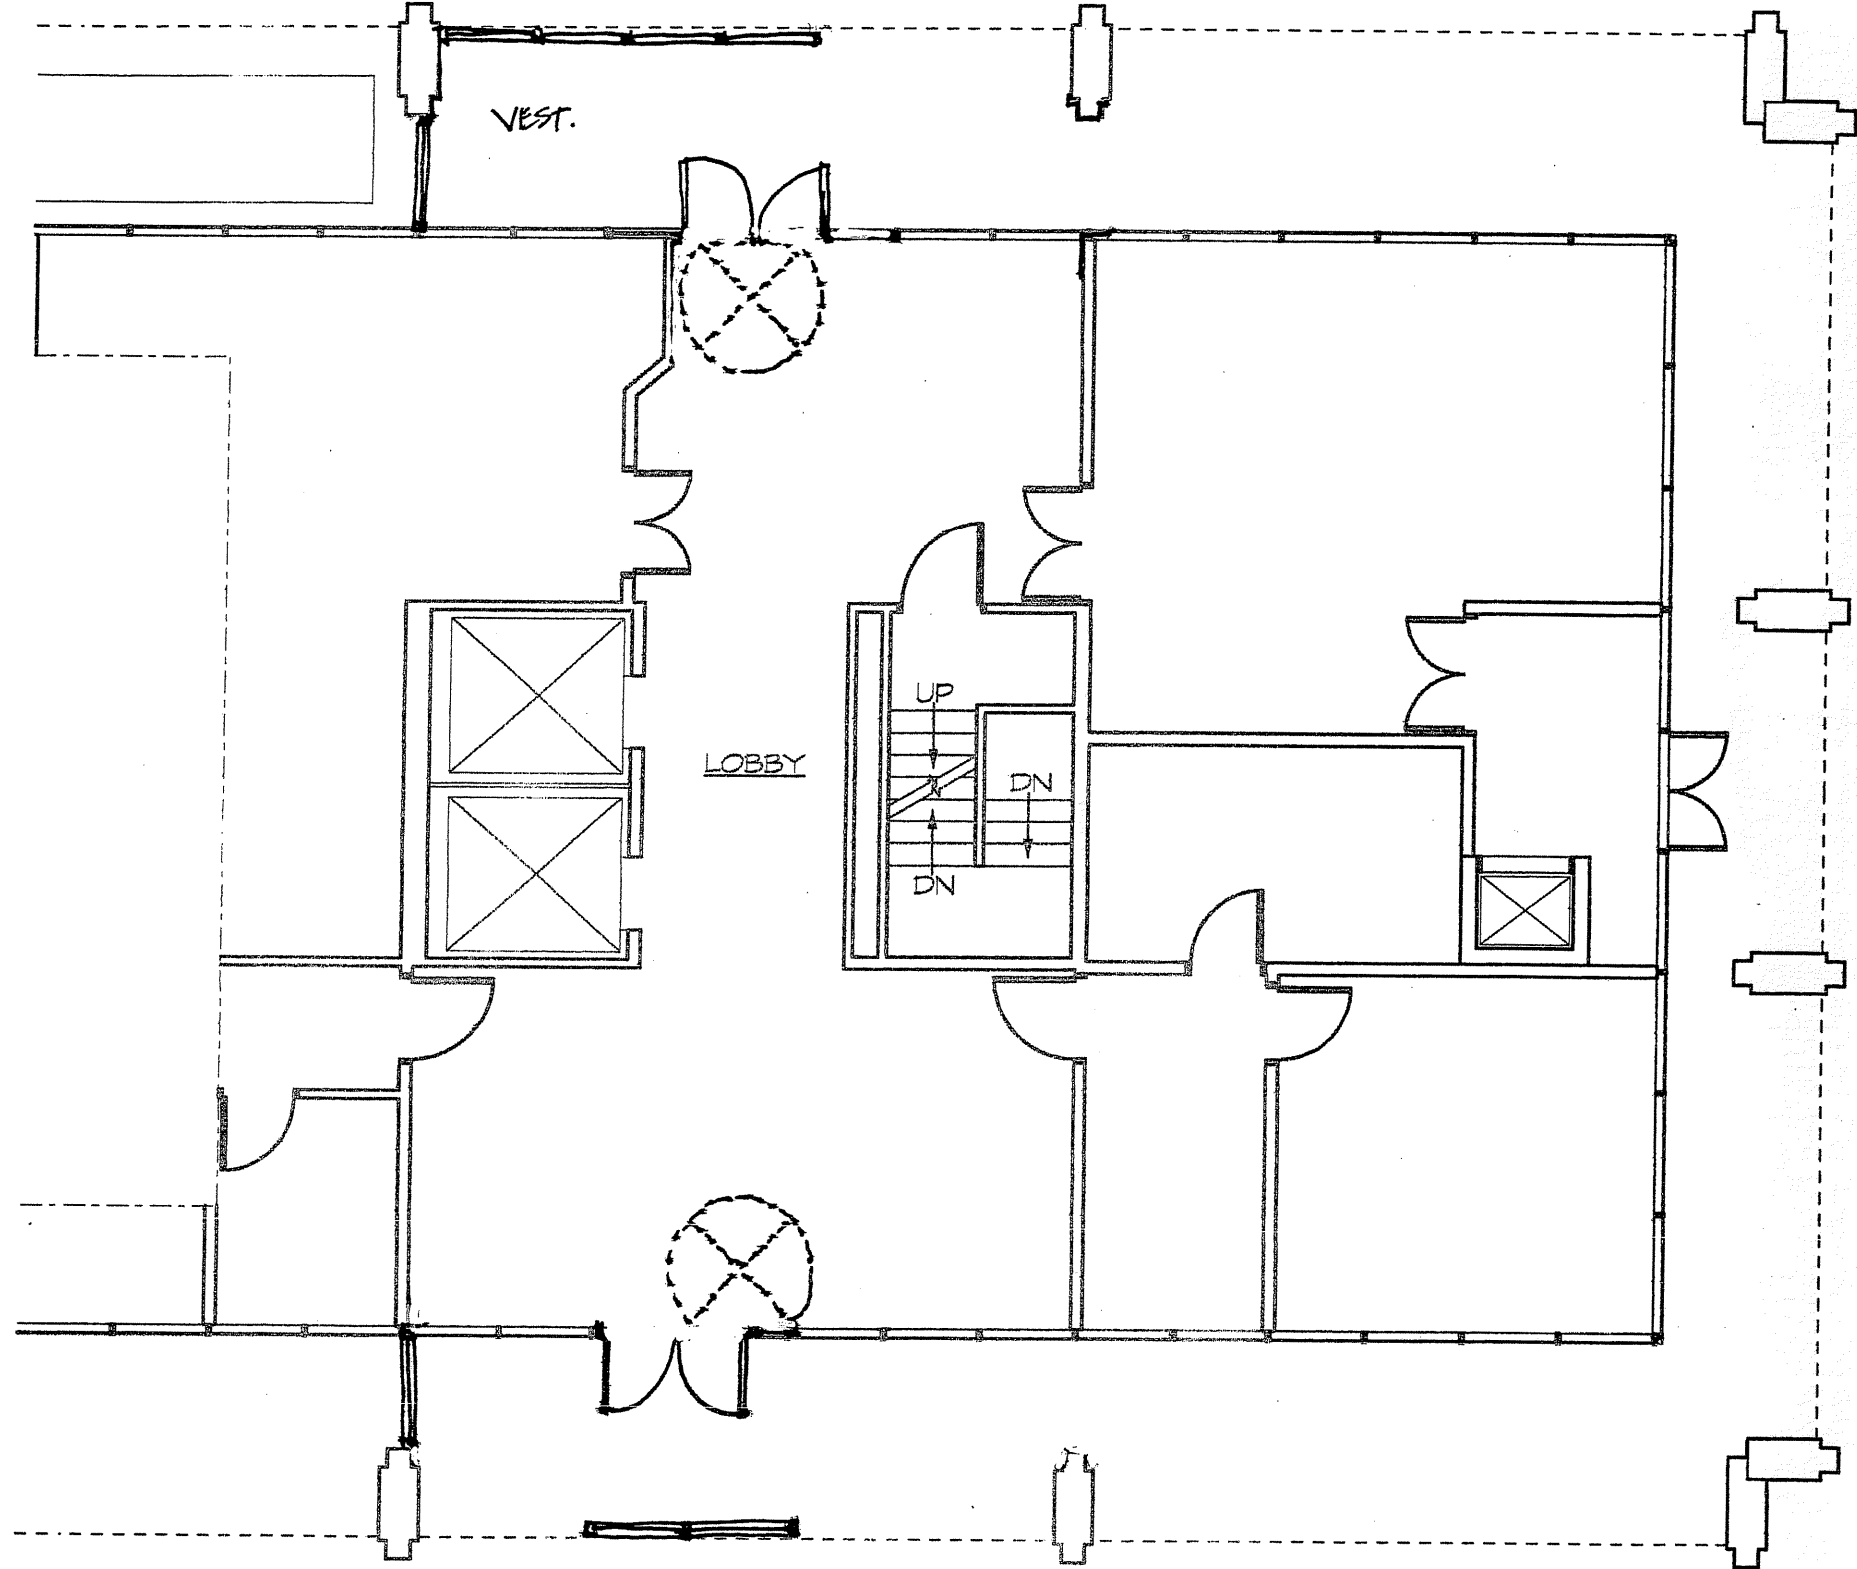
SHEET NUMBER <b>SK-7c</b>	
DATE JUNE 30, 1999	SCALE AS NOTED
JOB NUMBER 98-053	
S. U. N. Y. @ OSWEGO <b>SUNY OSWEGO</b> EXTERIOR BUILDING STUDY OSWEGO NEW YORK DRAWING DESCRIPTION	
JCM ARCHITECTURAL ASSOCIATES 300 HAWLEY AVENUE SYRACUSE, NEW YORK 13203 315-424-0141 FAX 315-478-8053

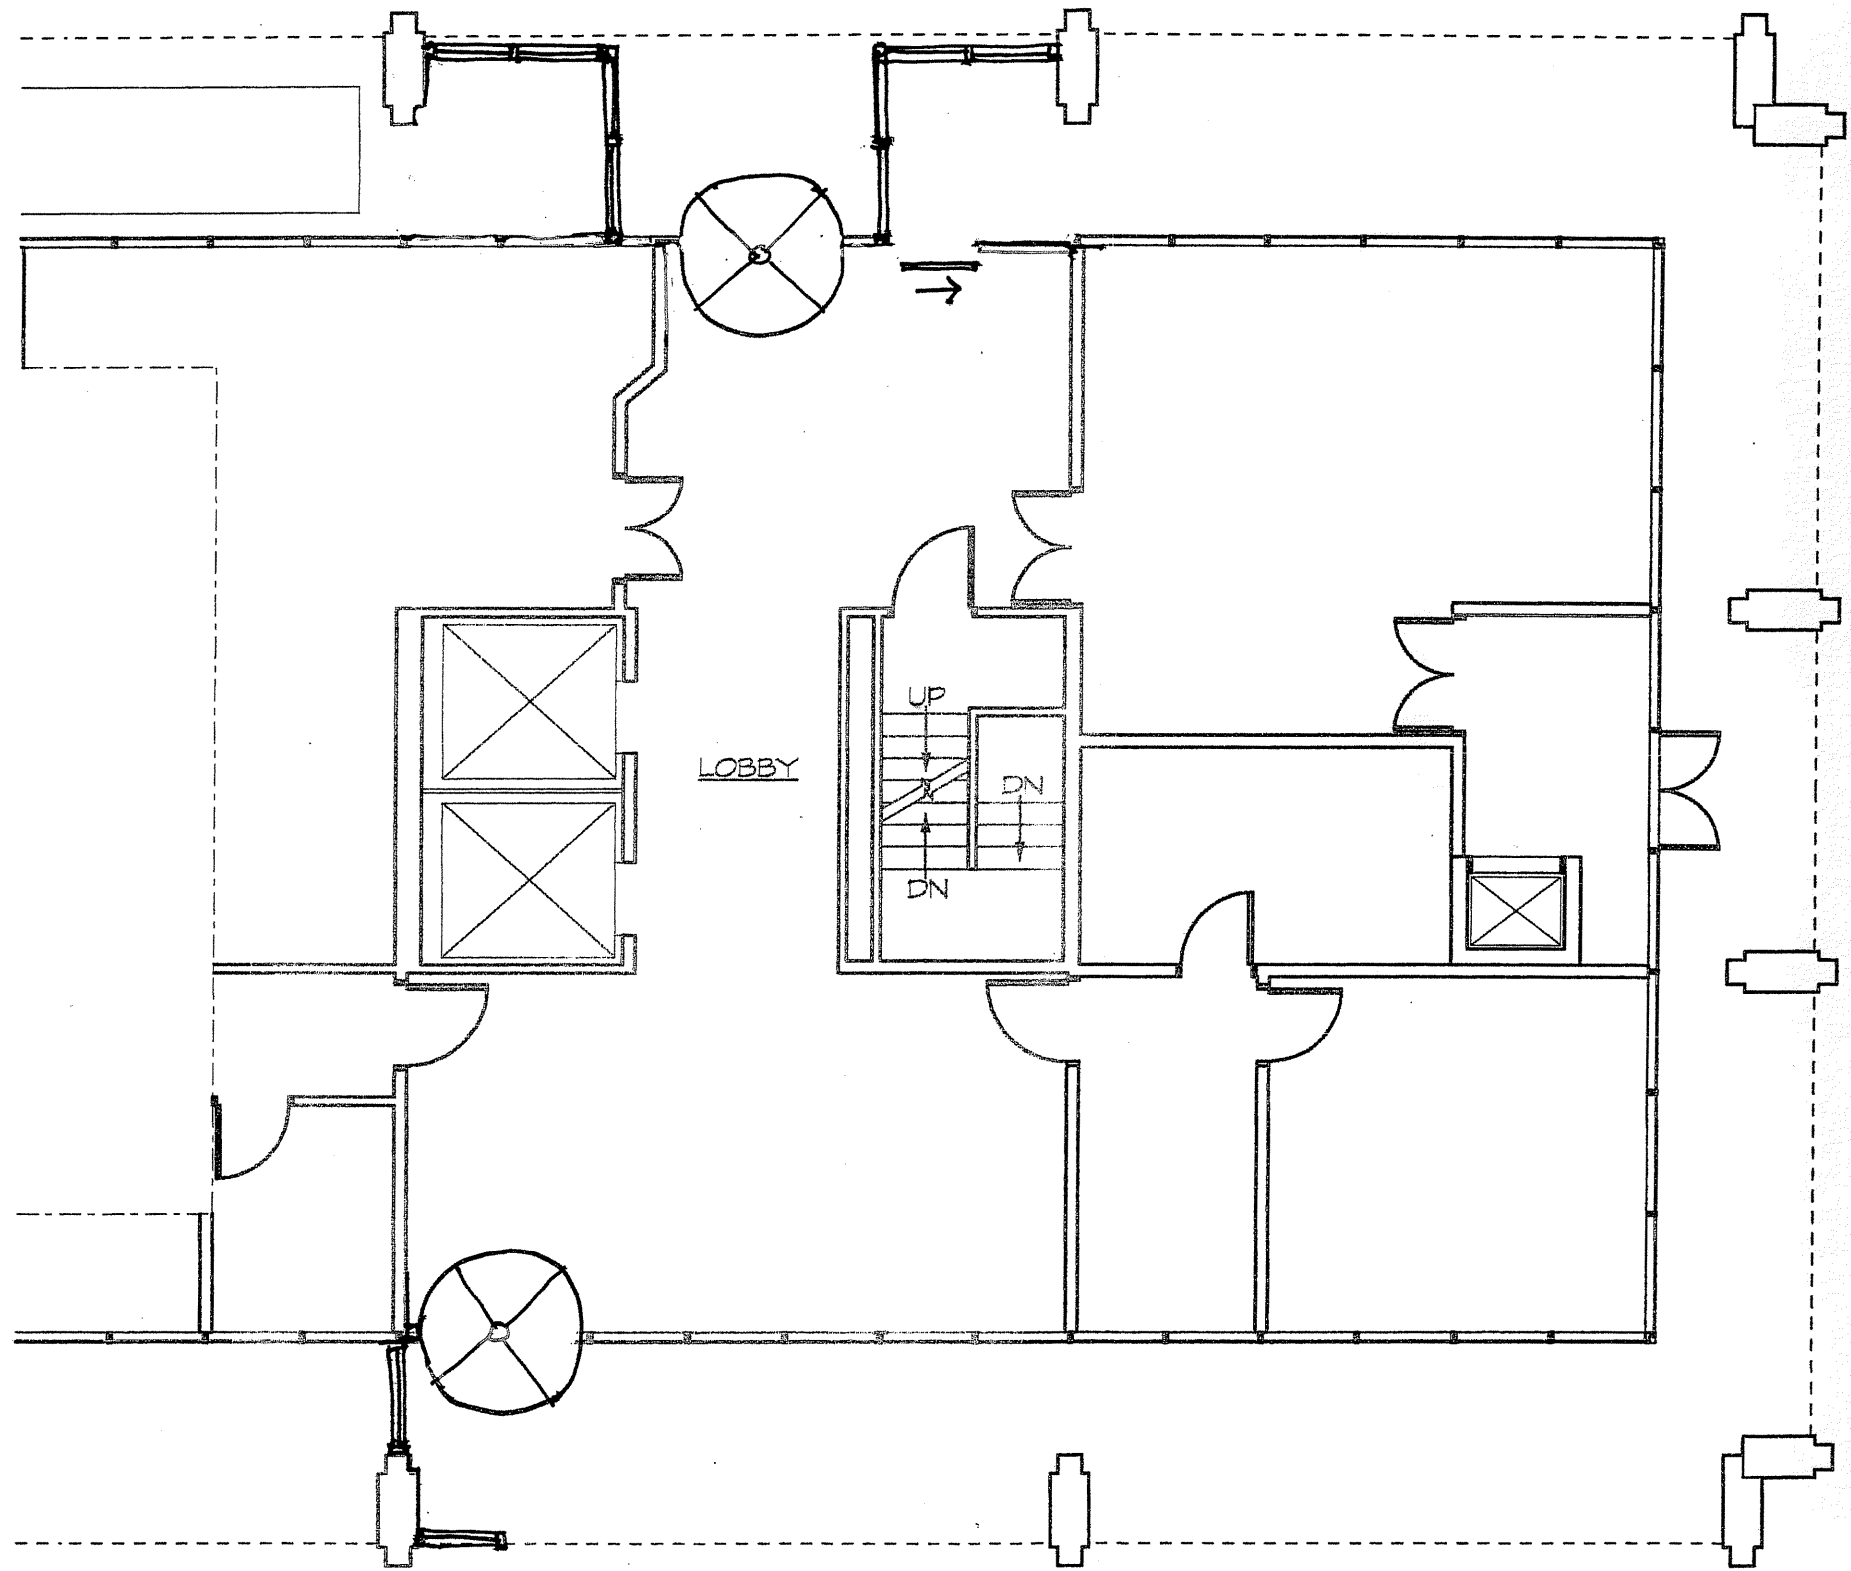
SHEET NUMBER <b>SK-7g</b>	
DATE JUNE 30, 1999	SCALE AS NOTED
JOB NUMBER 98-053	
EXTERIOR BUILDING STUDY Oswego, New York	
DRAWING DESCRIPTION	
JCM ARCHITECTURAL ASSOCIATES 300 HAWLEY AVENUE SYRACUSE, NEW YORK 13203 315-424-0141 FAX 315-478-8053

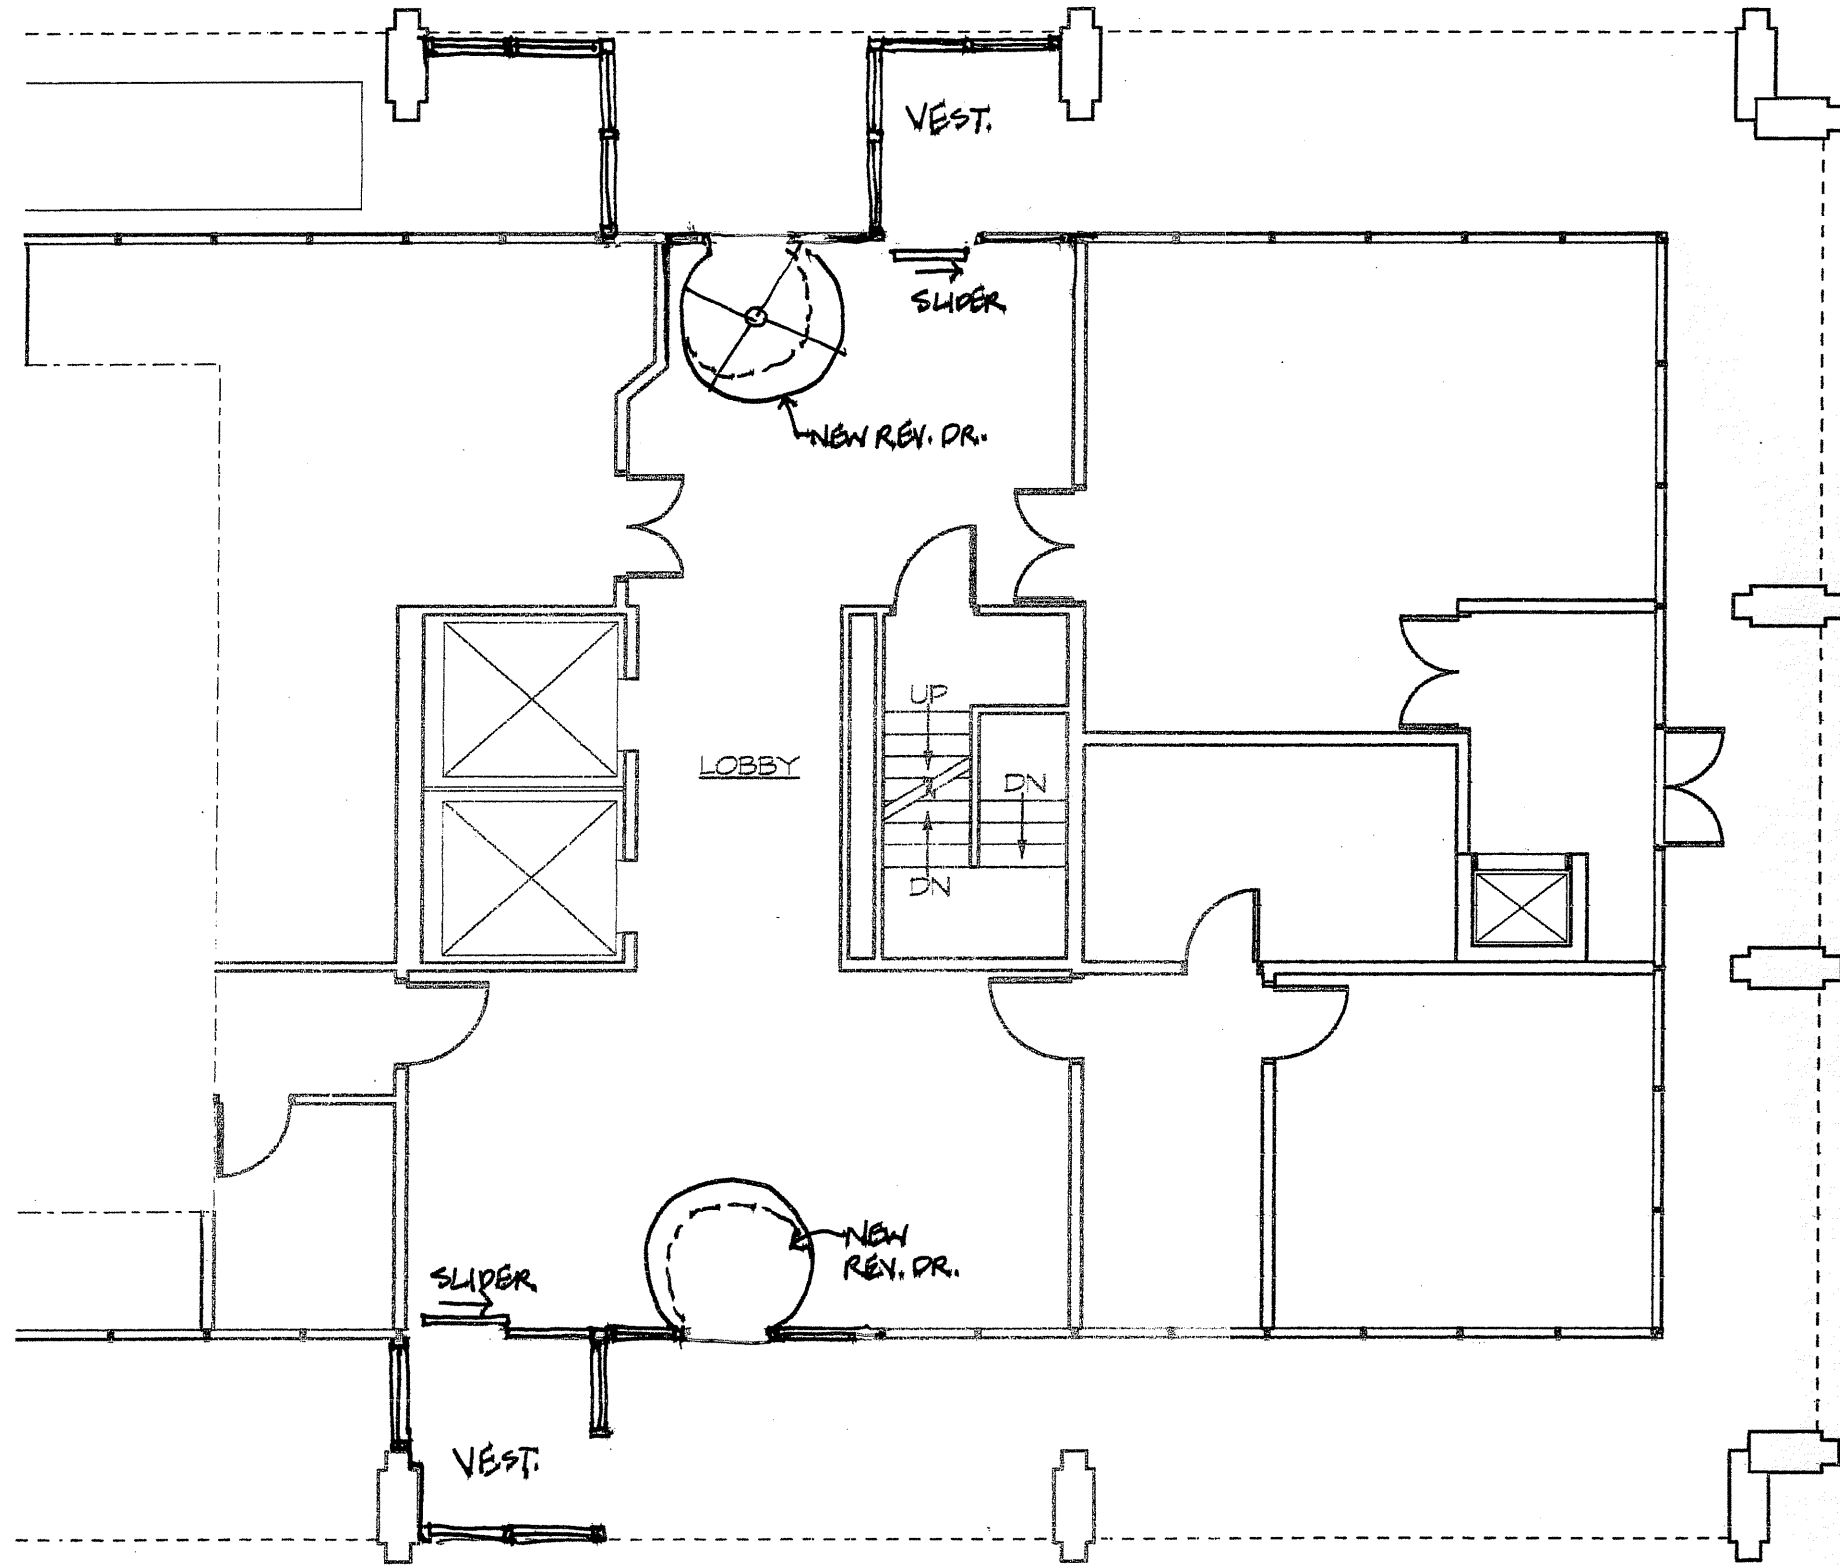
SHEET NUMBER  
**SK-7h**
