— SIMMONDS —

**EXTERIOR BUILDING STUDY**  
**for**  
**CULKIN HALL, MAHAR HALL & WILBER HALL**  
**SUNY OSWEGO CAMPUS**  
**OSWEGO, NEW YORK**

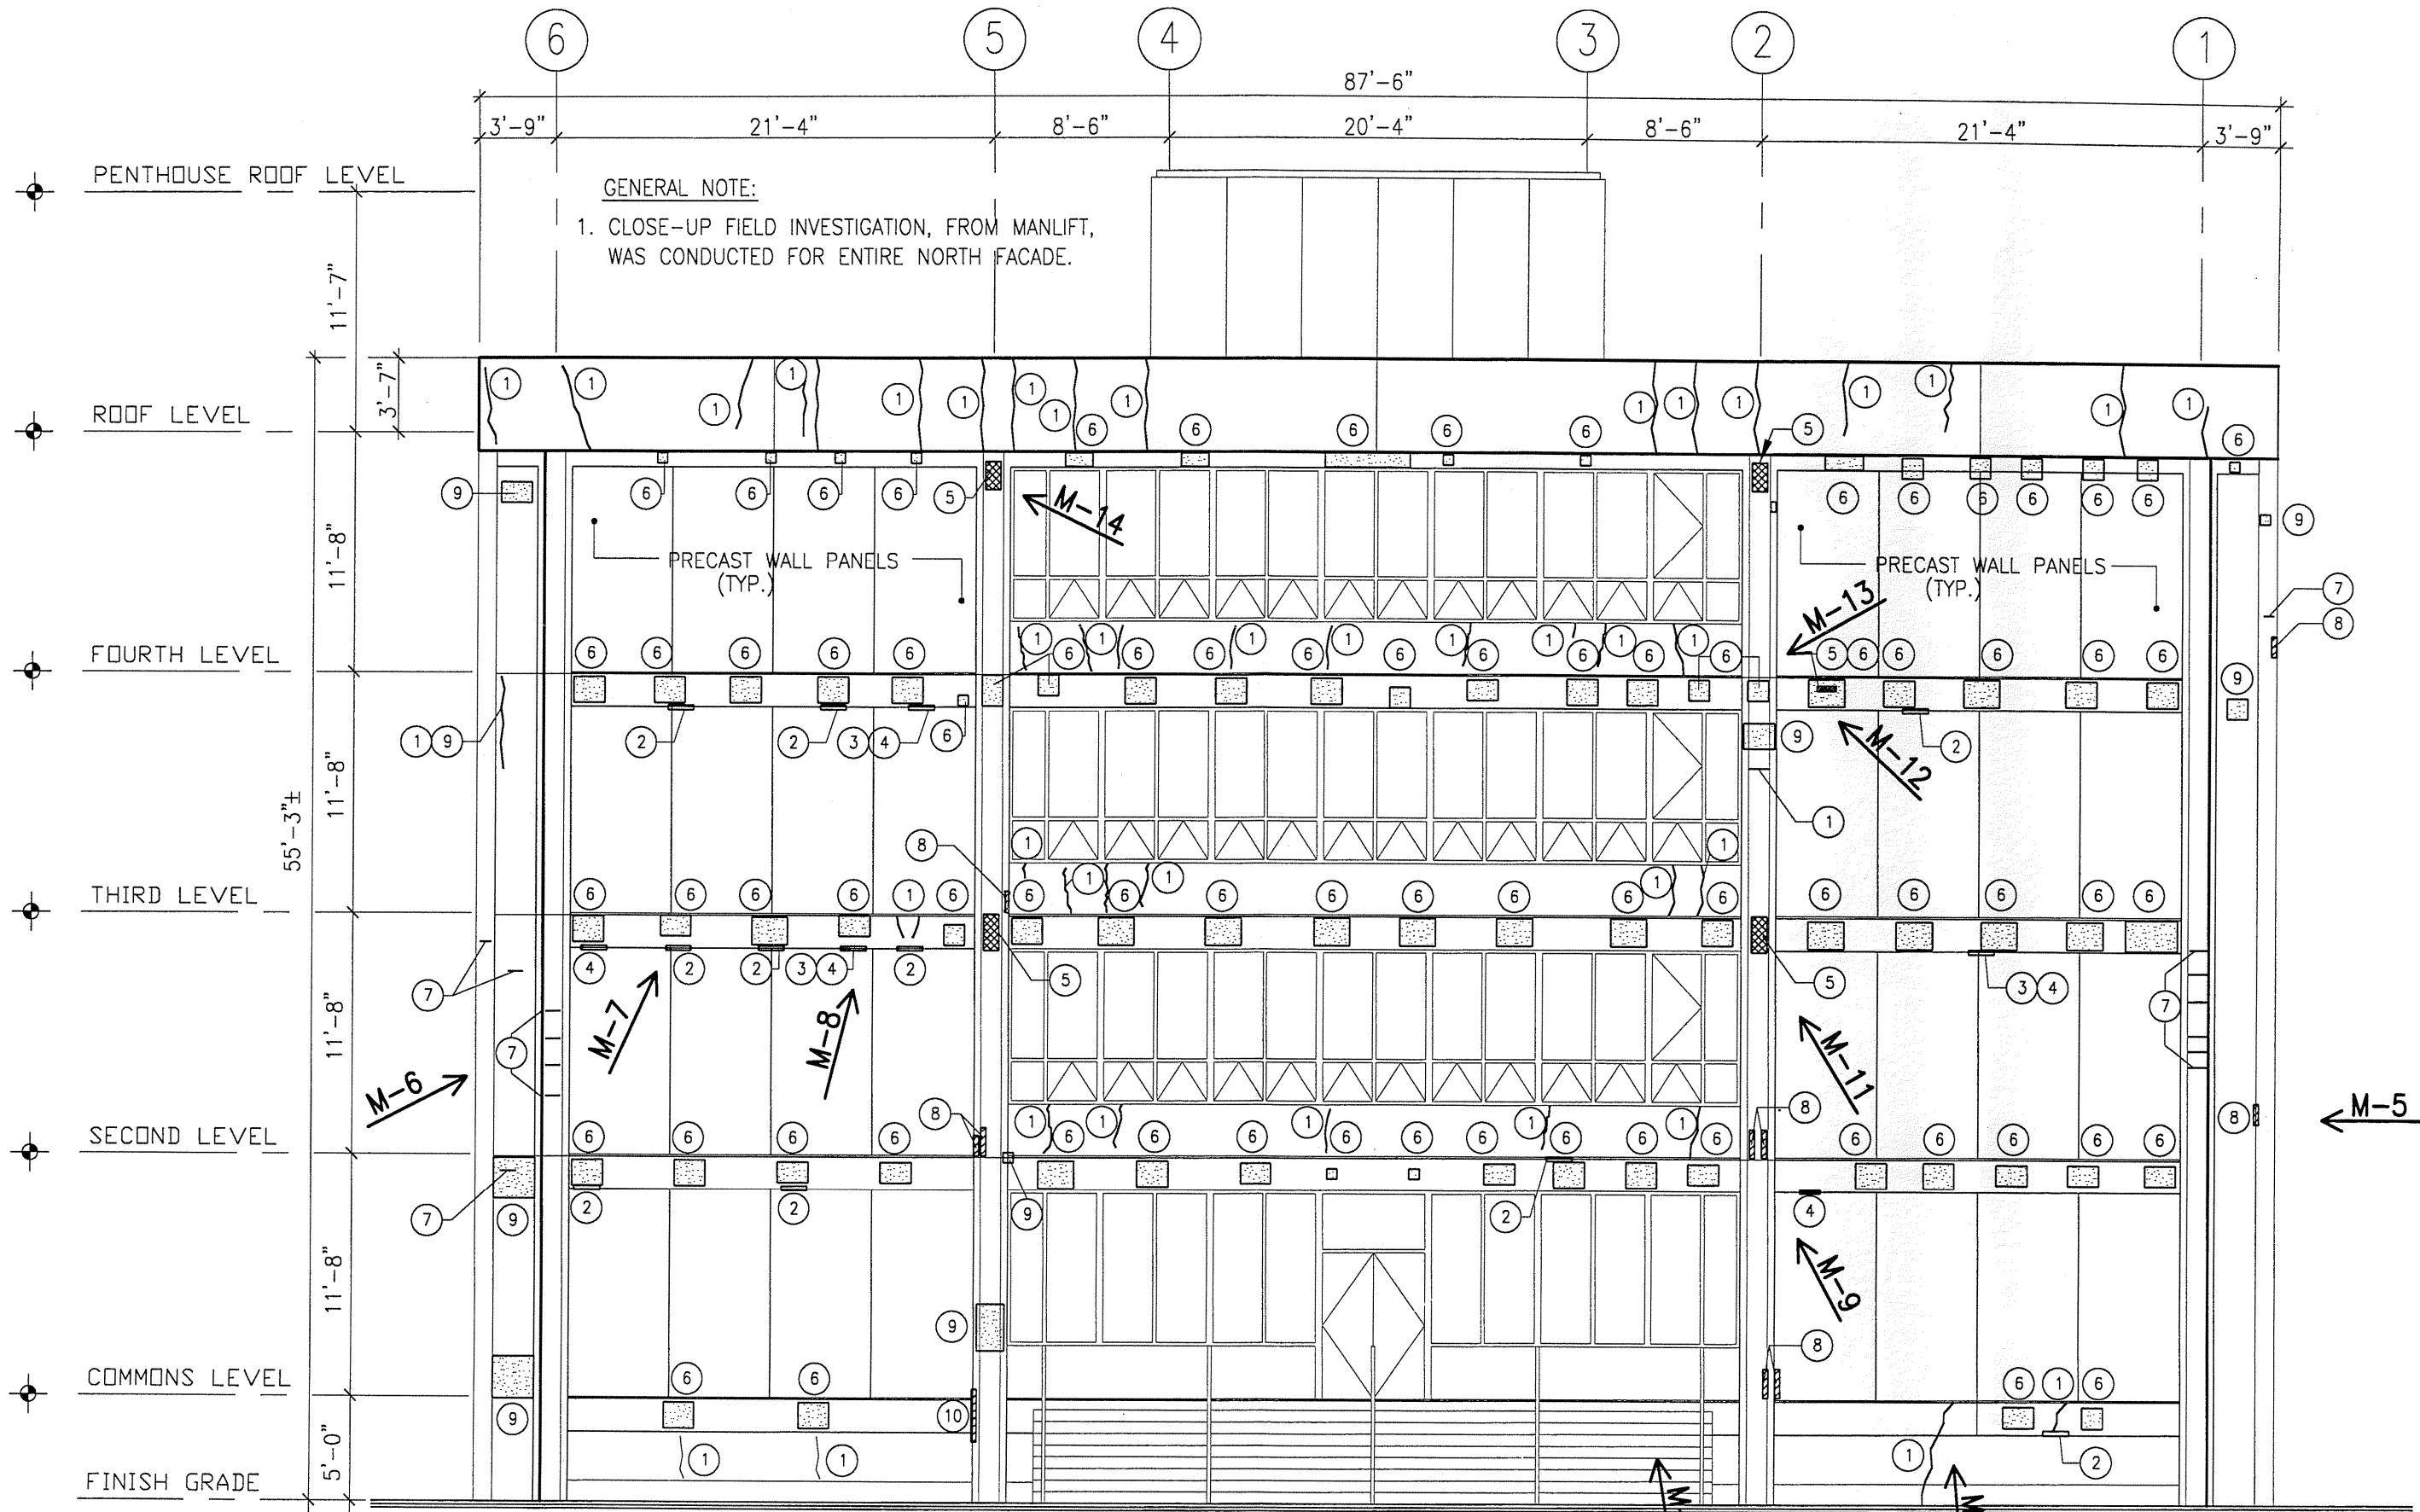
GENERAL NOTE:  
 1. CLOSE-UP FIELD INVESTIGATION, FROM MANLIFT, WAS CONDUCTED FOR ENTIRE NORTH FACADE.

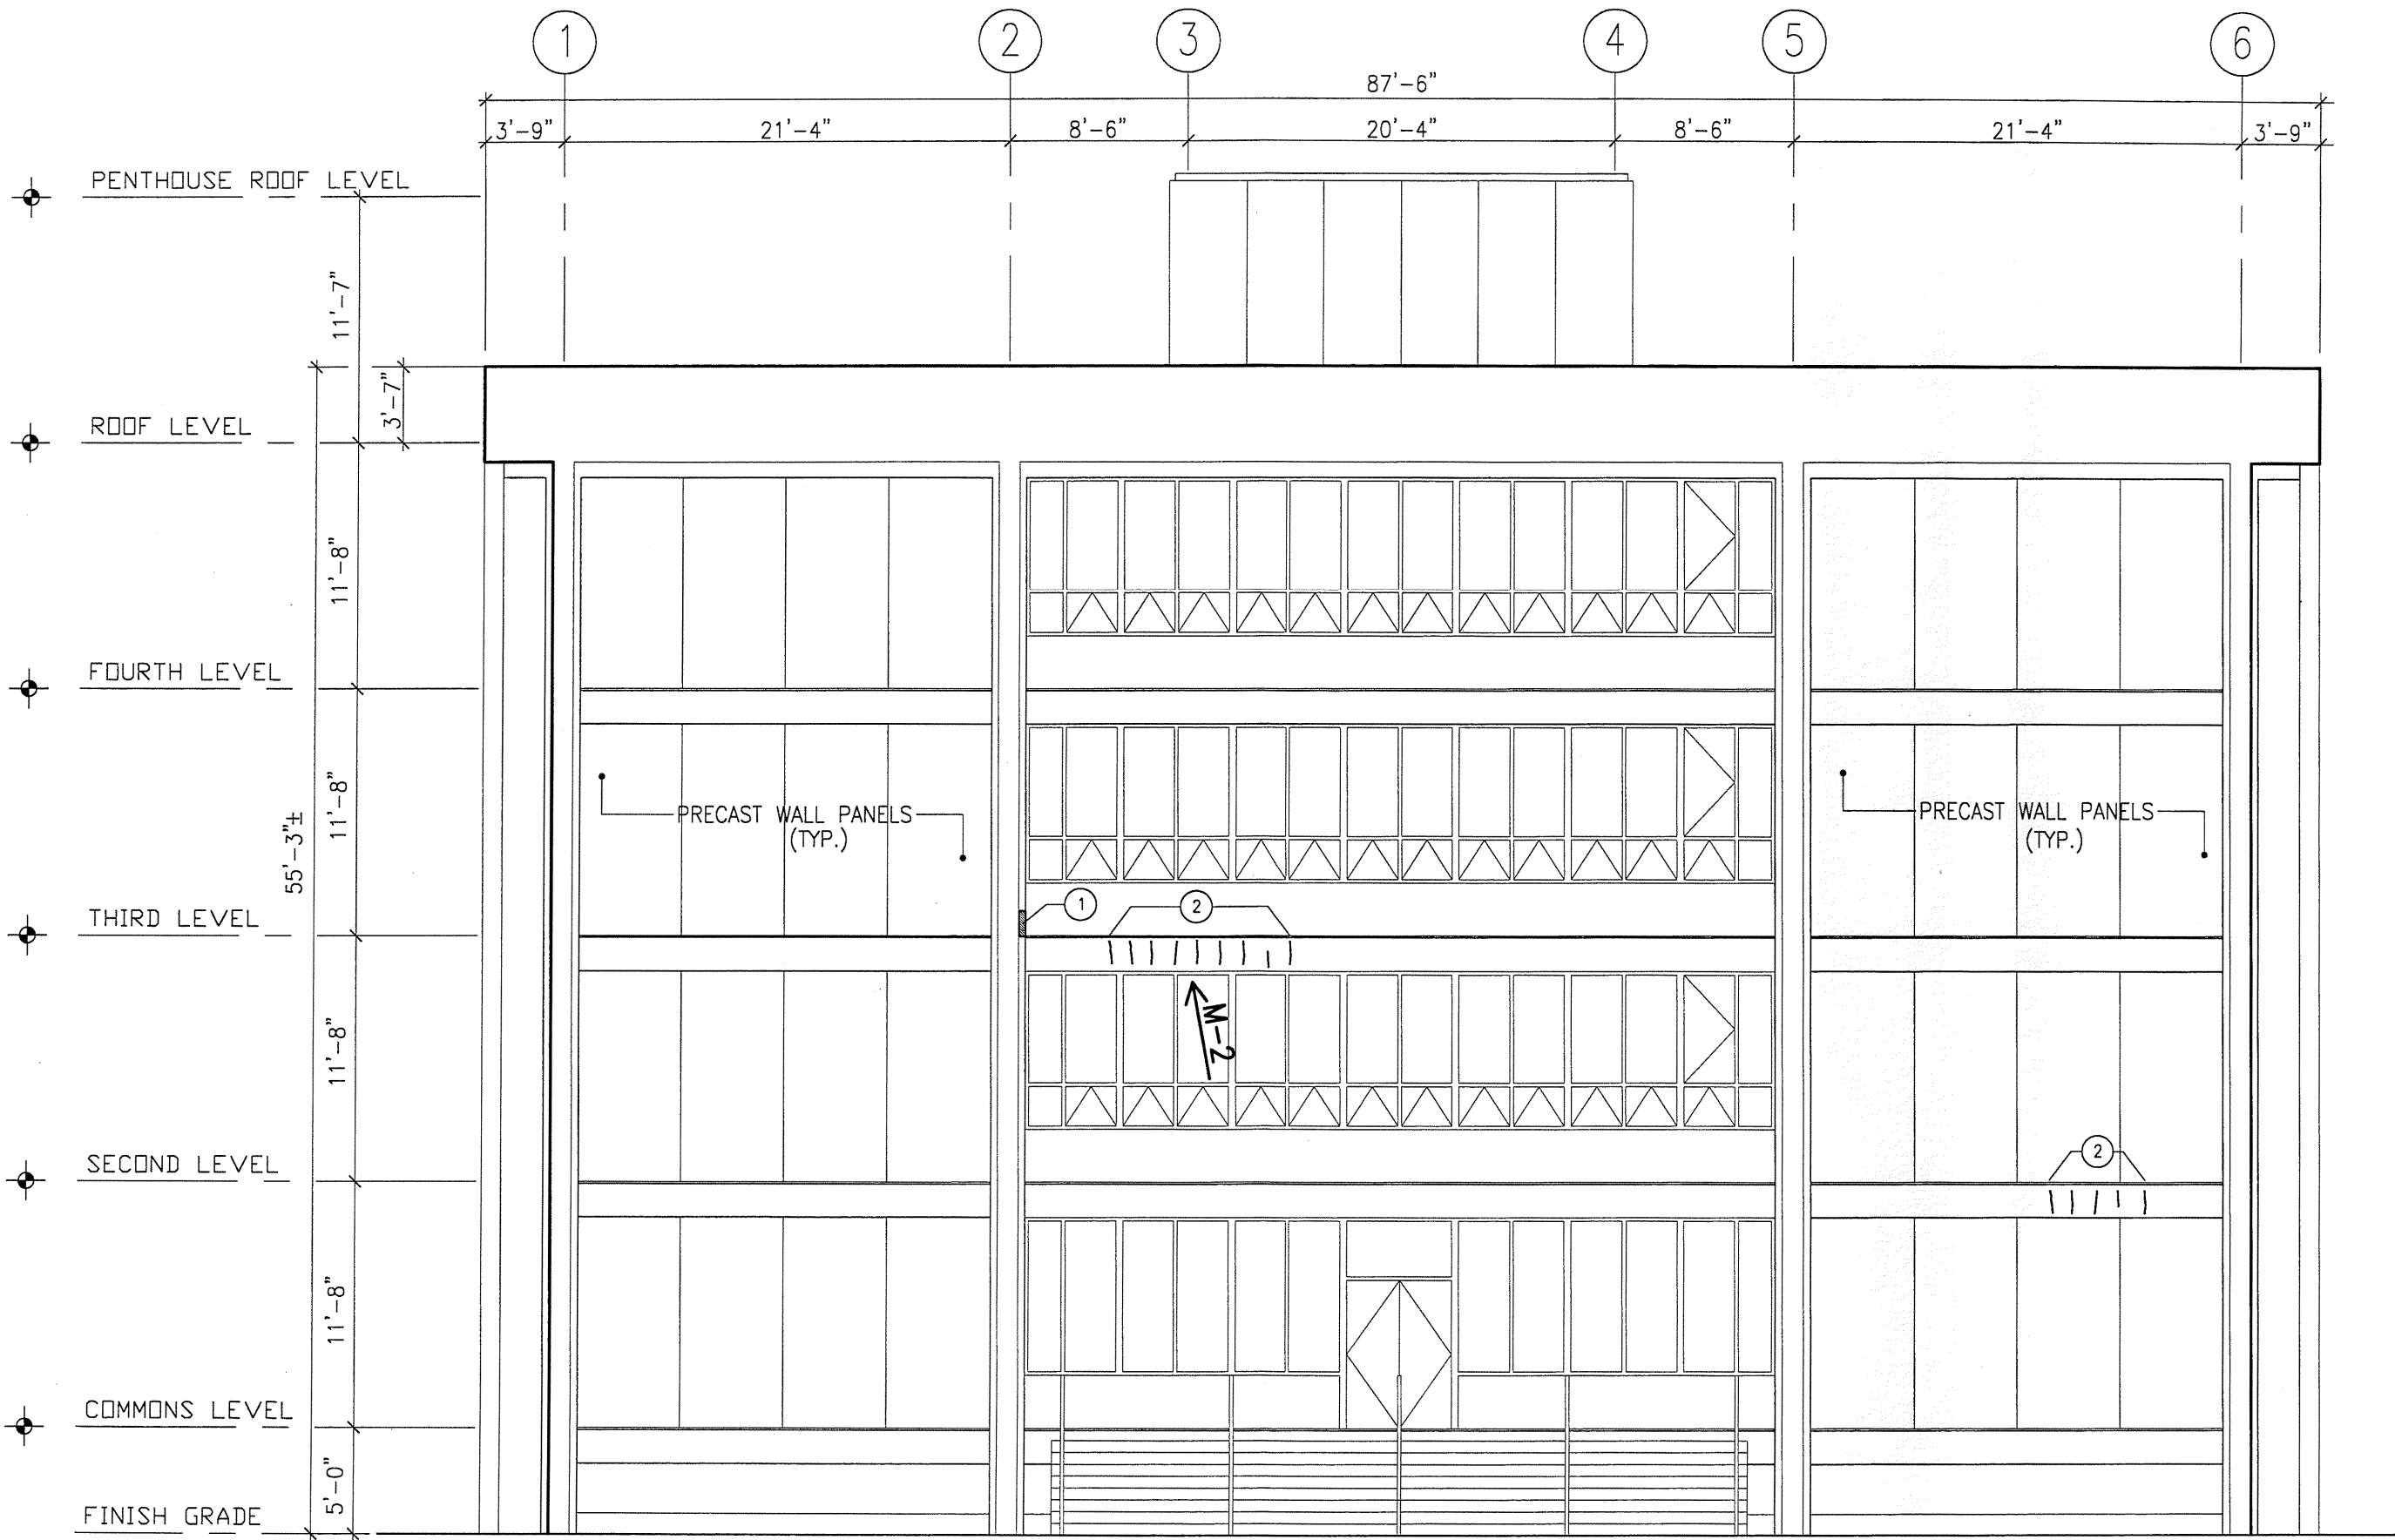
South Building Elevation

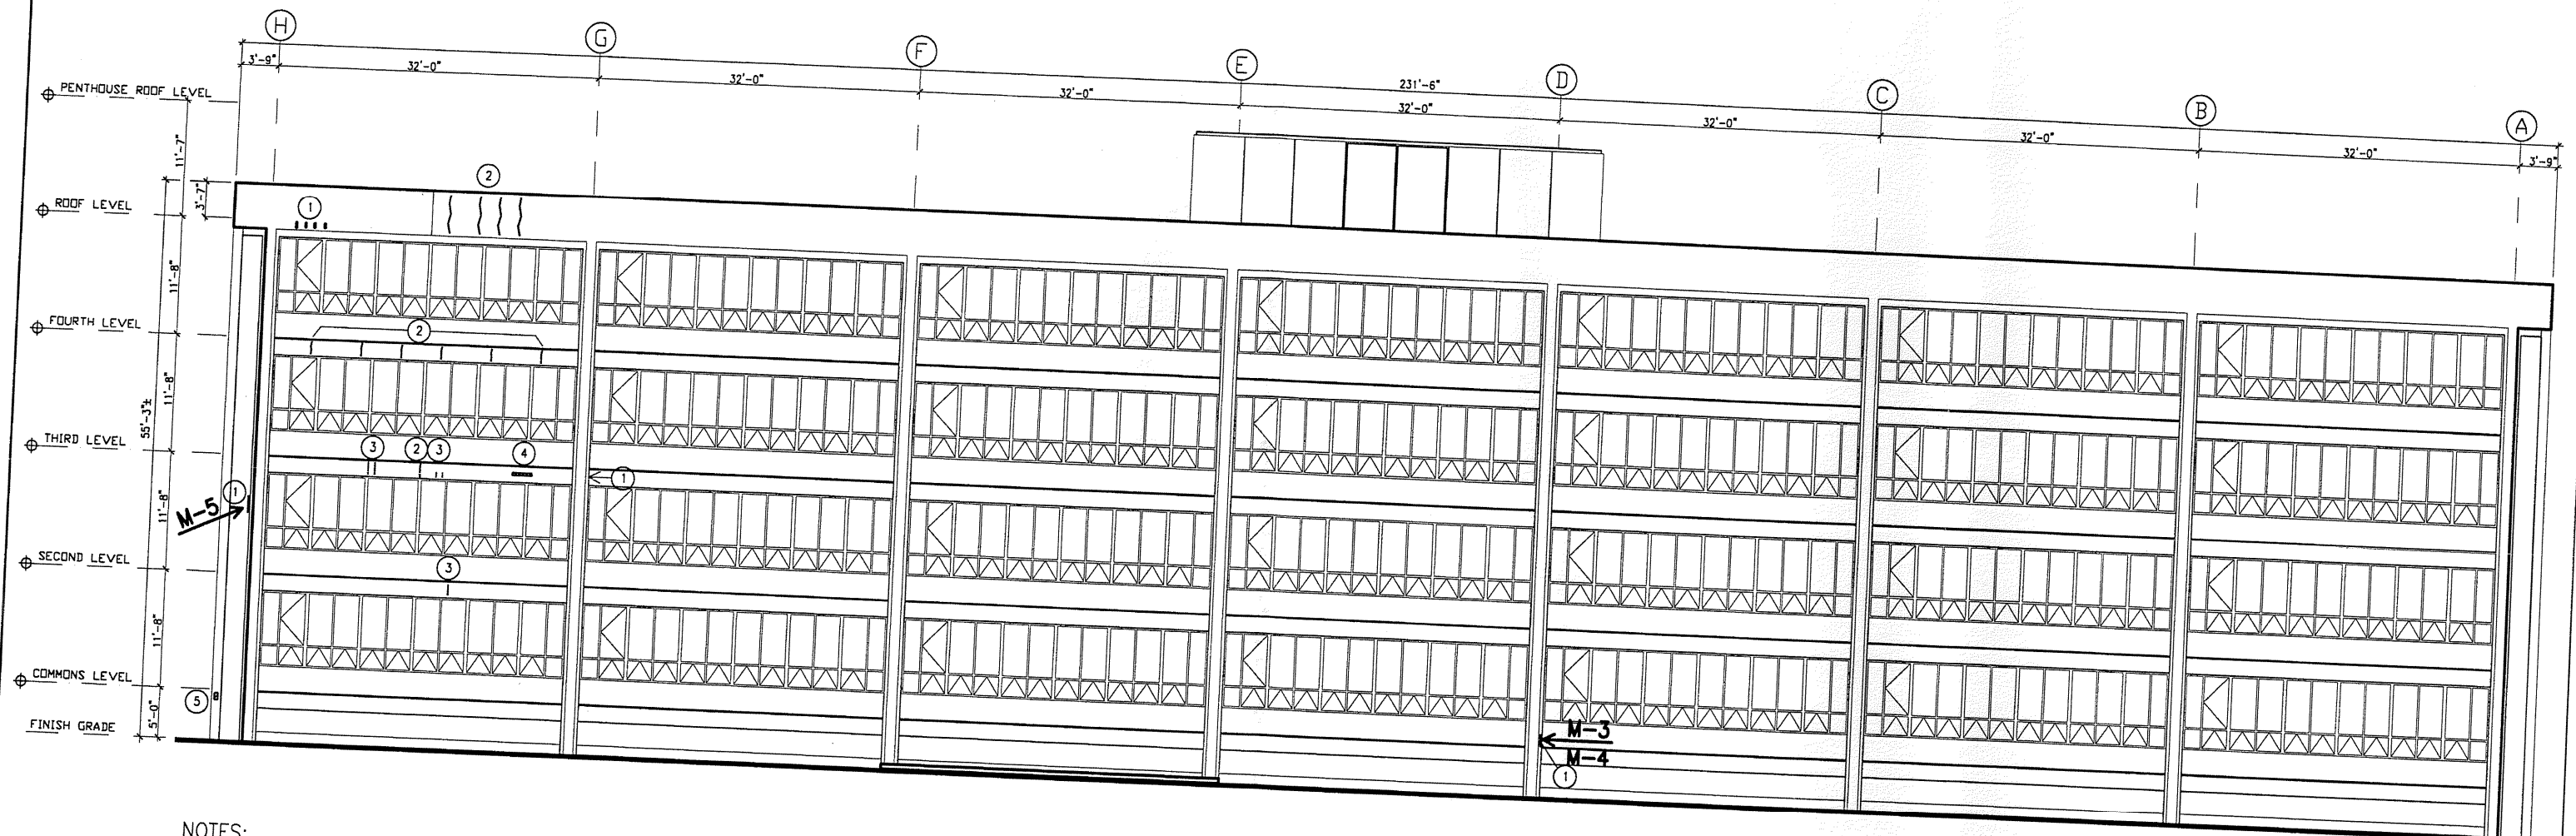
1. THIS DRAWING DOES NOT SHOW MOST OF THE DISTRESS CONDITIONS IN THE EXPOSED CONCRETE FRAME OF THE BUILDING FACADE BECAUSE LIMITED FIELD INVESTIGATION TIME DID NOT PERMIT DETAILED VISUAL OBSERVATIONS.

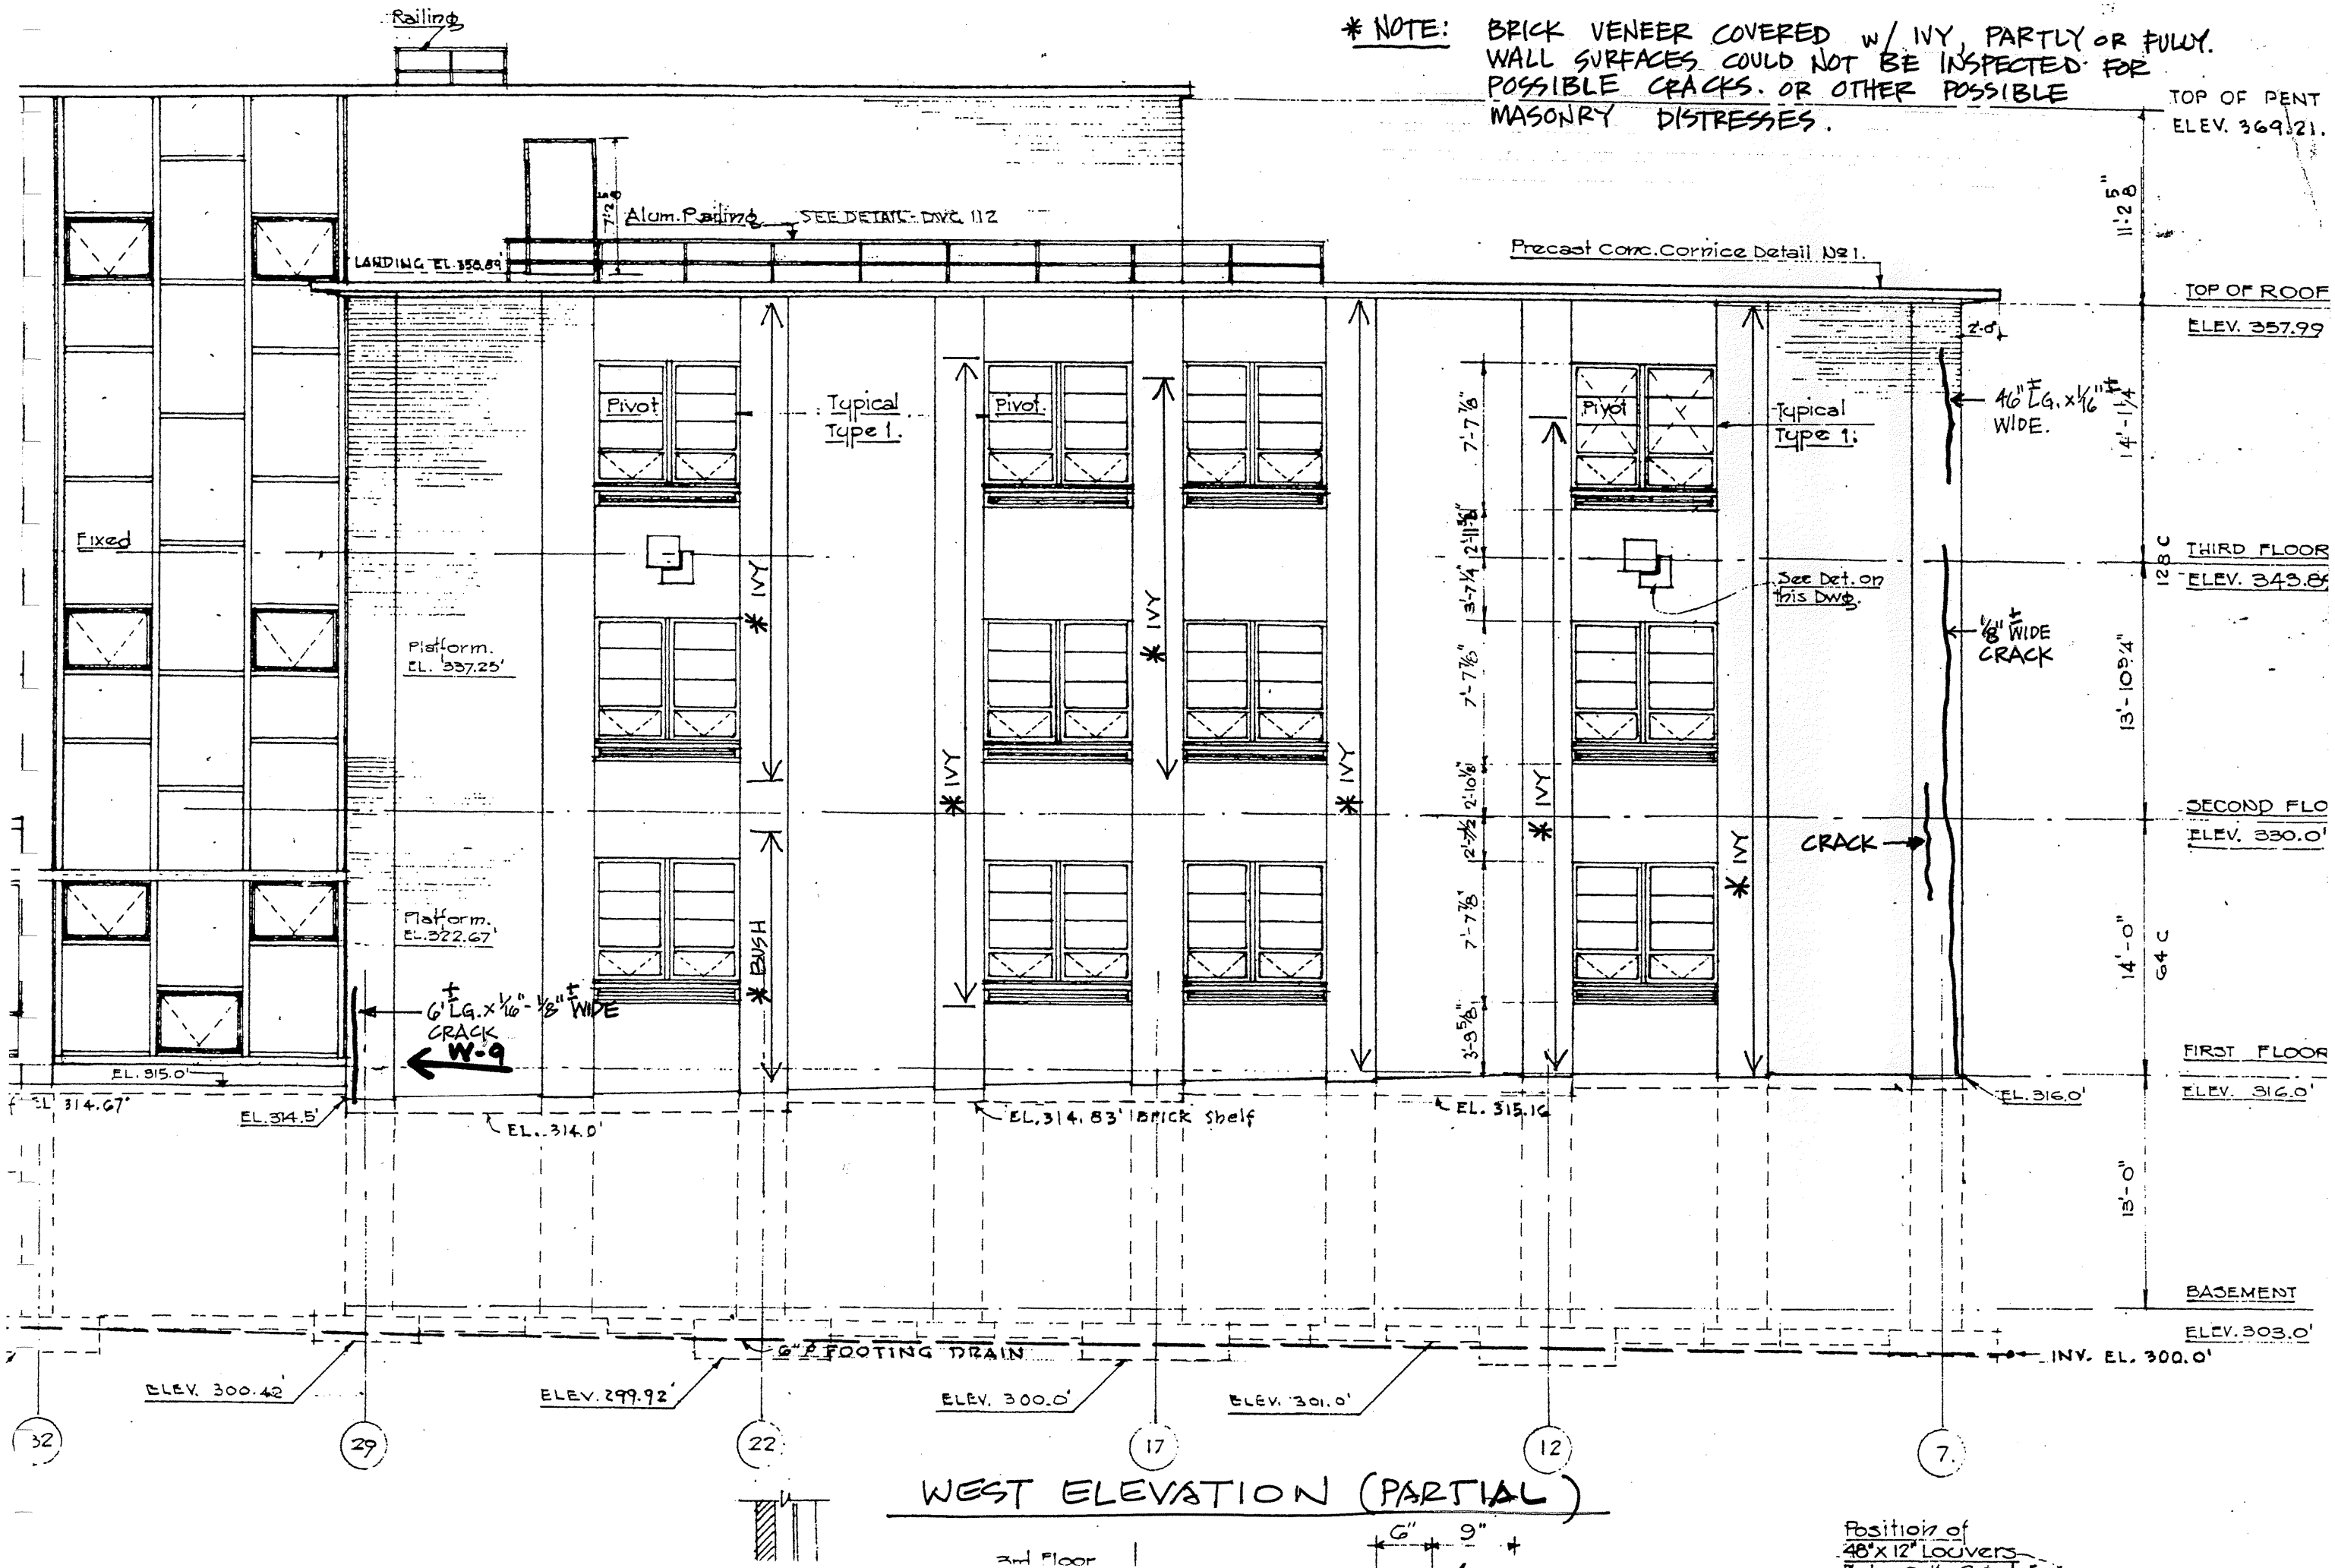
WEST ELEVATION (PARTIAL)

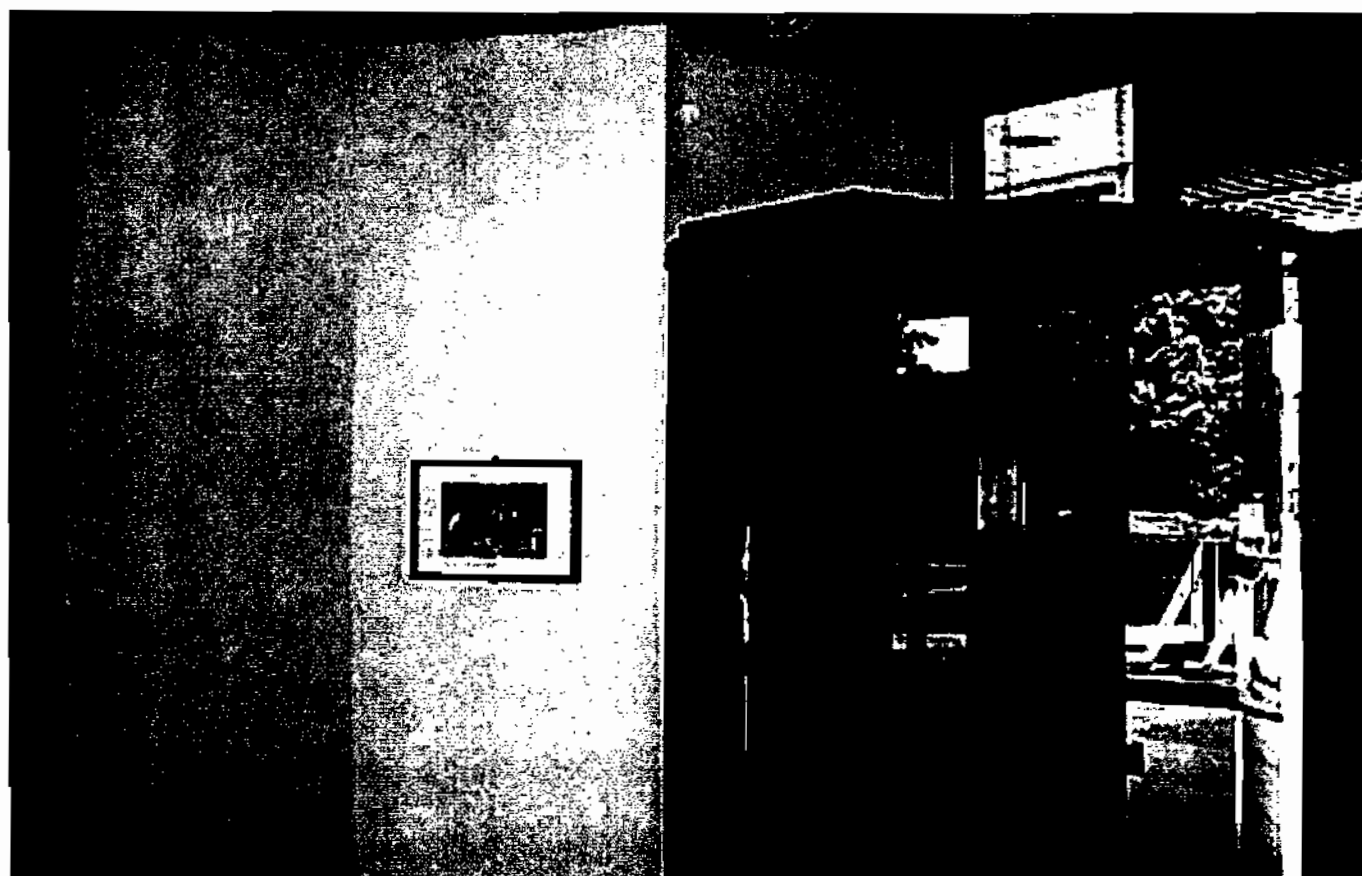
**NORTH ENTRY REVOLVING DOOR**
