STATE UNIVERSITY COLLEGE AT OSWEGO, NY ELEVATOR STUDY

HYDRAULIC ELEVATORS
UPGRADE STUDY
JUNE 20, 2008

Oswego College Elevator Upgrade Study #003291G

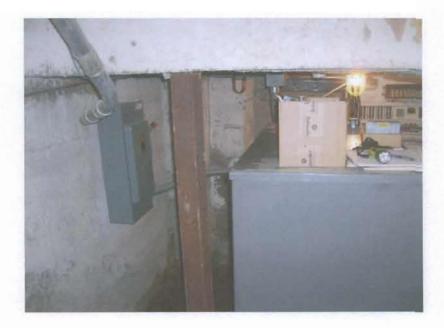
- 1.1.6.1. The elevator pit is required to have a pit ladder installed.
- 1.1.6.2. The existing machineroom does not comply with the current elevator code requirements for ventilation, lighting and head clearance. A review of options to relocate the elevator equipment to a new space is recommended. It is unlikely that the existing room would be granted a code variance to permit retention of equipment in the existing space.

Existing Machineroom

1.3.3.1. The existing machineroom does not comply with the current elevator code requirements for ventilation. A review of options to relocate the elevator equipment to a new space is recommended.

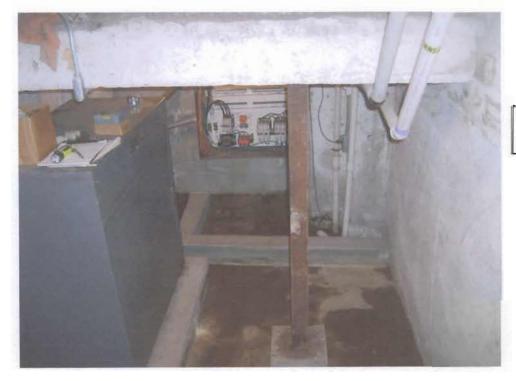
- 1. ELEVATOR #1 SHELDON HALL
- 1.1. EXISTING COMPONENT SUMMARY AND UPGRADE RECOMMENDATIONS:
 - 1.1.1. CONTROLLER: The existing Midstate Elevator microprocessor/ice-cube relay based elevator controllers was found to be in poor overall condition and maintenance appeared to be adequate. This controller was installed new in 1987 by Midstate Elevator Company which is no longer in business. The existing microprocessor is difficult to maintain and can fail completely by losing its flash-type memory. It is possible to back up the existing memory to prevent the loss of the entire memory, however finding a qualified individual familiar with Midstate equipment is becoming increasingly difficult. The design of this equipment even new had limited technical support, and that situation is significantly worse now. The controller should be upgraded sooner than later.

- 1.1.1.2. Its current location is not code compliant. It's location near an open water drain is a potential shock hazard and the surrounding moisture adds to its wear and unreliability. It is recommended that the location of the controller be changed at the time of controller upgrade.

Machineroom and Existing Controller

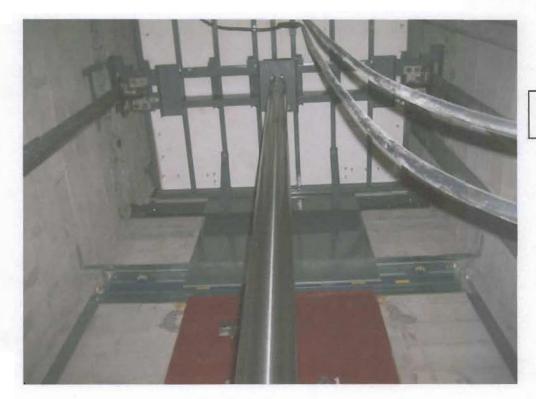
- 1.1.2. HOISTING COMPONENTS: The existing 40-HP submersible motor, valve, and hydraulic reservoir can likely be retained however they should be relocated as part of the controller relocation. The existing inground cylinder appears to be in good condition. Because the cylinder was installed after 1972, it is expected to have a double-bottom cylinder and can likely be retained. However the cylinder was not installed in a PVC jacket which would allow the cylinder integrity to be constantly monitored for corrosion and leaks. A QEI certified witnessing of the cylinder pressure test to verify its integrity should be completed as soon as possible.

Bottom of Car and Existing Piston

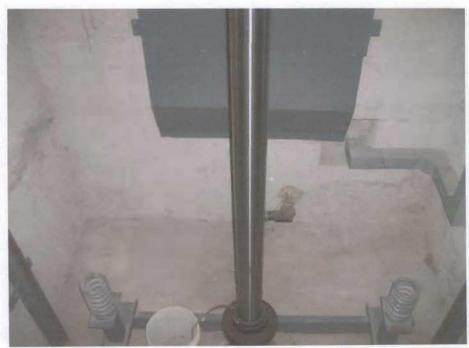
1.1.6.3. The existing pit switch is worn and should be replaced at the time of controller upgrade.

Existing Pit

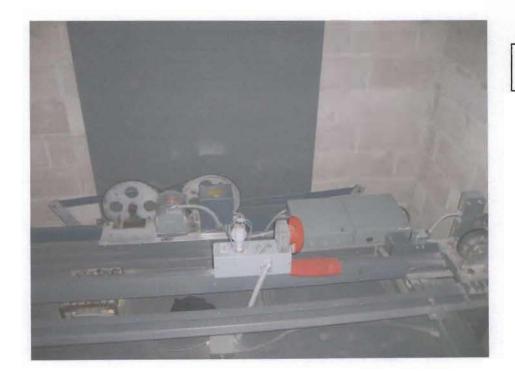
- 1.1.3.2. The existing GAL door operators are in fair condition but should be upgraded as part of the elevator controller upgrade.
- 1.1.3.3. Door restrictors are currently required, however they were not functioning at the time of CNY's inventory.

Top of Car and Exist Door Operator

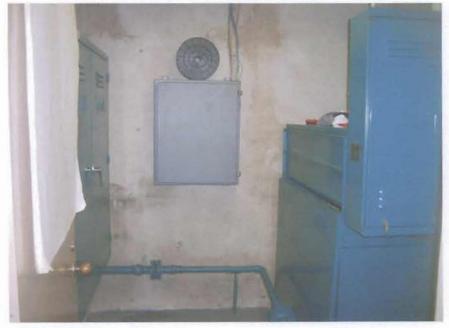
Existing Machineroom

- 2.3.3.1. The existing machineroom may require additional ventilation. A review of the current heating and cooling is recommended.
- 2.3.3.2. There is no vent in the hoistway. A vent is not currently required in an elevator shaft that penetrates 3 stories or less, therefore it is not likely that a vent will be required for this shaft unless the occupancy changes.

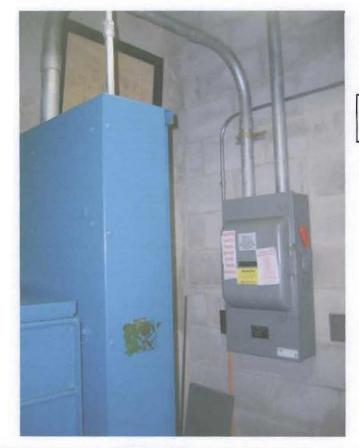
Machineroom and Existing Disconnecting Means.

- 2.3.1.1. The existing disconnecting means appears to be in good condition and can be retained. It is recommended that the main line ground be verified prior to replacement of the controller. If fire sprinklers are added to the machineroom or the hoistway, a new shunt-trip type disconnect would be required.

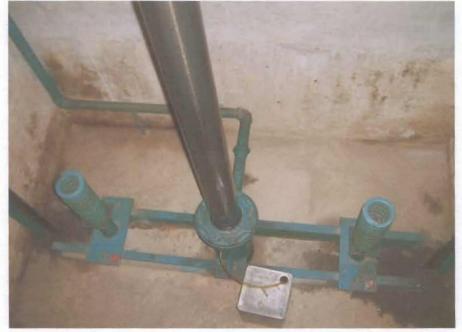
- 2.1.2. <u>HOISTING COMPONENTS</u>: The existing 20-HP belt drive motor, valve and hydraulic reservoir should be replaced at the time of the controller upgrade. The existing cylinder is a single-bottom cylinder and should be replaced as soon as possible. It is not required to do the controller replacement at the time of the cylinder replacement but it is recommended. The existing cylinder should have a QEI certified witnessing of the cylinder pressure test as soon as possible to verify its current integrity.

- 2.1.6.1. The elevator pit is required to have a pit ladder installed.
- 2.1.6.2. The existing traveling cables should be replaced sooner than later. The cloth covered cables are subject to failure and should be replaced sooner than later.
- 2.1.6.3. The existing pit switch is worn and should be replaced at the time of modernization.

Existing Pit and Piston.

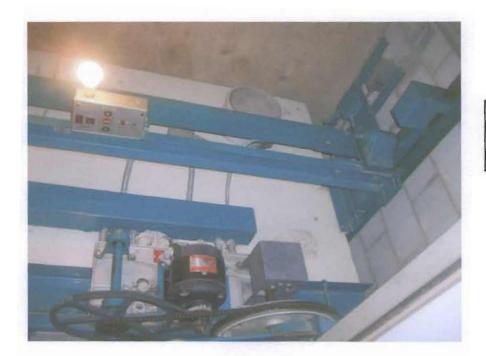
- 2.1.3.2. The existing Dover model door operator is in poor condition and should be replaced as part of the next elevator controller upgrade.
 - 2.1.3.3. New door restrictors are required to be provided at the time of the door operator replacement.

Top of Car and Exist Door Operator.

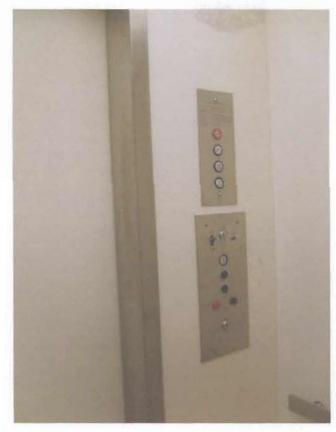
- tracks may be retained. The existing door gibs and rollers should be replaced at the time of the controller.
- 2.1.3.6. The existing interlocks and limit switches should be replaced at the time of controller upgrade.
- 2.1.3.7. The existing car doors are in fair condition and likely can be maintained.
- 2.1.4. <u>CALL STATIONS</u>: The existing hall call stations in the lobbies do not conform to current ADA standards and will require replacement at the time of the controller replacement.
 - 2.1.4.1. The car operating panel will require replacement at the time of the controller replacement to comply with current elevator codes for fire service.

Exist Car Operating Panel and Fire Service Add-On Panel.

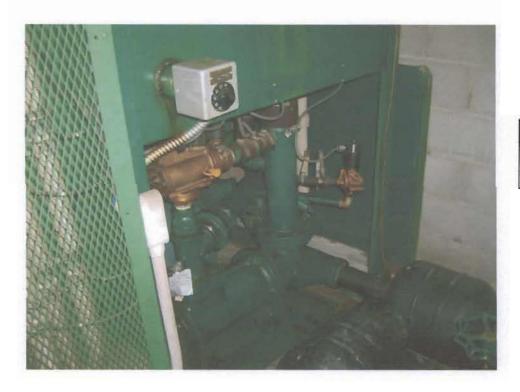
- 3.1.2. HOISTING COMPONENTS: The existing 50-HP belt drive motor, valve and hydraulic reservoir should be replaced at the time of the controller upgrade. Maintenance records indicate that the valve has consistent problems and should be replaced sooner than later. The existing cylinder is a single-bottom and should be replaced as soon as possible. It is not required to upgrade the controller at the time of the cylinder replacement, but it is recommended. It is recommended that a QEI certified witnessing of the cylinder pressure test be performed as soon as possible to verify the integrity of the cylinder.

Existing Valves and Pump.

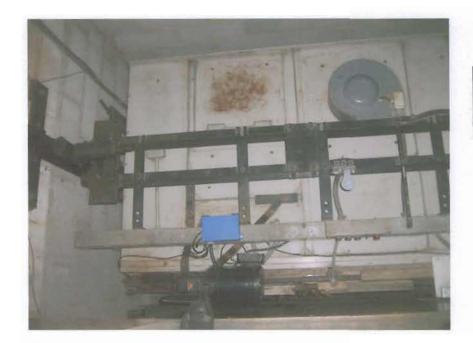
- 3.1.5.1. The cab was found to be in fair condition and likely be retained, however there appeared to be some rust on the top of the cab which should be cleaned up and repainted to protect against further wear.
- 3.1.5.2. The existing lighting should be checked to verify that the ballasts are electronic, if not, the fixtures should be replaced. The existing lamps should be provided with a protective cover to prevent breakage at the time of the renovation.
- 3.1.5.3. The existing handrails should be verified to assure that they are located between 34" and 38" to the top.

Existing Top of Car
