5. Building Condition Survey

EXISTING BUILDING CONDITION SURVEY, PARK HALL

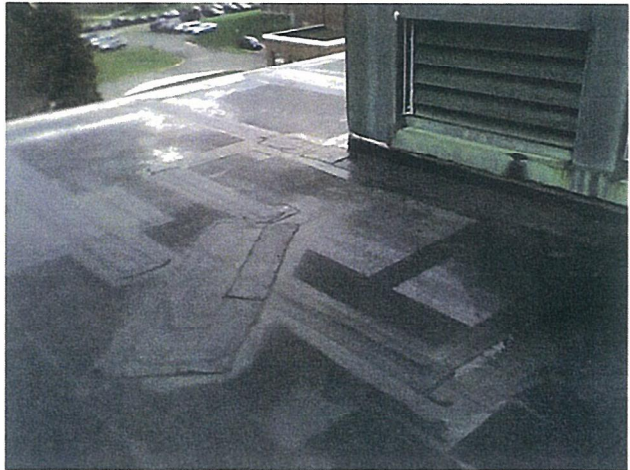
Park Hall - Roof

Many existing roof patches were observed, some cracking at the roof patches were discovered, and the joints were in poor condition. Many walkway pads are missing, and the ones that remain are in poor condition. There are several areas of masonry cracks at the brick chimneys and penthouse. In the short term, it is recommended that the flat roof be replaced and new walkway pads installed. It is also recommended that the masonry joints at the chimneys and penthouse be re-pointed.

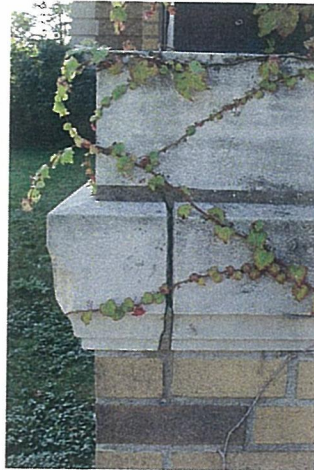
Missing Mortar at Limestone

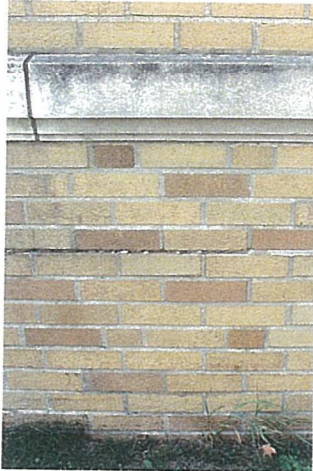
Park Hall - Surface Staining

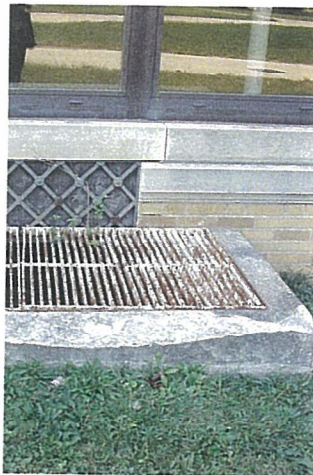
Area Grate and Foundation Wall

The brick wall is in fair to good condition. The brick, limestone, and concrete that are part of this wall are heavily soiled. The upper portion of the cornice is damaged/broken. The existing replaced windows appear in good condition. The existing sealant at the louvers has failed or is missing. The existing wood entry doors no longer function properly. The existing original windows appear to be losing integrity. Mortar between the limestone panels and the entry surround is cracking. The areaway grate and foundation wall at the southern end are rusty and the wall is breaking apart. It is recommended that the masonry be cleaned and repointing at areas of cracked or missing masonry at the brick, limestone, and concrete. It is also recommended that limestone be repaired at the upper portion of the cornice, the windows be cleaned and cracked sealant be replaced, the sealant be replaced at the louvers, the damaged northern entry limestone be repaired, the entry doors be replaced, repair or replacement of the windows, repointing between the limestone panels and the entry surround, and the areaway grate and foundation be refinished and repaired.

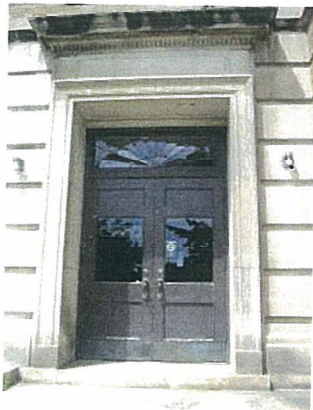
Park Hall - Exterior Doors

The exterior doors are wood doors with panic hardware that are in fair to poor shape and are of inappropriate sizes. The door closers do not meet foot pound pull requirements; they are difficult to open. In the short term, it is recommended that the doors be replaced with appropriately sized thermally broken handicapped accessible doors where appropriate with site conditions.

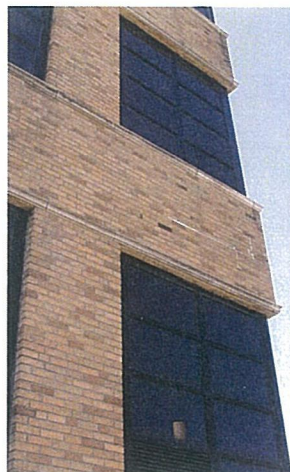
The brick wall is in good condition. The east corner of the wall is cracked. The wall is soiled and the limestone joints have failed. The existing sealant at the windows is starting to crack and is missing at the louvers. The limestone at the lower west end has been damaged. It is recommended that the areas of broken brick be replaced, repointed, and a joint added. It is also recommended that the masonry be cleaned, the limestone joints be repointed, the sealant at the windows be replaced, and the limestone be repaired at the lower west end.

Park Hall - East Corner

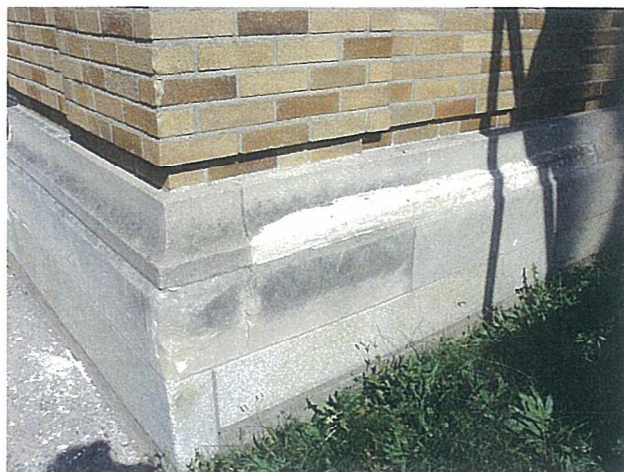
The brick wall is in good condition. The limestone joints have failed. The windows appear to be in good condition. Sealant at the windows is cracked and missing at the louvers. The wall surfaces are soiled. The limestone base is cracked and chipped throughout. The wood doors and frames are beyond useful life. It is recommended that the limestone joints be repointed, sealant at the windows and louvers be replaced, the masonry be cleaned, the limestone base be repaired, and the wood doors and frames be replaced.

Park Hall - Limestone Base

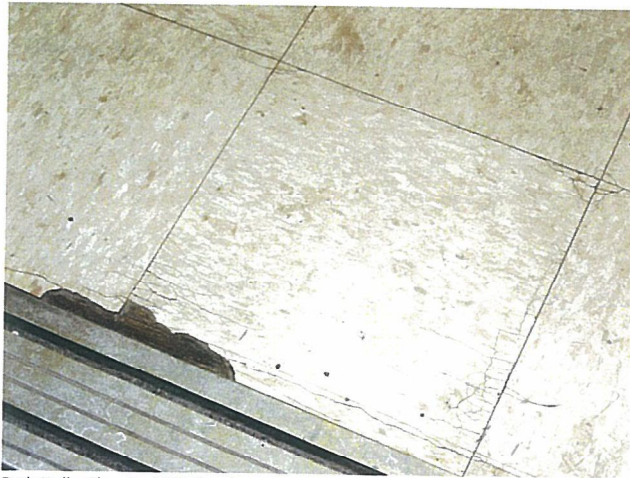
Park Hall - Elevator VCT Flooring

The elevator is a 4,500# Dover elevator with a VCT floor, laminate walls, and metals doors and frames showing some wear. The elevator finishes are in good condition with some repair recommended in the VCT flooring near the door. The elevator near Lobby floors, walls and doors are in need of repair/replacement

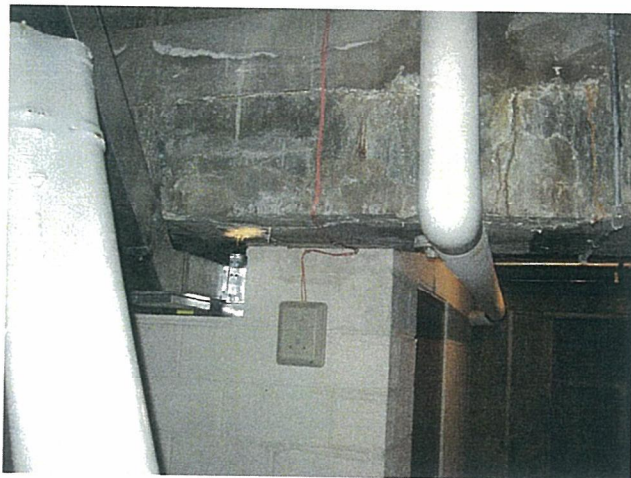
Park Hall - Water Damage in Sub-Basement

The ceiling and wall structure is exposed poured concrete and is in good condition with some deteriorated concrete joists with exposed rebar. There is a small area with a steel beam support structure near the ramp. There is long-term water damage at the concrete beam just east and a bit north of the sub-basement elevator. There is also significant long-term water damage at the ceiling and walls of the room just south of the elevator. The elevator threshold is in poor condition due to water damage. In the short term, it is recommended that the deteriorated concrete joists be repaired, the elevator threshold be replaced, the source of the water be located and repaired, and areas of water damage be repaired.

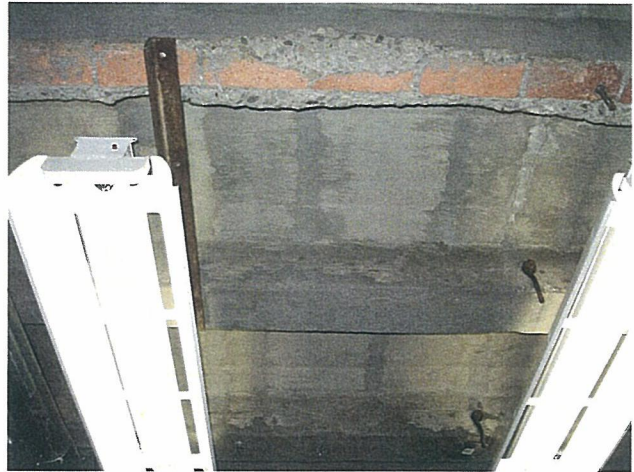
Rooms B1 through B13, Basement
The ceiling is exposed poured concrete joists with some deteriorated concrete joists with exposed rebar in room B9. The walls are masonry construction consisting of terracotta tile, brick, and concrete masonry units and are in good condition. The floors are concrete and in good condition. The exterior wall in Room B9 has an opening in the wall to the outside that was covered with insulation. Basement Shower Room B3 has areas of damaged concrete ceiling joists. In the short term, it is recommended that the deteriorated concrete joists be repaired in Room B3 and the Room B9 opening to the exterior be infilled with a more permanent system.

Park Hall - Basement Ceiling

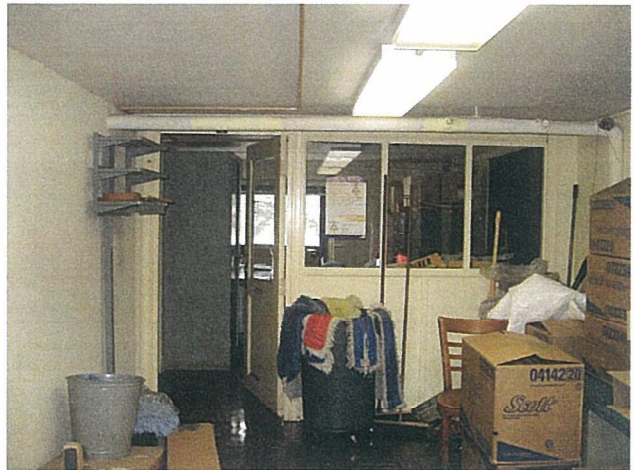
Room M1, M2A, M3, M4 Custodial/Mezzanine
The ceiling and walls are plaster and in good condition. The plaster ceiling is cracked. There is a metal panel partition wall to M1 and M3 that is in good condition. The wall to Room M4 is GWB and is in good condition. The wall separating the Mezzanine Rooms from the Transportation Lab below is a GWB wall with a metal panel system behind and is in good condition. The floor is 9x9 vinyl composition tile and is in fair condition. In the short term, it is recommended that the flooring be replaced and monitored for asbestos content, and the plaster ceiling crack in M4 be repaired.

Park Hall - Custodial Room

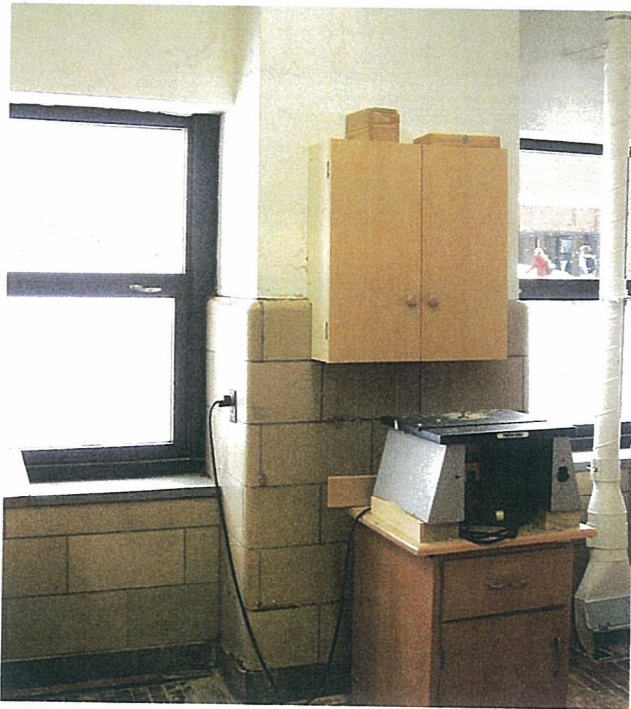
Park Hall - Room 101F - Stained Pier

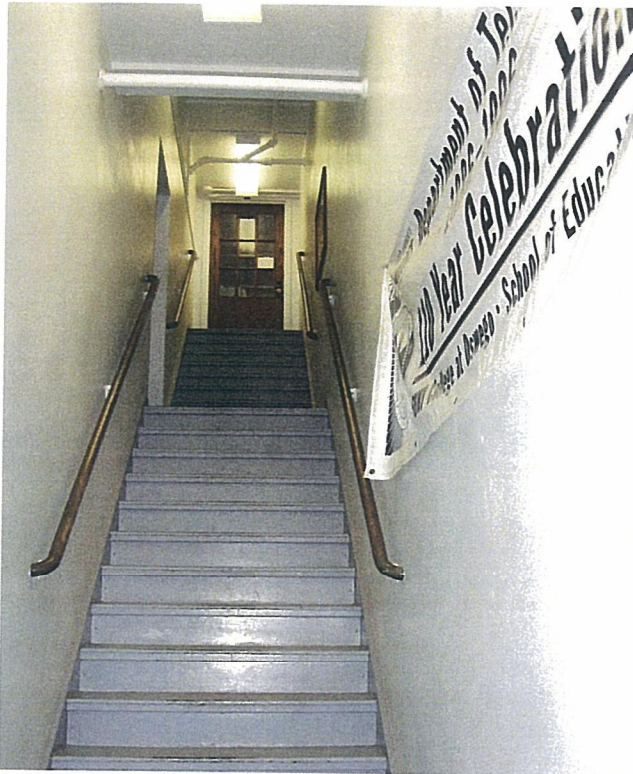
Park Hall - Room 105 - Stairs

There are twelve steps down from the main corridor to the entry door of the Transportation Lab. The ceiling and walls are plaster and in good shape. The floor is concrete and is in good condition. The stair door is wood with nine pane glazing and is in serviceable condition. In the short term, it is recommended that the areas of previous plaster patch be refinished and the floor be sealed.

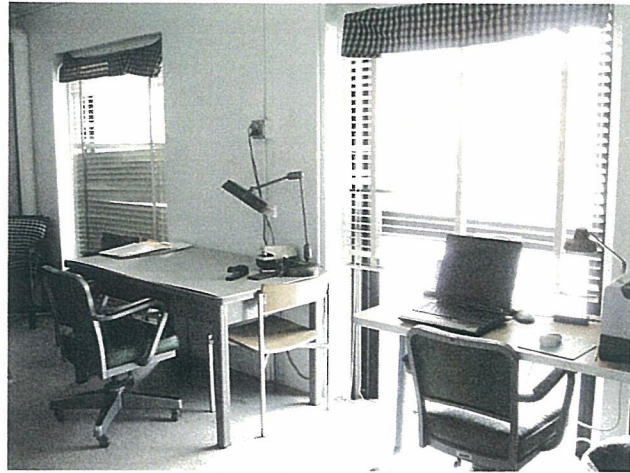
Park Hall - Room 105C - Office Work Room

This room is at an upper level, built over Office 105A, with thirteen steps up from the main level, with an open metal stair system. The windows for this space are shared with Office 105A below. The ceiling is a 2x2 suspended ceiling system with three water damaged tiles in the southeast corner. The walls are plaster and in good condition. The floor is carpeted and in poor condition. The door is metal with a metal frame. In the short term, it is recommended that the damaged ceiling tiles be replaced, the area of previous wall plaster repair be refinished, and the carpet be replaced.

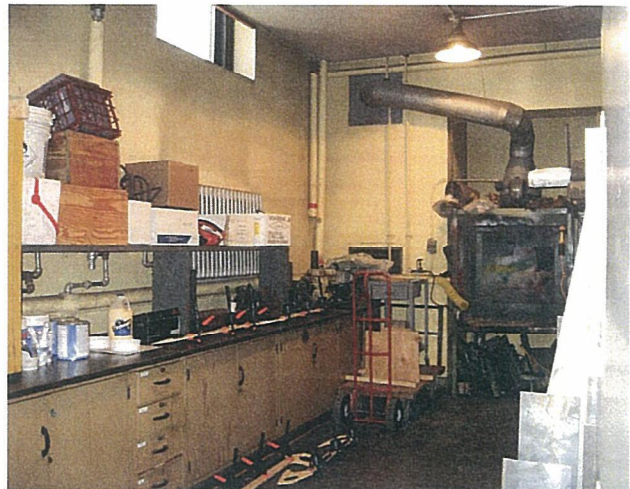
Park Hall - Room 105D - Storage

The ceiling and walls are plaster and in good condition. The floor is concrete and in fair to good condition. There is a large wood door panel system to the room that appears to be in good condition; it was not possible to move the panels to see if they function as designed. In the short term, it is recommended that the concrete floor be refinished.

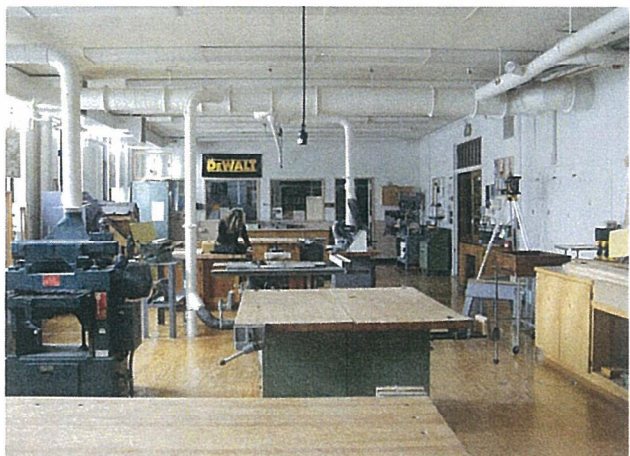
Park Hall - Room 108 - Construction Systems Lab

The ceiling is a 1x1 z-spline ceiling that is in fair to poor condition; some tiles near the east wall are discolored, others are damaged. The walls are plaster and are in good shape, with several electric panels on the west wall. The floor is wood and in good condition, it was recently refinished. The sink is in good condition, while the millwork is in fair condition. The entry to the room is from the stair landing and double door system from the main corridor with each door having nine panes with a wood and glass transom and metal frame system. The corridor doors are in poor condition, with splitting and cracking wood. In the short term, it is recommended that the ceiling system be replaced, the millwork be refinished, the corridor entry doors be refurbished, and the location of the door in the stair be reviewed.

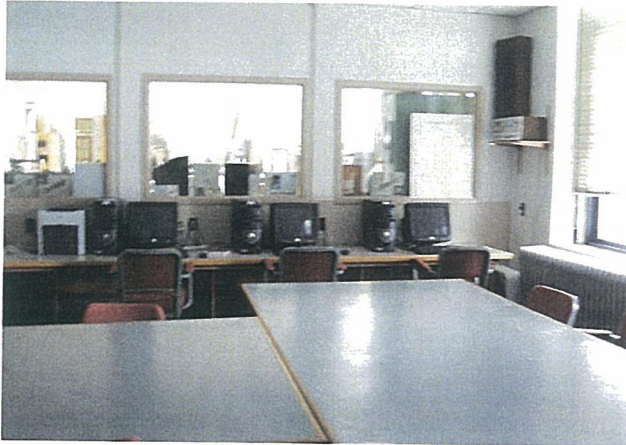
Park Hall - Room 108C- CAD LAB

The ceiling system is a 2x2 suspended ceiling system that is in good condition. The main walls are plaster with GWB and glass partition walls that are in good condition. The floor is carpeted and is in fair condition. The original horizontal blinds are in poor condition. The south sill is in poor condition. In the short term, it is recommended that the carpet be replaced, the blinds be replaced, and the south window sill be repaired.

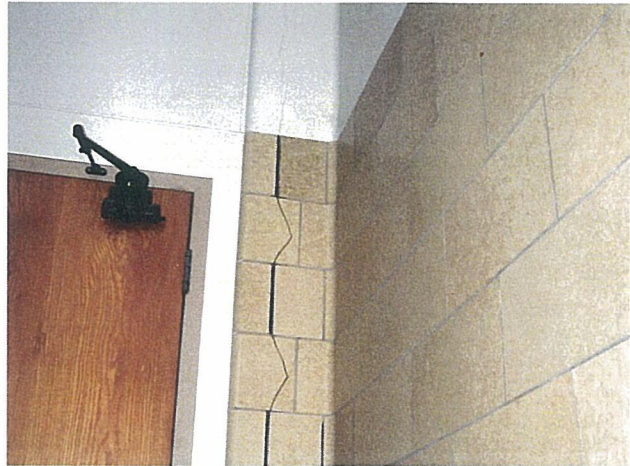
Park Hall - Cracked Glazing and Plaster

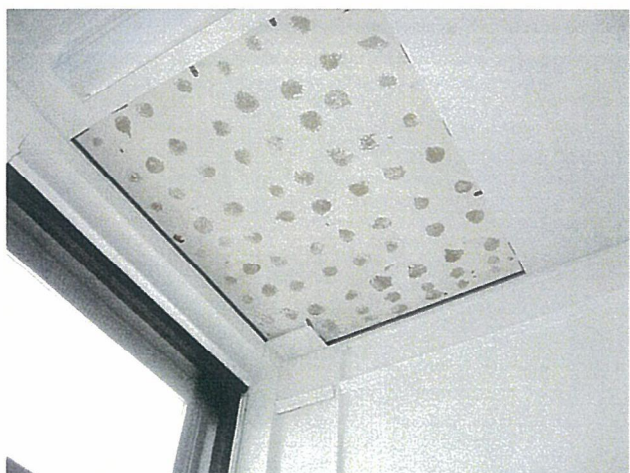
The z-spline ceiling is in good shape. At room 303F, there are several areas of ceiling replacement that are not secure, and the most northern room off of the coffee room has a large area of missing ceiling tile. There are plaster and GWB walls with hollow metal and glass windows at the hallway side of the walls that are in good condition. The sun shading black blinds are in good condition, but they let a good amount of

Park Hall - Room 303 - Missing Ceiling Tiles

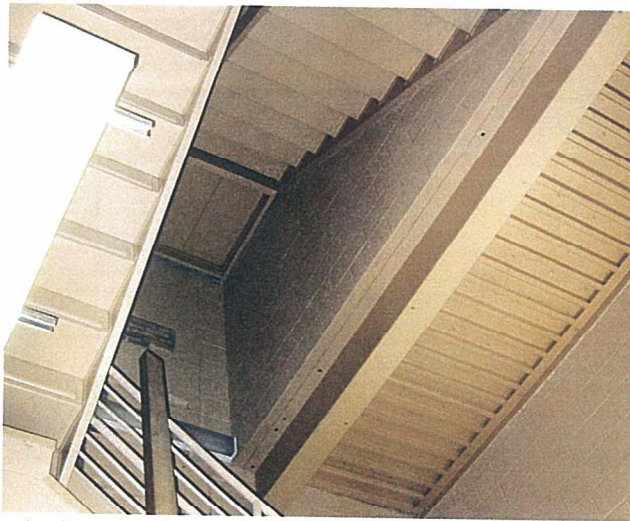
Park Hall - Room 305 - Auditorium - West Exit Stair

The ceilings are z-spline and plaster. The walls are plaster and GWB; the plaster walls are in poor condition. The stairs are steel and in good condition. The floor is VCT (tan) and the base is rubber (gray); they are both in good condition. The door and frame are hollow metal with wire glazing, panic bar and closer which are in good condition, the hardware is brass. In the short term, it is recommended that the plaster walls and ceilings be repaired and refinished.

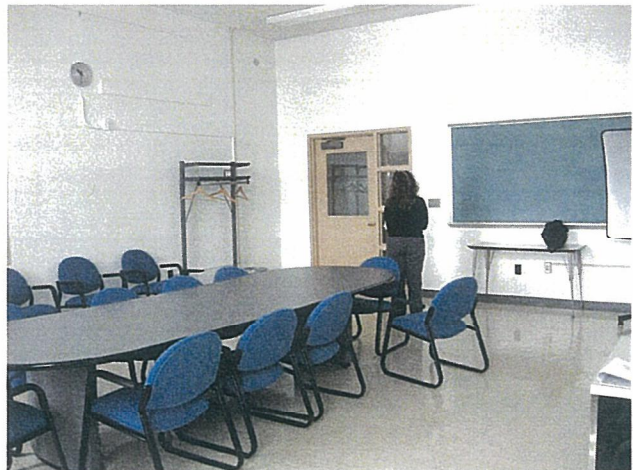
Park Hall - Room 306 - Technology Conference Room

The z-spline ceilings are in serviceable condition with two areas that are not secure. The walls are plaster and GWB with surface raceway. There is an area of partial wood trim on a wall that should be removed. The VCT floors (tan) and rubber base (gray) are in good condition. The hollow metal door and frame have wire glazing and a sidelight and are in good condition; the hardware is brass. In the short term, it is recommended that the ceiling tiles either be secured or replaced. It is also recommended that the rough plaster walls be refinished or furred out to conceal the raceway, and the blinds be replaced.

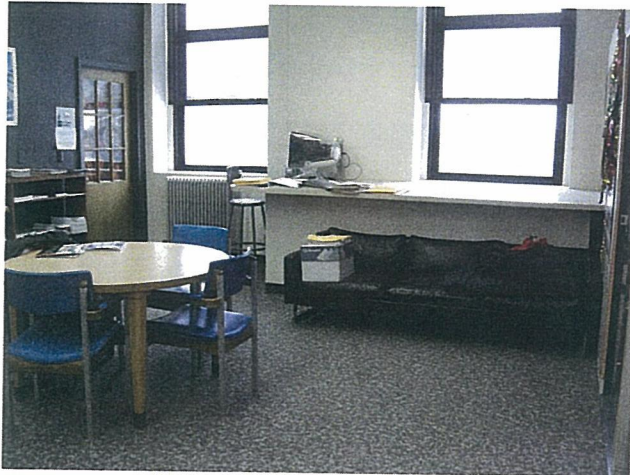
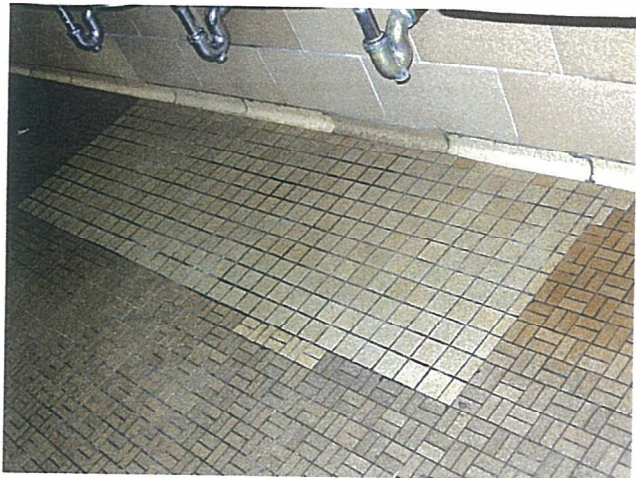
Park Hall - Suite 307 - Millwork Concealing Decommissioned HVAC Unit

raceway in the rooms. There is a large millwork work surface that is concealing a decommissioned HVAC unit. The window sills are in good shape but need repainting. The office doors in the suite are of mixed configuration; solid wood, wood with nine panes, and wood with the upper half clear glazing with no mullions. The main door to the space is a wood double door with nine pane glazing and a six pane wood transom above that are set in a hollow metal frame; these doors are worn. The floor is carpeted and is in good condition. In the short term, it is recommended that the areas of previous plaster patch be sanded and re-plastered for a better finish, and the millwork concealing the decommissioned HVAC unit, and the unit, be removed and the area of removal be patched. It is also recommended that the window sills be repainted, the crack in the north plaster wall of the storage room be repaired, and the main entry doors be refinished and new handicapped accessible hardware installed.

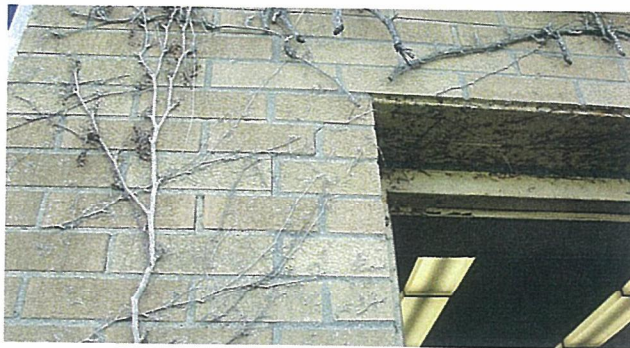
Wilber Hall - West Wall - Mortar Cracks

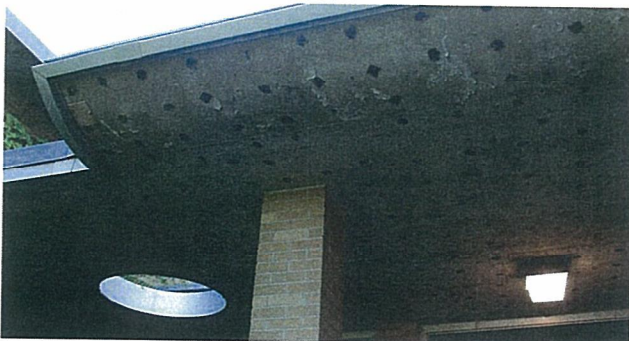
Wilber Hall - West Wall - Black Mastic Remnants

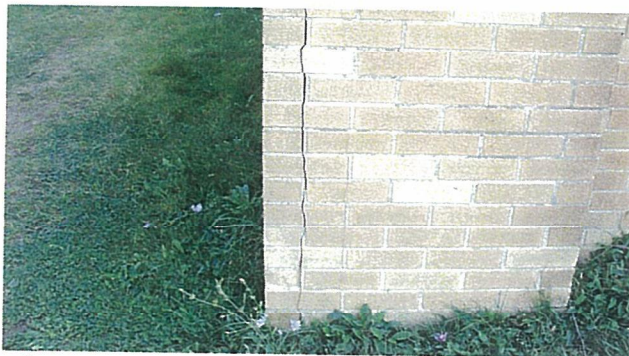
Wilber Hall - West Wall - Northern Pier Crack
