# PROPERTY and BUILDING CONDITION ASSESSMENT REPORT

Oswego State University of New York Mary Walker Health Center  
Rudolf Road, SUNY Oswego Campus  
Oswego, New York

QPK Project Number: 213222.00

Date: February 10, 2014

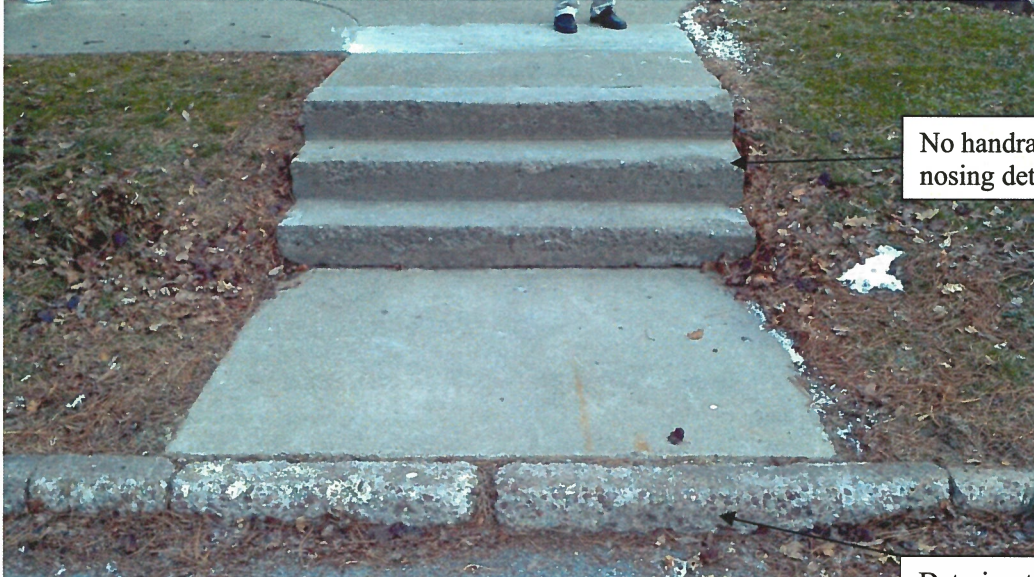
**Sidewalk Stair**

- 1) Sidewalk stairs from parking area. This set of stairs consists of (3) risers and shows deterioration at the leading edge/ nosing. There are currently no handrails on this stair.  
Recommendation: Replace stairs and install (1) handrail on each side of stair. Option to replacing stairs is to install abrasive nosings.
- 2) Loading dock stairs: Stairs are concrete, located to the north of the loading dock and consists of 5 risers. Some cracking and spalling evident, but stairs appear to be in fair condition.

No handrails; stair nosing deterioration

Deteriorating concrete curb

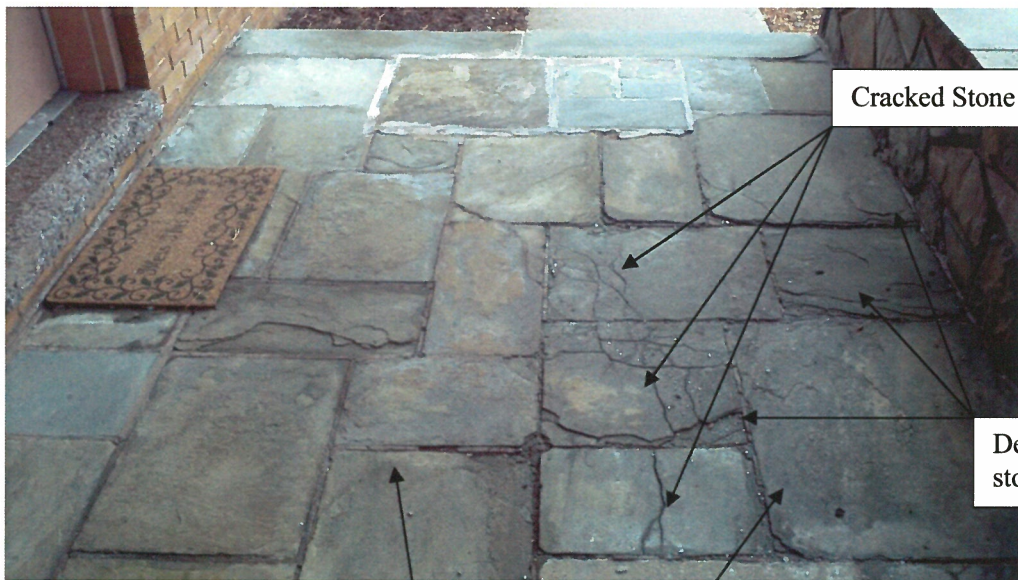
**Slate Patio**

- 4) Concrete sidewalk at door north of the loading dock has deteriorated.  
Recommendation: Replace concrete pad.
- 5) Slate Patio at resident entry on the west wall: Slate is showing signs of delamination, cracking and loss of joint material.  
Recommendation: Replace cracked stone, re-set stones as needed to provide positive drainage and replace joint filler material.

Cracked Stone

Delaminating stone

Evidence of ponding water this area; loss of joint material

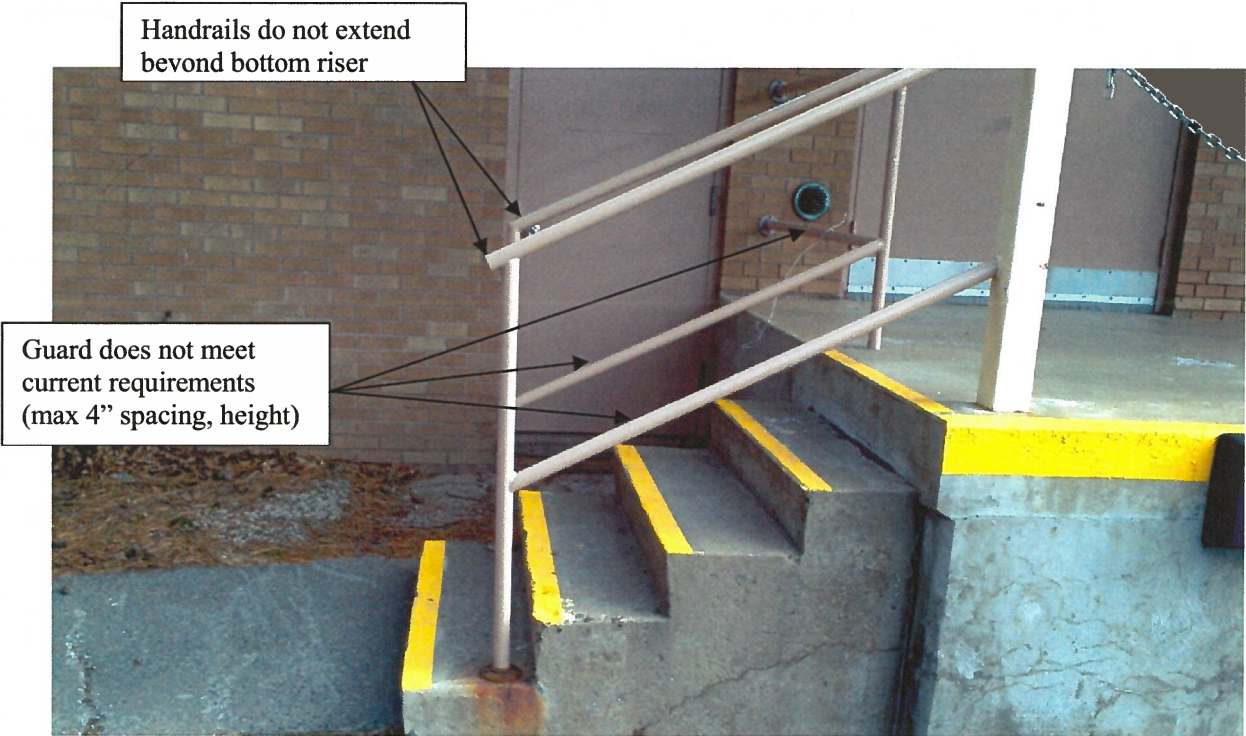
**Loading Dock Stair**

- 2) Loading dock Stair: The stair currently has a steel handrail on each side of the stair. The handrails continue down from the loading dock and terminate short of the last riser. The “guard” or fall protection resembles an “industrial” or warehouse 2-rail design. Recommendation: Due to regular pedestrian traffic, replace existing handrails and guards with NYS code compliant guards and handrails.

Handrails do not extend beyond bottom riser

Guard does not meet current requirements (max 4" spacing, height)

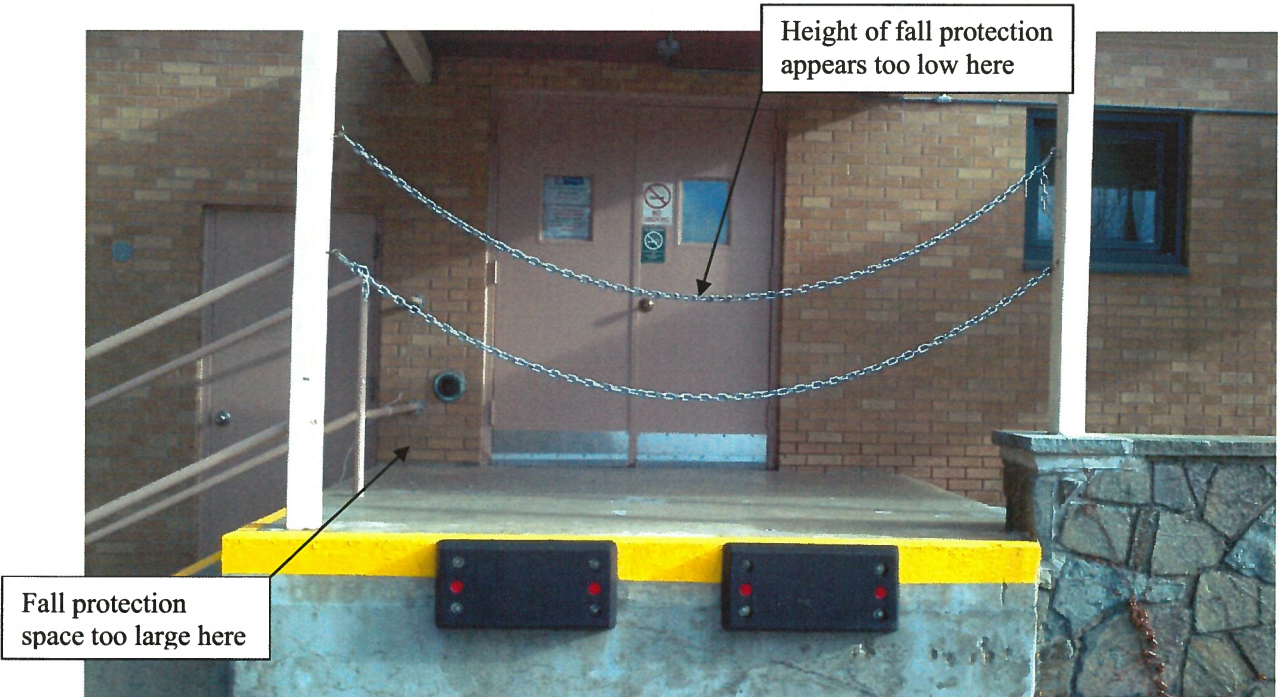
**Loading Dock Guard Rail**

- C. Railings: There are two distinct areas where railings are present.
- 1) Loading dock Guard: The current fall protection or “guard” consists of (2) chains spanning across a 10’-0”+ opening with loop clasps on each side for removability. Although guards are not required by the current Building Code of NYS at loading docks, this location is directly adjacent to a building exit discharge location and employee entrance. Recommendation: Due to regular nearby pedestrian traffic, install a removable galvanized guard pipe rail system that conforms to current NYS building codes for “guards”.

Height of fall protection appears too low here

Fall protection space too large here

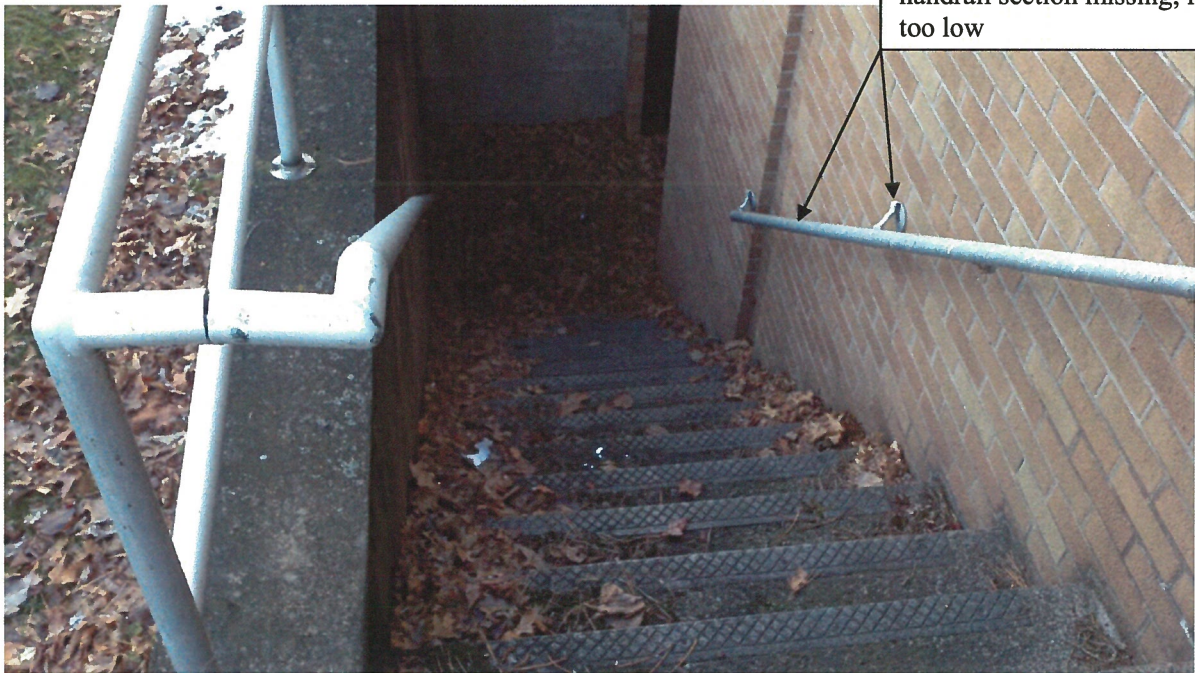
**Exterior Basement Stair**

- 3) Basement Stairs; existing metal guard fall protection and hand rails on each side of stair. The wall mounted stair hand rail is loose, and stops approximately  $\frac{3}{4}$  of the way down the stairs. Handrail brackets appear to have been damaged and are bent down resulting in a lower than normal handrail height. The guard appears to be sturdy, but is of an industrial guard design. Recommendation: Replace existing handrails and guard with NYS code compliant guards and handrails.

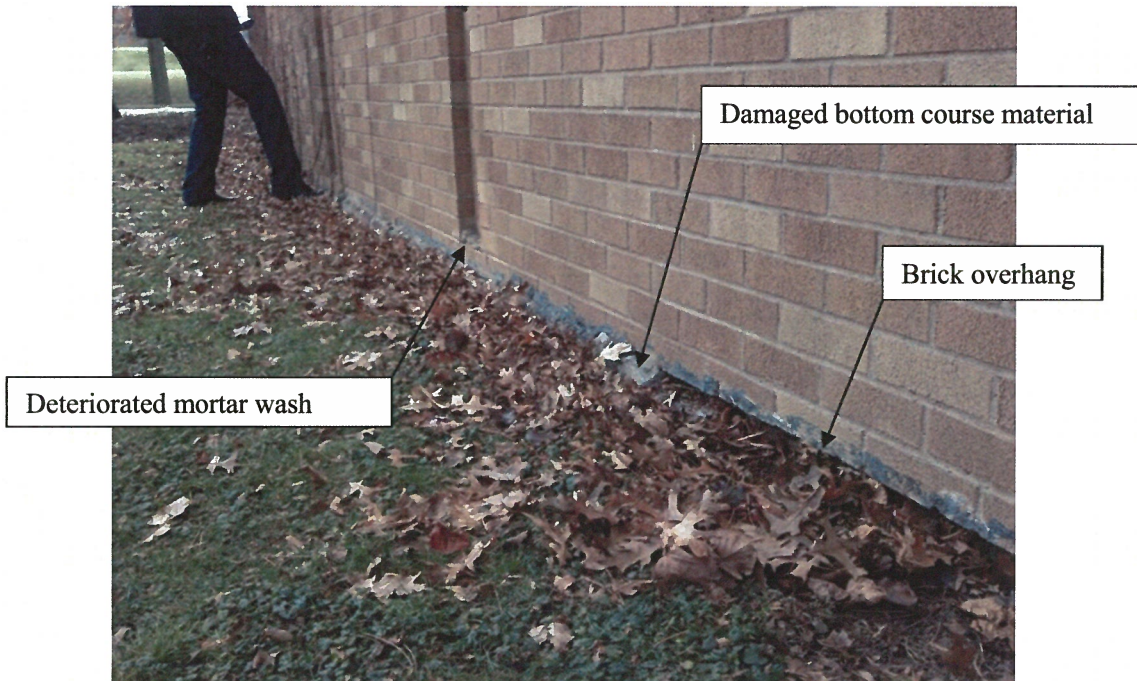
**Brick Overhang at East Wall Looking South**

On the east wall, the brick veneer was overhanging the exterior face of the foundation wall. In some areas, the base course of brick was missing, crumbling or loose resulting in a possible lack of adequate support for the brick wall and potential entry for moisture at the top of the foundation wall. It appears that past repairs have been attempted in this area.

Confirm existing support system for brick wall is adequate. If not, excavate below frost, repair/ replace damp-proofing and backfill with frost resistant material. Install a support (Stainless or Galvanized steel angle) at the foundation wall and reinstall brick and mortar base course to support existing wall (Provide new brick and mortar with similar properties as existing brick and mortar).

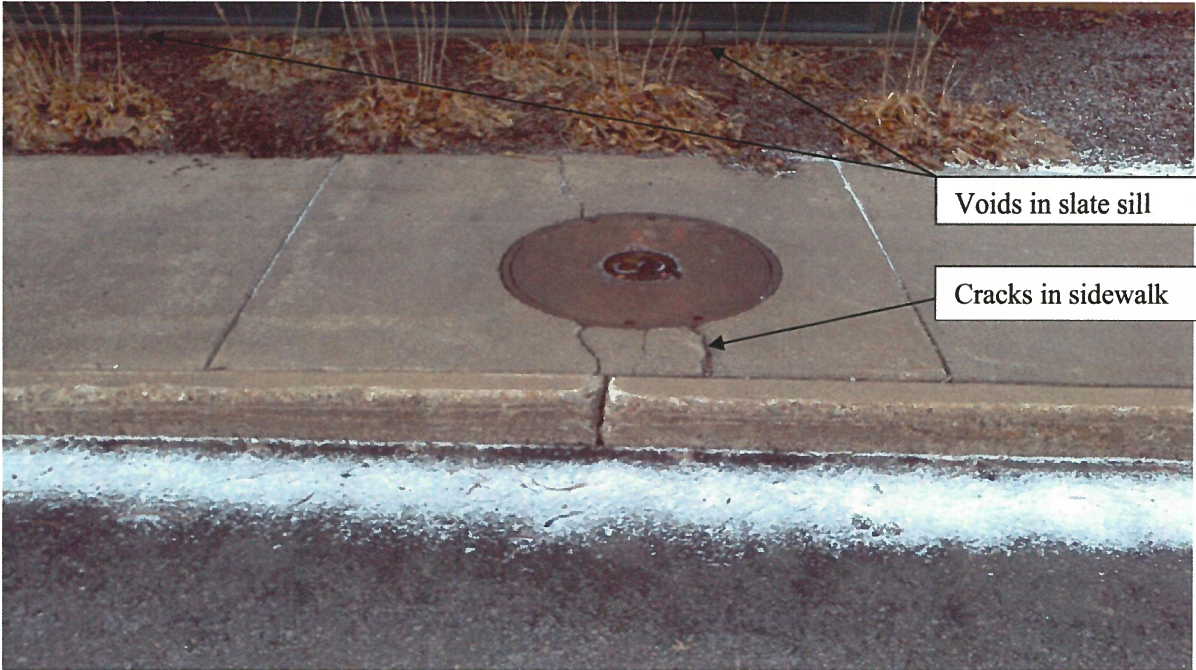
**South Sidewalk**

- 1) Cracking was evident in the concrete sidewalk at the manhole in front of the building and at the intersection of the front and side sidewalks.  
Recommendation: Fill all existing cracks with pourable urethane sealant to prevent water intrusion and further freeze/thaw damage (considered a maintenance item).

Voids in slate sill

Cracks in sidewalk

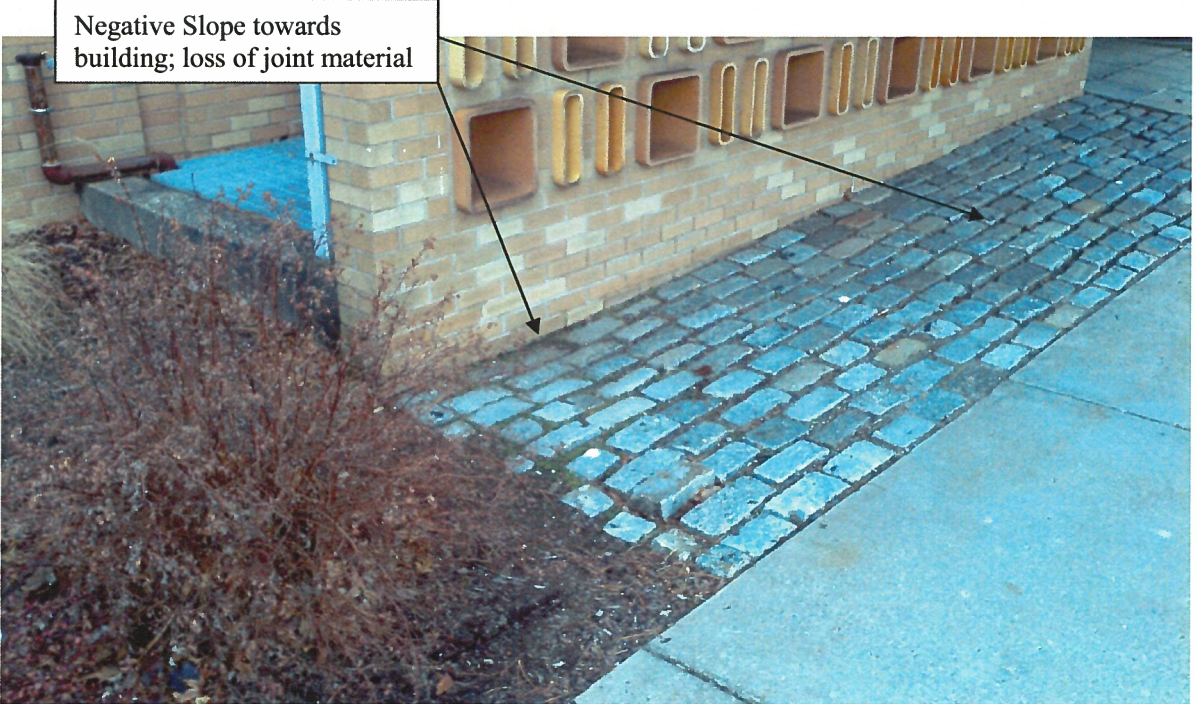
**Paver Patio by Main Entry**

- 6) Paver patio area at front entry: Pavers have settled and are sloping towards the building; joint material is recessed.  
Recommendation: Reset pavers as needed to provide a positive slope and fill joints with poly-sand.

Negative Slope towards building; loss of joint material

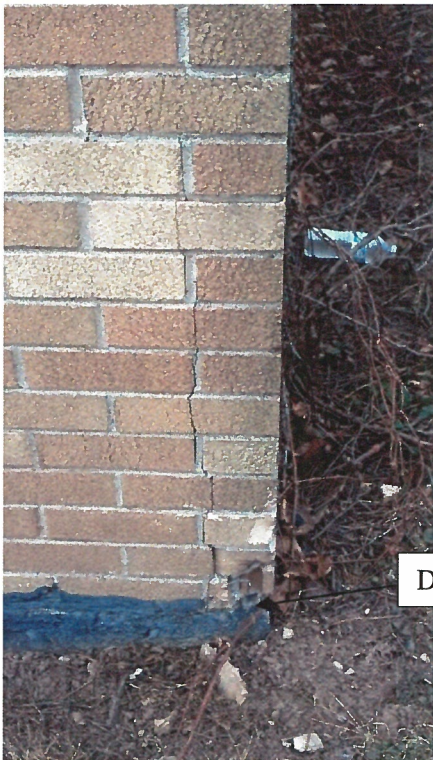
**Northeast Corner**

Damaged Brick

- At damaged brick locations, replace damaged brick with brick and mortar that have similar physical and visual properties as the existing brick and mortar.

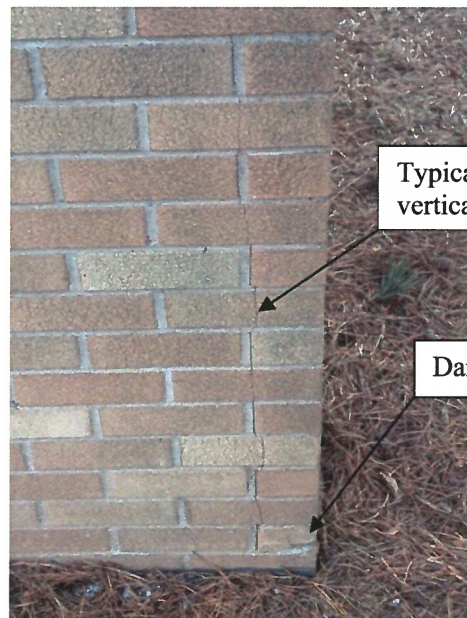
**Northwest corner**

Typical outside corner vertical cracking

Damaged Brick

**Typical Outside Corner Vertical Cracking Observations**

- At vertical cracking, the long term solution is to cut full height control joints into the brick and fill the joints with backer rod & sealant to alleviate the stress forces and water infiltration (water and moisture intrusion may have caused freeze/thaw damage observed at bottom bricks). However, we recommend the less expensive option of replacing the cracked brick and re-pointing loose and cracked mortar joints since 50 years have resulted in minimal cracking to date.

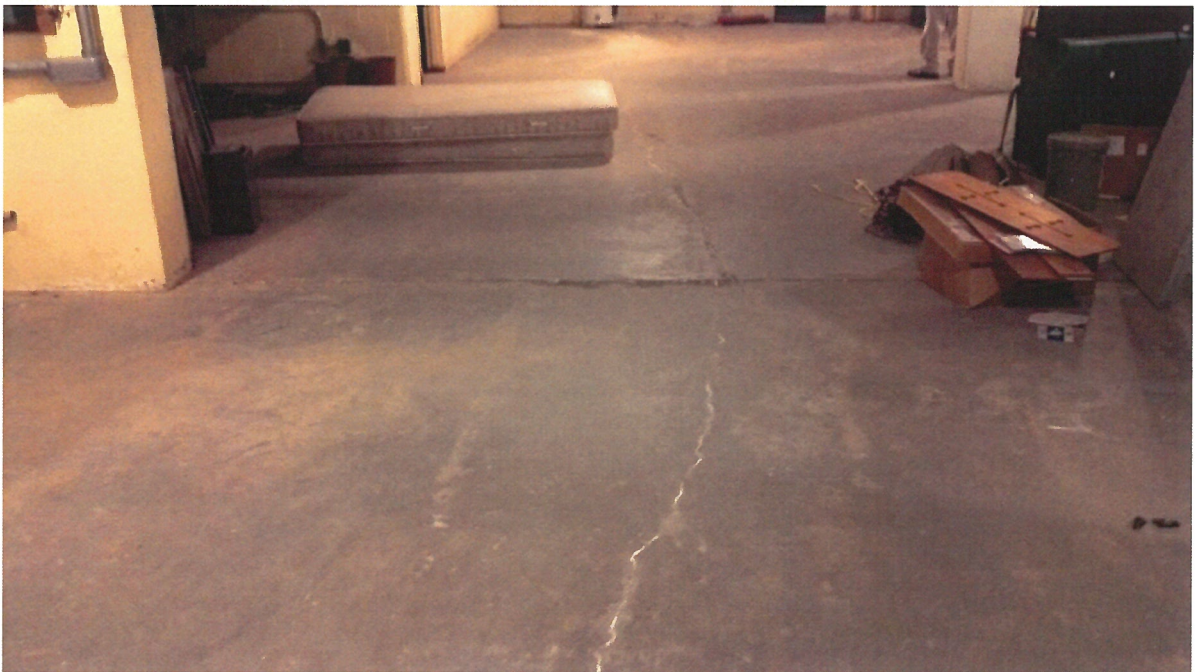
**Basement Slab Cracking**

The existing concrete slab on grade may have experienced hydrostatic pressure resulting in heaving and cracking of the slab through-out (the tops of the slab at the cracks felt higher than the surrounding floor while walking normally). Refer to Appendix #3 for schematic slab cracking plan.

Staining and efflorescence at the cracks in the slabs were observed suggesting that there may be some trapped moisture under the slab, but that it has been drying out over time. The basement did not have a noticeable musty or mildew odor suggesting that the presence of moisture was not persistent or constant.

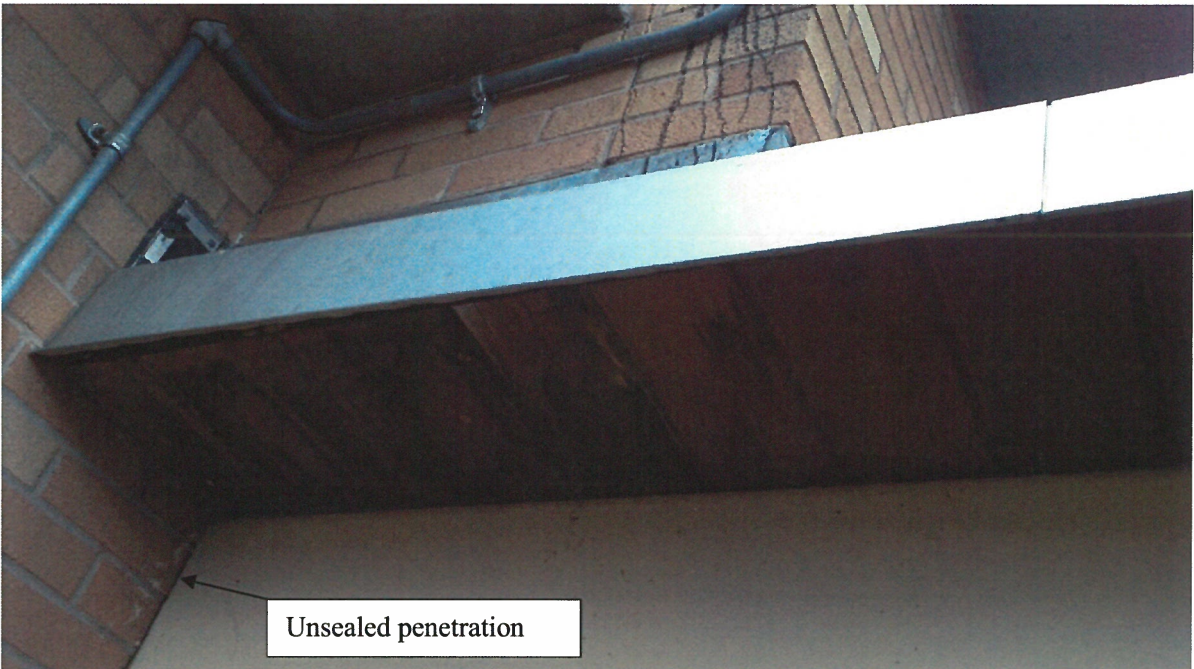
**Water Damage at Front Entry Roof Soffit**

Unsealed penetration

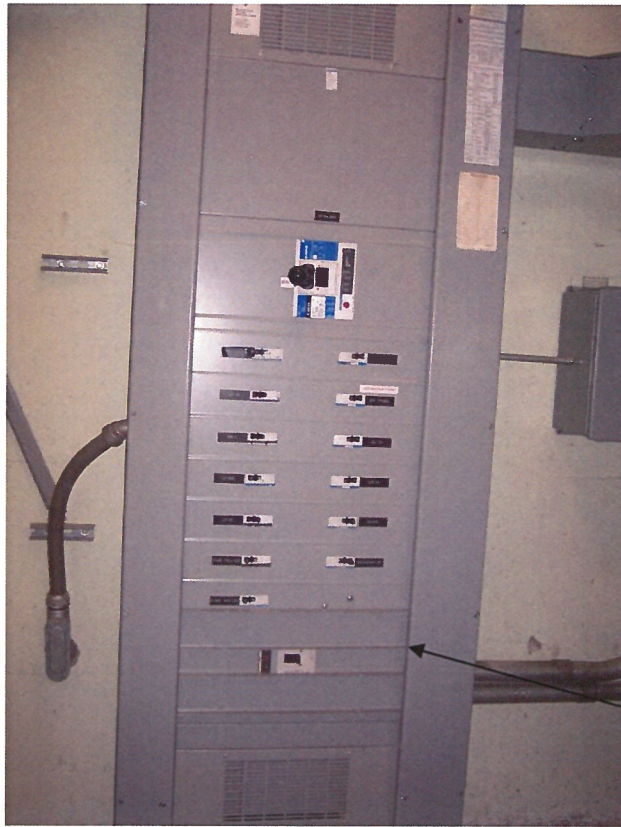
**Main Electrical Panel**

Covers at the bottom of panel causing improper installation of side covers

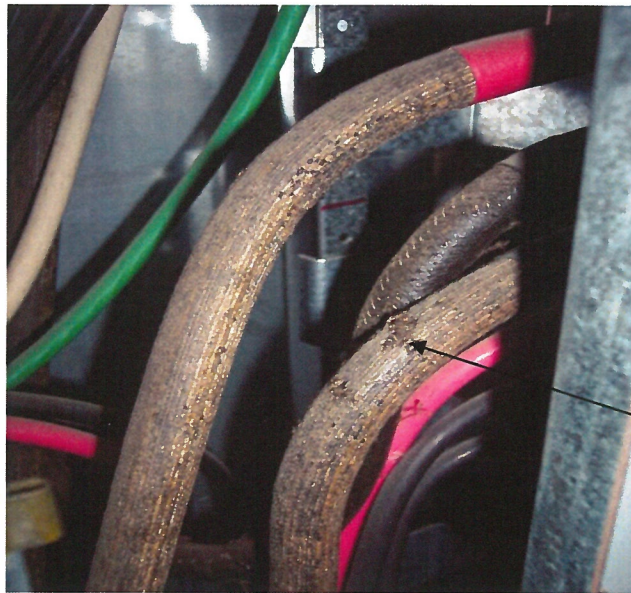
**Cloth Insulated Wire**

Cloth insulated feeder cables with damage to insulation

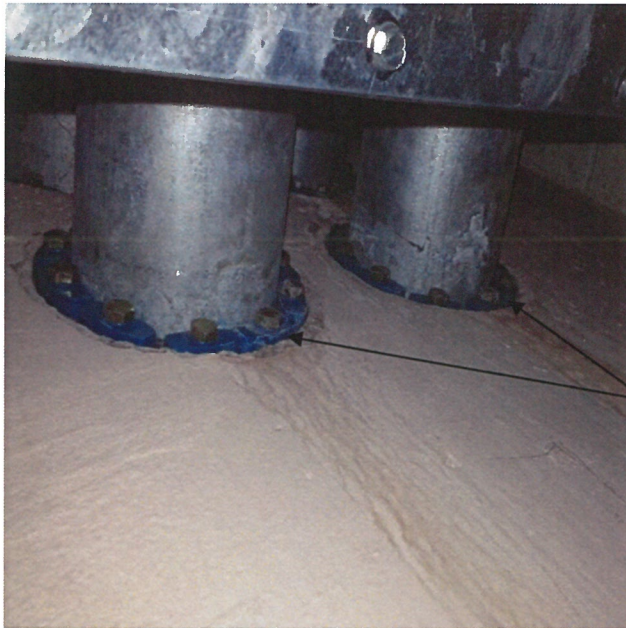
**Foundation Conduit Penetrations**

Water leaking through foundation conduit penetrations.

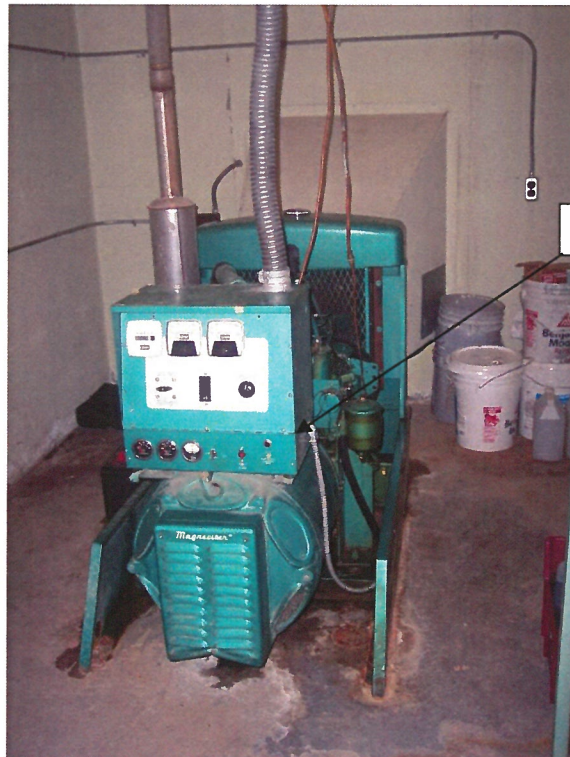
**Emergency Generator**

Undersized emergency generator

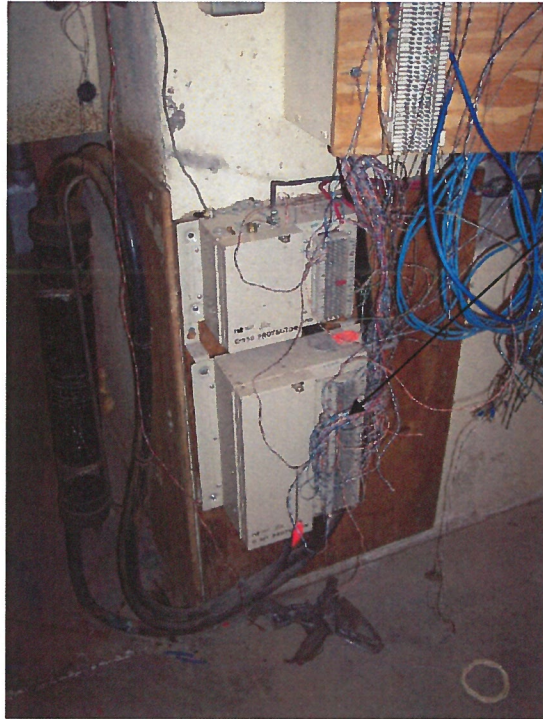
**Old Telecommunications**

Unorganized old telecommunication wiring

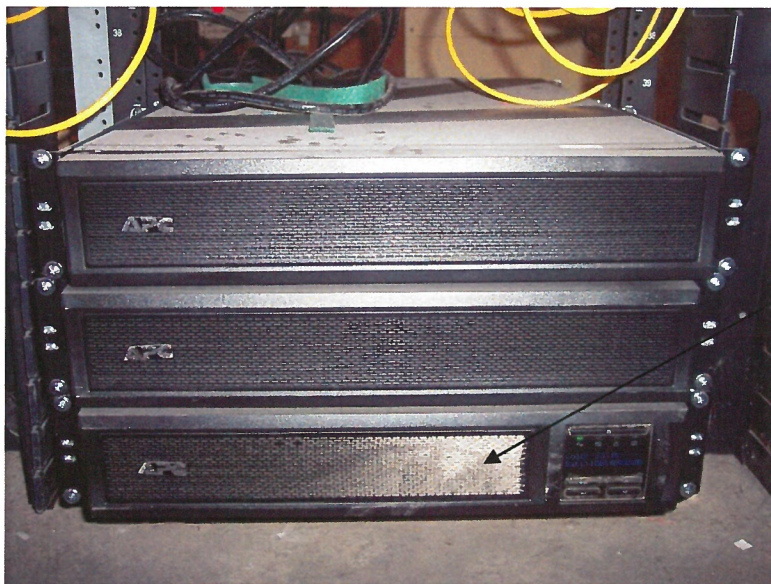
**Data Rack UPS**

Excessive dust on UPS fan filters

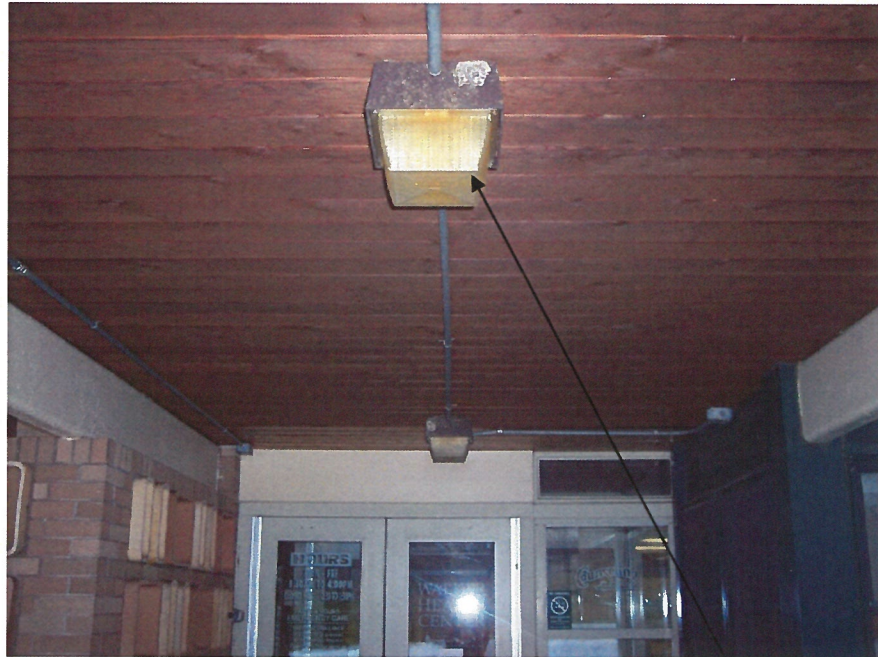
**Entry Canopy Fixtures**

Deteriorating inefficient H.P.S. light fixtures

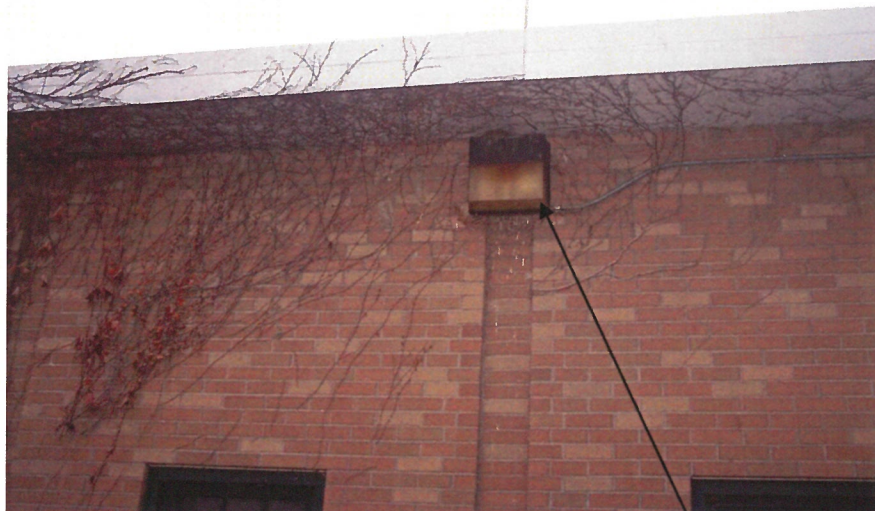
**Building Site Light**

Deteriorating inefficient H.P.S. light fixtures

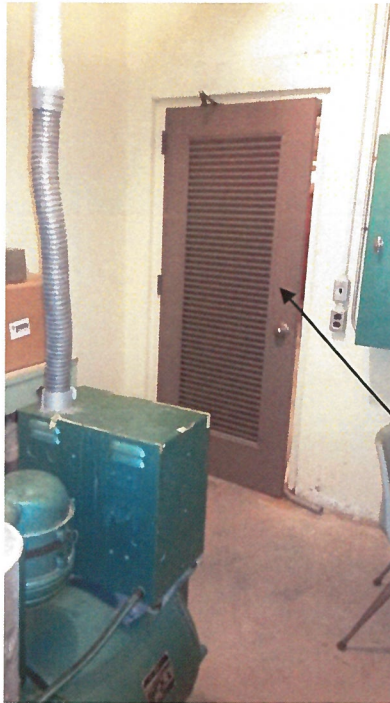
**Generator Room Door**

Louvered door to the emergency generator room is not rated

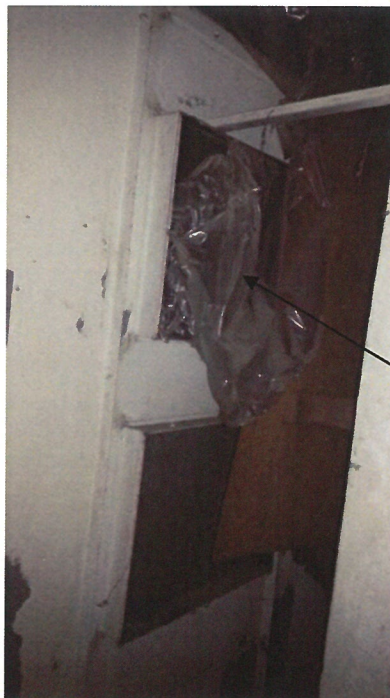
**Basement Outside Air Plenum**

Outside air plenum openings are no longer utilized. There are no isolation dampers present and cold air enters the building freely.

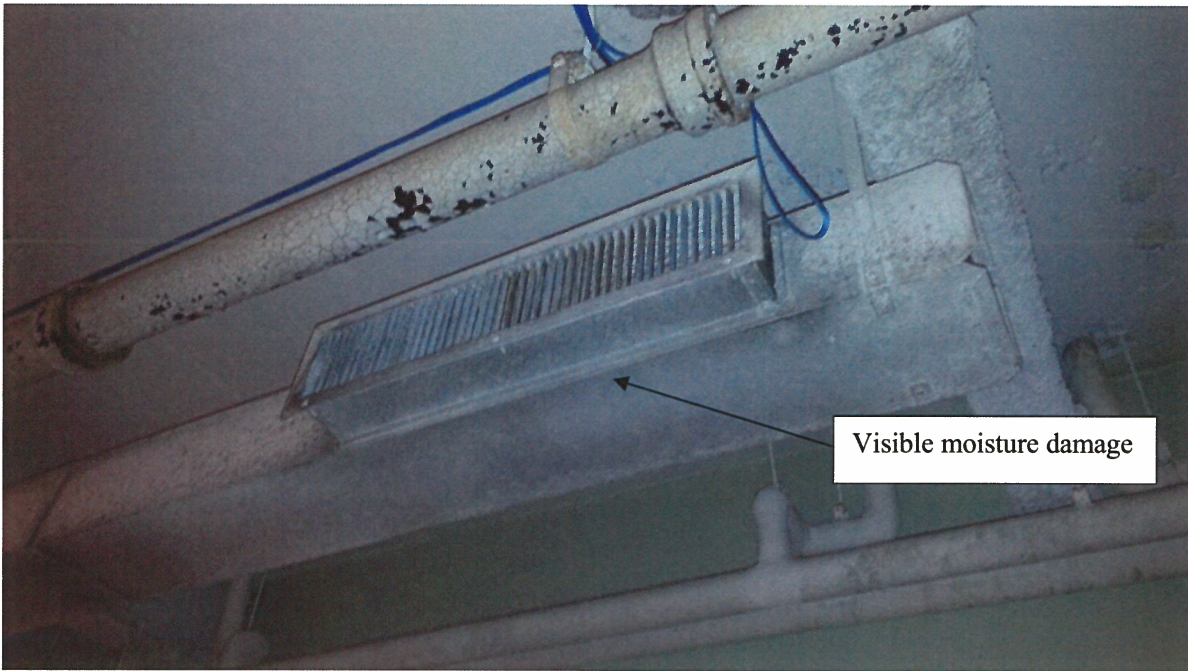
**Basement Distribution Duct**

Visible moisture damage

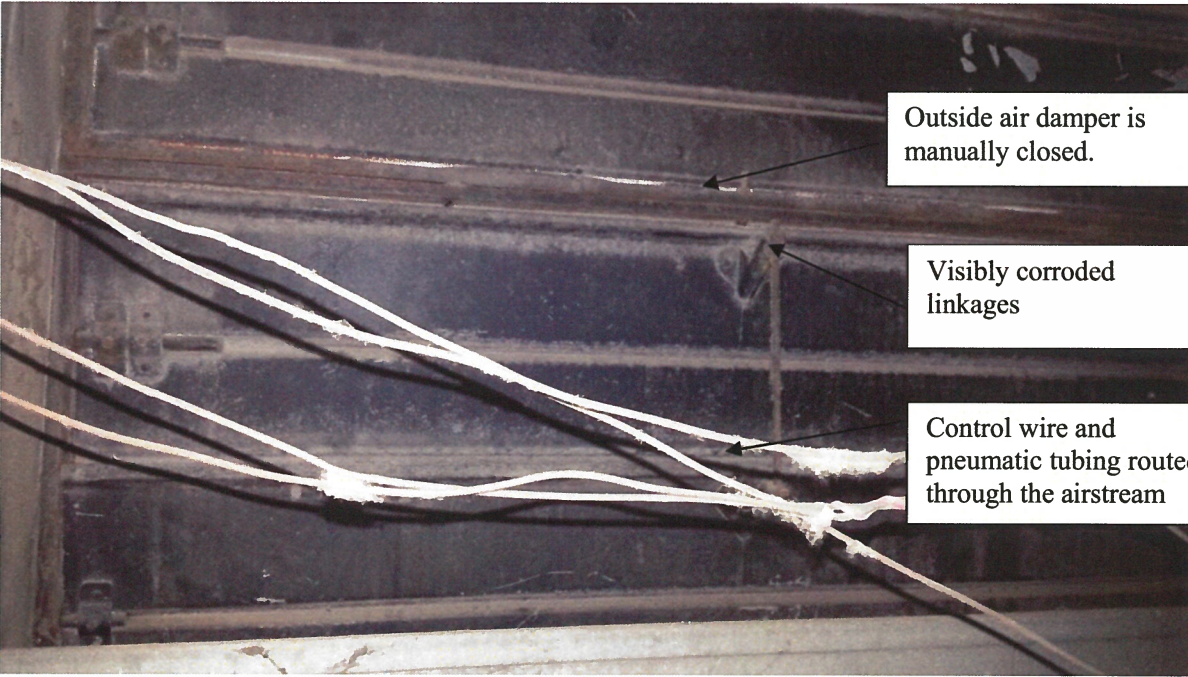
**Penthouse Outside Air Duct**

Outside air damper is manually closed.

Visibly corroded linkages

Control wire and pneumatic tubing routed through the airstream

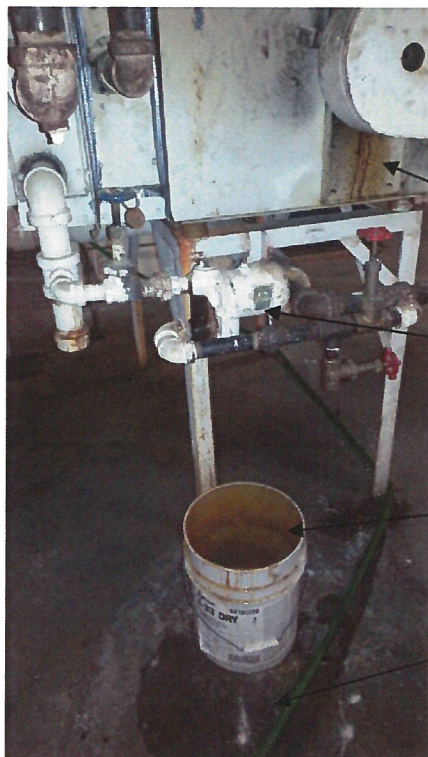
**Penthouse Steam Coil**

Visibly corroded cabinet

Leaking condensate trap

Potential for moisture damage

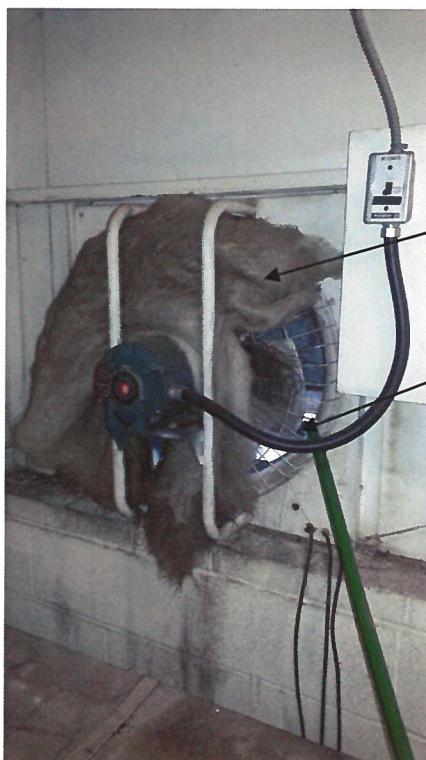
**Penthouse Ventilation Fan**

Blocked airflow path

No closure damper present at wall penetration

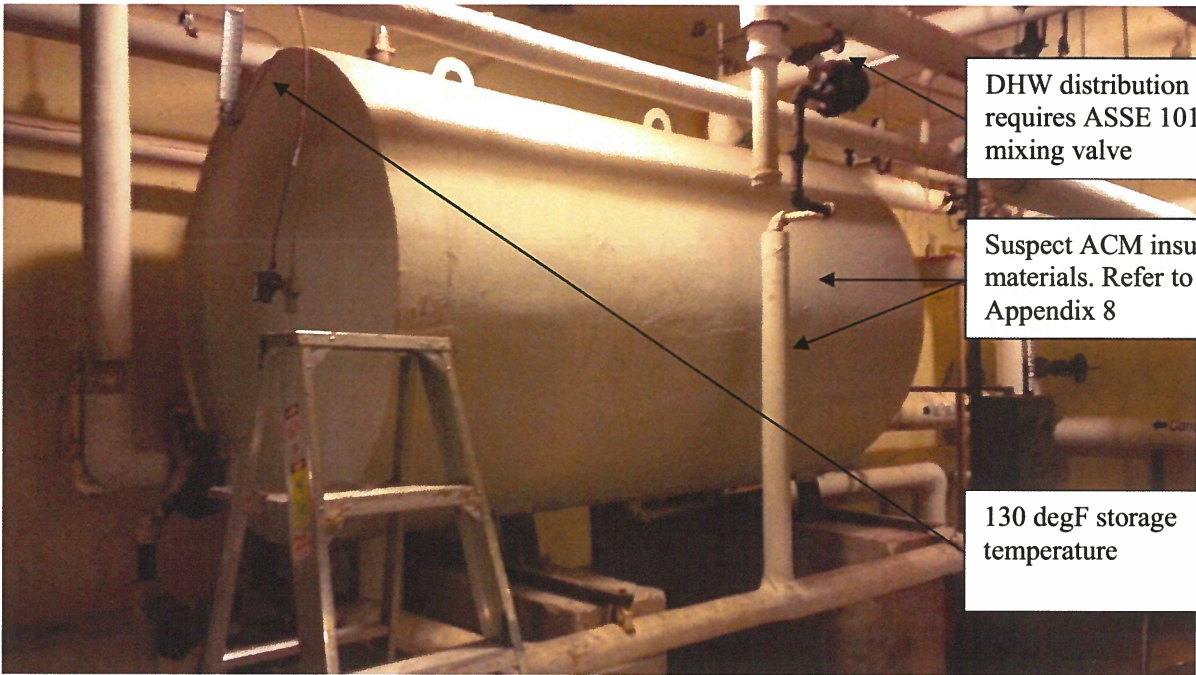
**Domestic Hot Water System**

DHW distribution main requires ASSE 1017 mixing valve

Suspect ACM insulation materials. Refer to Appendix 8

130 degF storage temperature

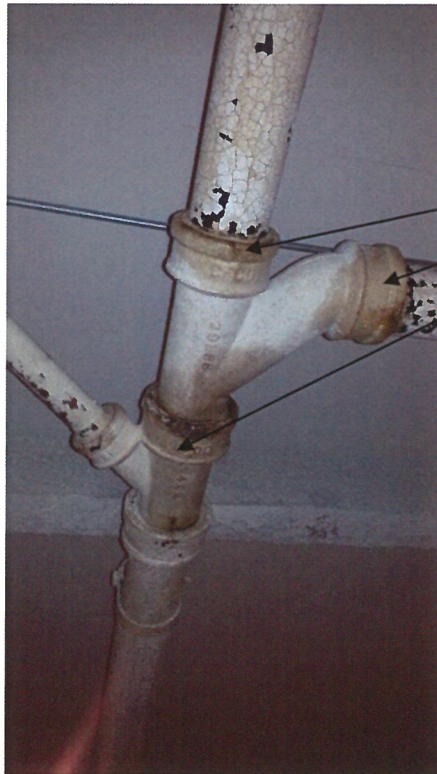
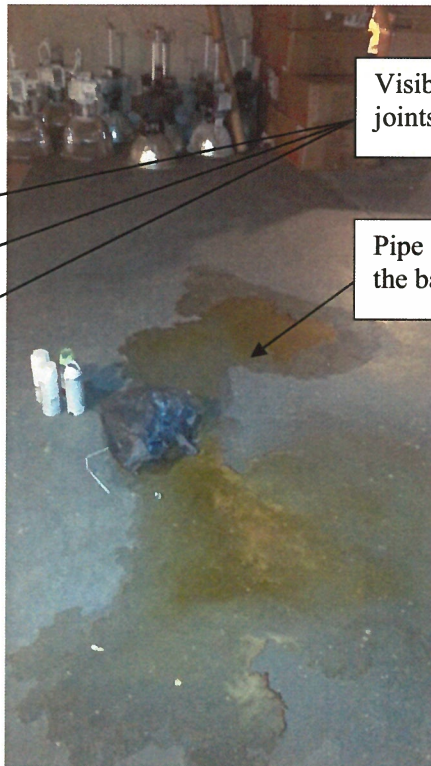
Visible leaks at fitting joints

Pipe fitting leaks pooled on the basement floor
