Program Study

## Intercollegiate Athletics

Laker Hall

April 2017

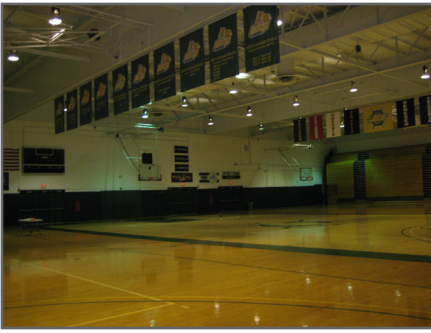
Gymnasium

- The operable partition in the gymnasium does not work properly. It should be replaced with a high-quality, operable partition that will provide better acoustic separation when the gymnasium is being used by multiple groups.

- The operable partition in the main gymnasium does not work properly. It should be replaced with a high-quality, operable partition that will provide better acoustic separation when the gymnasium is being used by multiple groups.

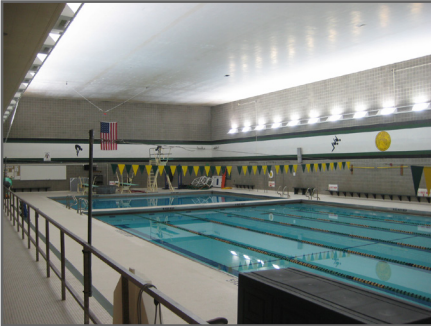
Swimming Pool

- Staff reported that an ongoing gutter issue often results in ponding on the deck of the pool.
- The wood bleachers in the swimming pool are in fair to poor condition and should be replaced. Accessible seating areas should be created as part of the project.

- Some of the ceramic floor tile in the swimming pool is failing and should be replaced.
- Deteriorating carpet in the basement and vinyl floor tile on the second floor should be replaced.

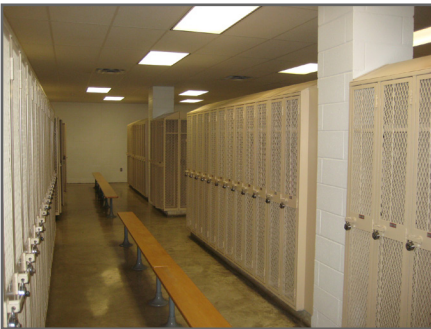
Locker Room

- Staff reported that the current configuration of the locker rooms does not adequately support the number and size of the athletic teams.
- Existing single-glazed windows are in fair to poor condition. All windows should be replaced with double-glazed, energy-efficient units.

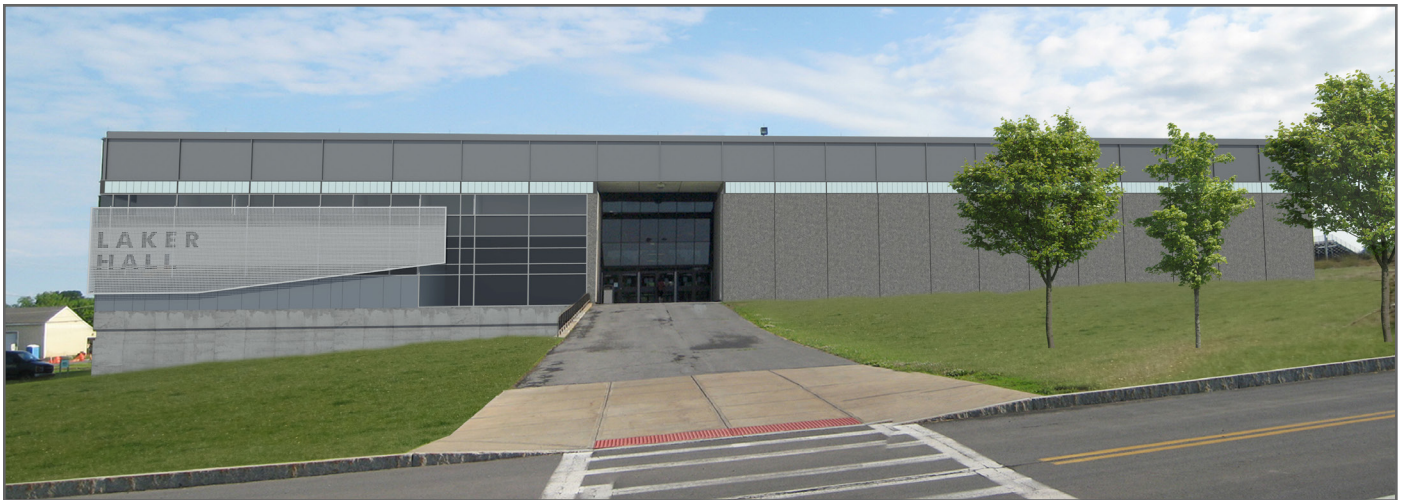
Proposed Main Entrance

The final concept plans are included on the following pages. As part of the renovations, the exterior wall assembly on the northwest and southwest corners of the building will be replaced with an aluminum curtainwall system. This will provide an opportunity to update the appearance of the building; engage the first floor student lounge with the main entrance; and provide natural light and views from first and second floor offices. The cementitious wall board around the perimeter of the building will also be replaced with a window system to provide natural light into the gymnasium and swimming pool.

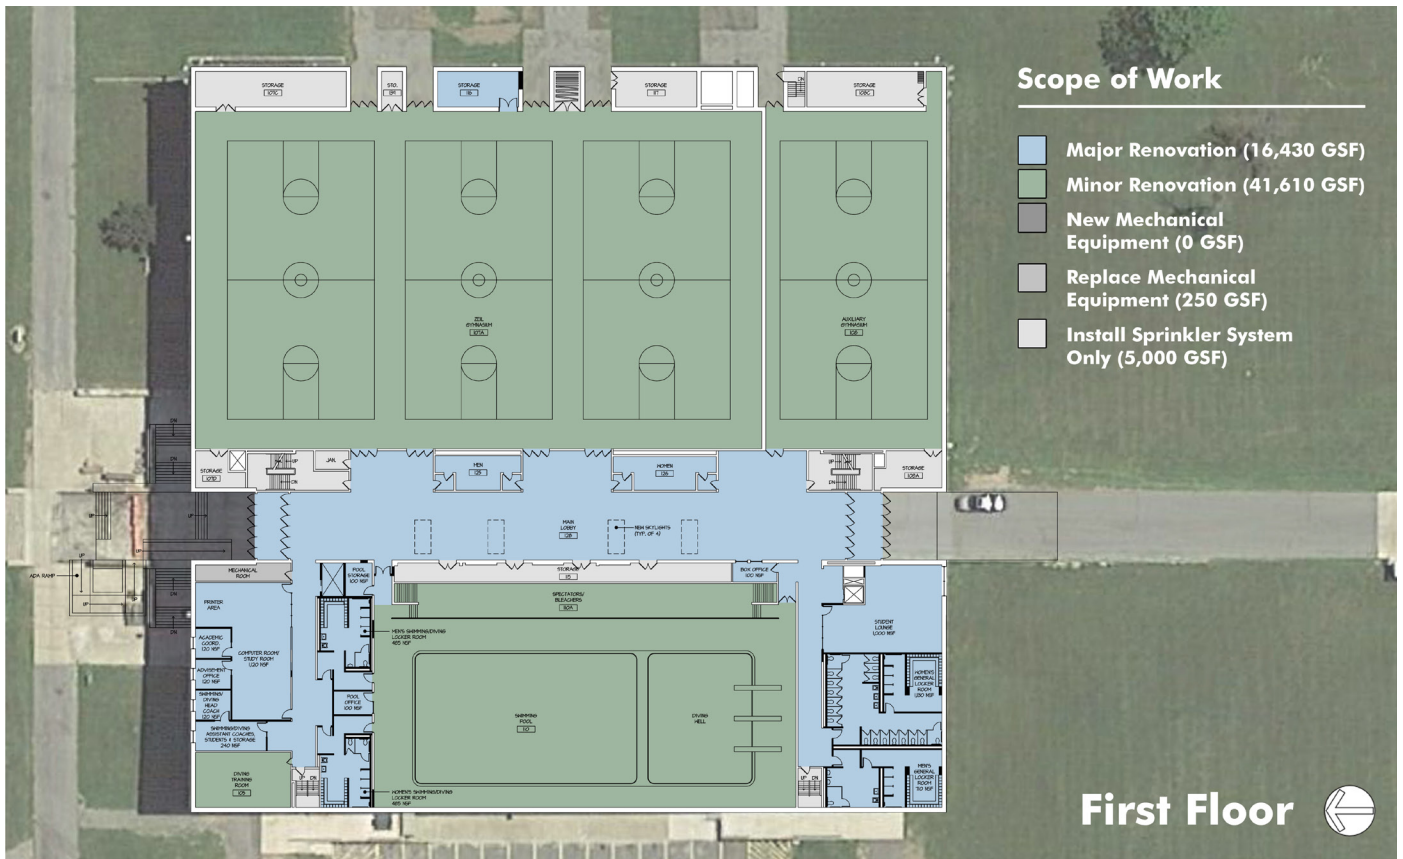
Proposed First Floor Plan

First floor renovations will also include upgrades to the gymnasium and toilet rooms. An interior door will be installed in Storage Room 116 so that it can be utilized as a “half-time” room during athletic competitions.

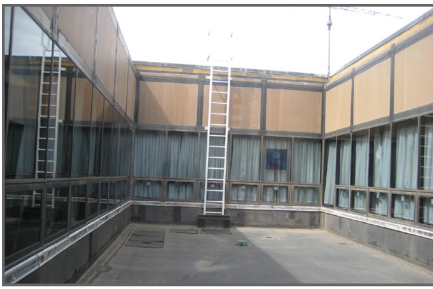
Existing single-glazed windows are in fair to poor condition.

- Existing single-glazed windows are in fair to poor condition. Evidence of past leaks was discovered at the second floor light wells. All windows should be replaced with double-glazed, energy-efficient units.
- Building signage is dated and difficult to read. It should be replaced with new signage that is visible from the adjacent road and parking lot.
- SUNY Oswego has detailed records that indicate asbestos is present in exterior wall insulation and water proofing. An allowance for abatement should be included for all areas that are renovated. The bulk sample report is included in Appendix C.

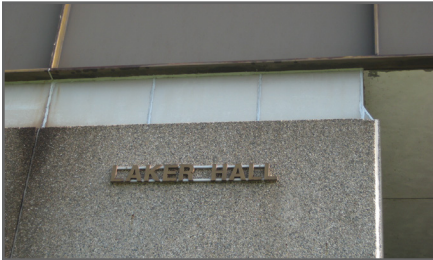
Building signage is difficult to read and should be replaced.

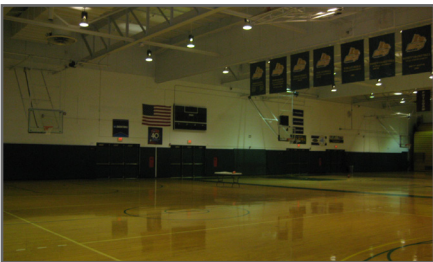
Staff reported acoustic issues in the main gymnasium.

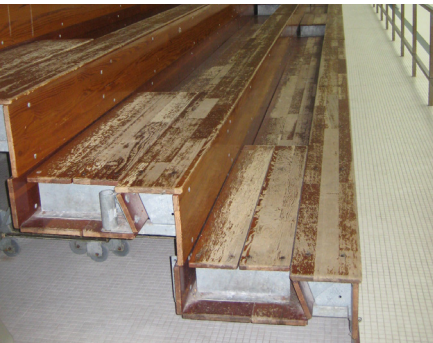
Wood bleachers in the swimming pool are in fair to poor condition.

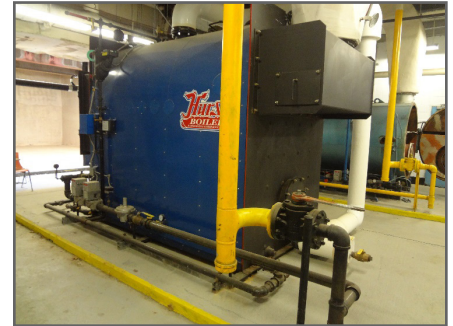
Steam Boilers

Steam from the boilers is distributed to the heating and ventilating units by steam piping. Each main and branch is sized to capacity and terminates at the respective coils in the units. The piping in is fair condition. Insulation on various sections of the pipe mains and branches in damaged or missing, which leads to a loss of energy and efficiency of the system.

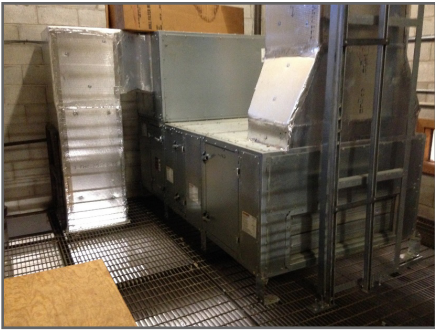
Heating and Ventilating Unit Behind Main Gymnasium

All heating and ventilating (HV) equipment is operational, but beyond its thirty year useful life. Units, coils, piping, and insulation are in fair condition. All units and controls need repair and updating to operate effectively and efficiently.

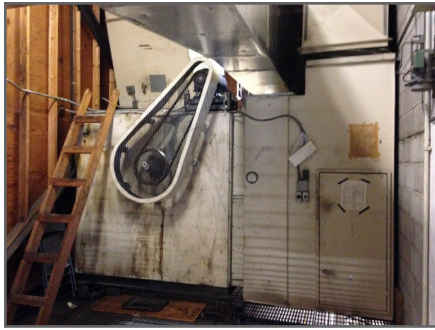
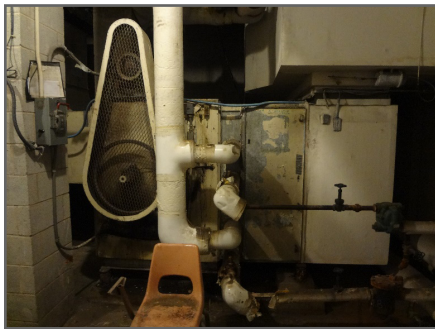
Exhaust Fan

Exhaust fan (EF) equipment is beyond its thirty year useful life. Units and controls need repair and updating to operate effectively and efficiently.

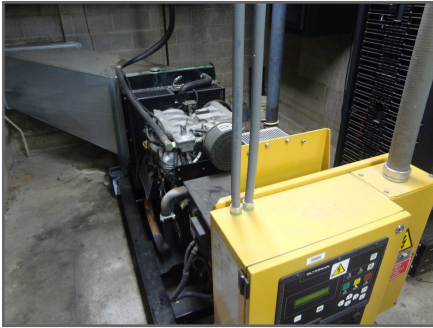
Emergency Generator in Electric Room 12A

- The emergency system appears to feed select lighting circuits, exit signage, sump pump, and some receptacles in Mechanical Room 12.
- The emergency generator and transfer switch appear to have been installed in 2007 and are in good condition.

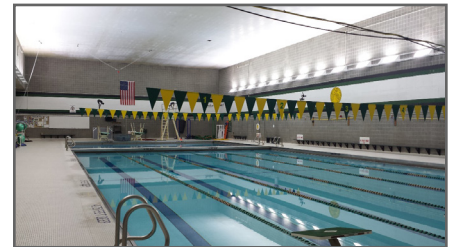
Pool Lighting

- With the exception of the gymnasium and swimming pool, lighting fixtures will likely need to be replaced with higher efficiency fixtures and additional lighting controls in order to meet the watts per square foot requirements in the latest edition of the New York State Energy Conservation Construction Code.
- Exit signs are required to consume a maximum of 5 Watts per face, therefore, replacement will likely be required to meet the requirements in the latest edition of the New York State Energy Conservation Construction Code.

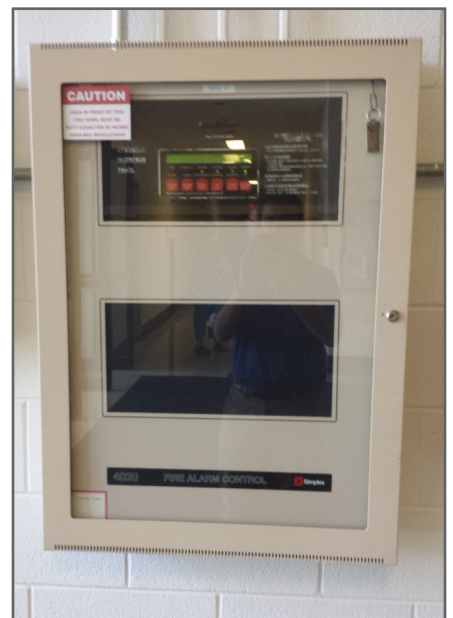
Fire Alarm Control Panel in Main Lobby

- Some areas are provided with smoke detection. The swimming pool has beam-type smoke detectors that provide coverage for the pool area.
- HVAC units appear to utilize duct-type smoke detection with automatic shutdown upon detection.
- The system is in good working condition.

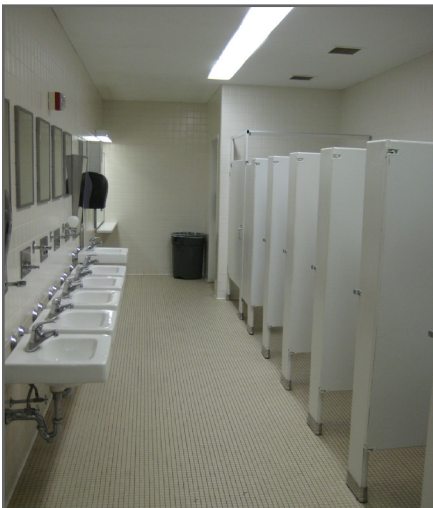
Toilet rooms have been updated, but require additional modifications to bring them into full compliance with ADA requirements.

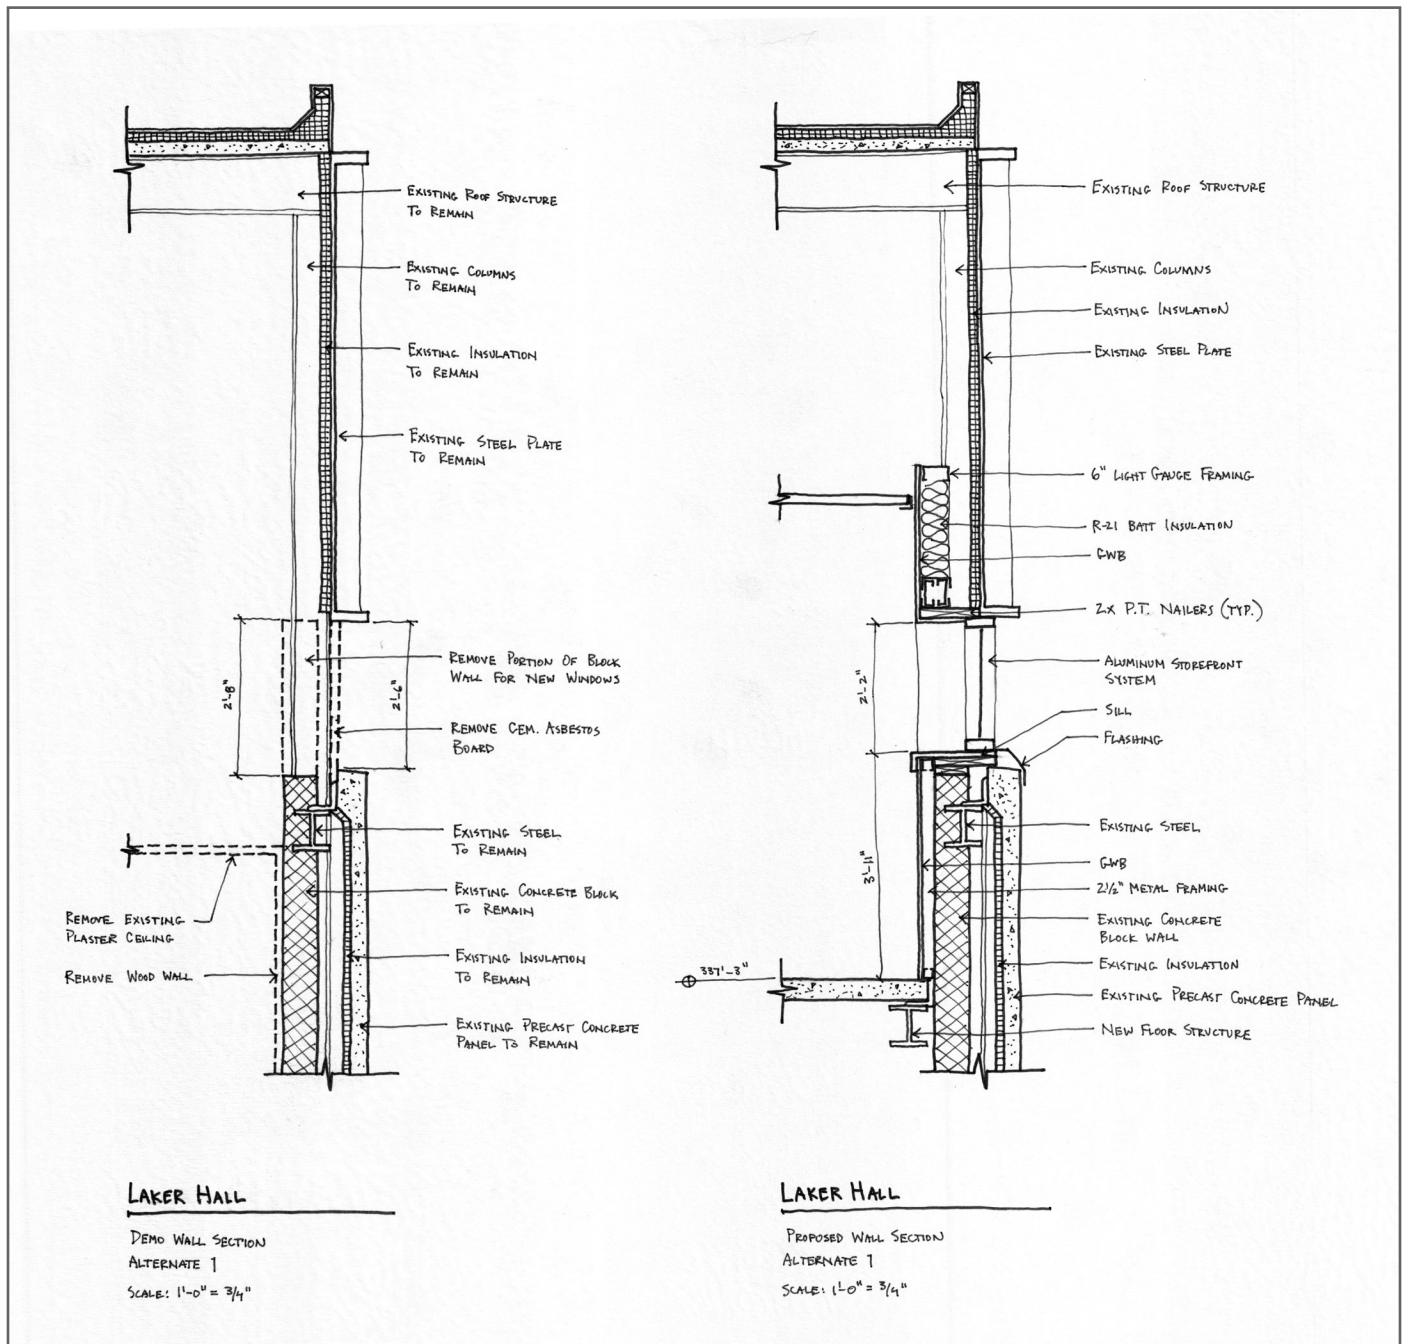
Option 1 - Proposed Exterior Wall Section

To provide additional natural light and views in second floor offices at the existing racquetball and squash courts, the planning team explored three options for the installation of a window system. In Option 1, the cementitious wall panels will be removed, a portion of the concrete block wall behind the panels will be demolished, and an aluminum storefront system will be installed. At an estimated cost of \$40,000, this option will be the most economical. The sill of the windows, however, will be 3'-11" above the floor and will limit exterior views.

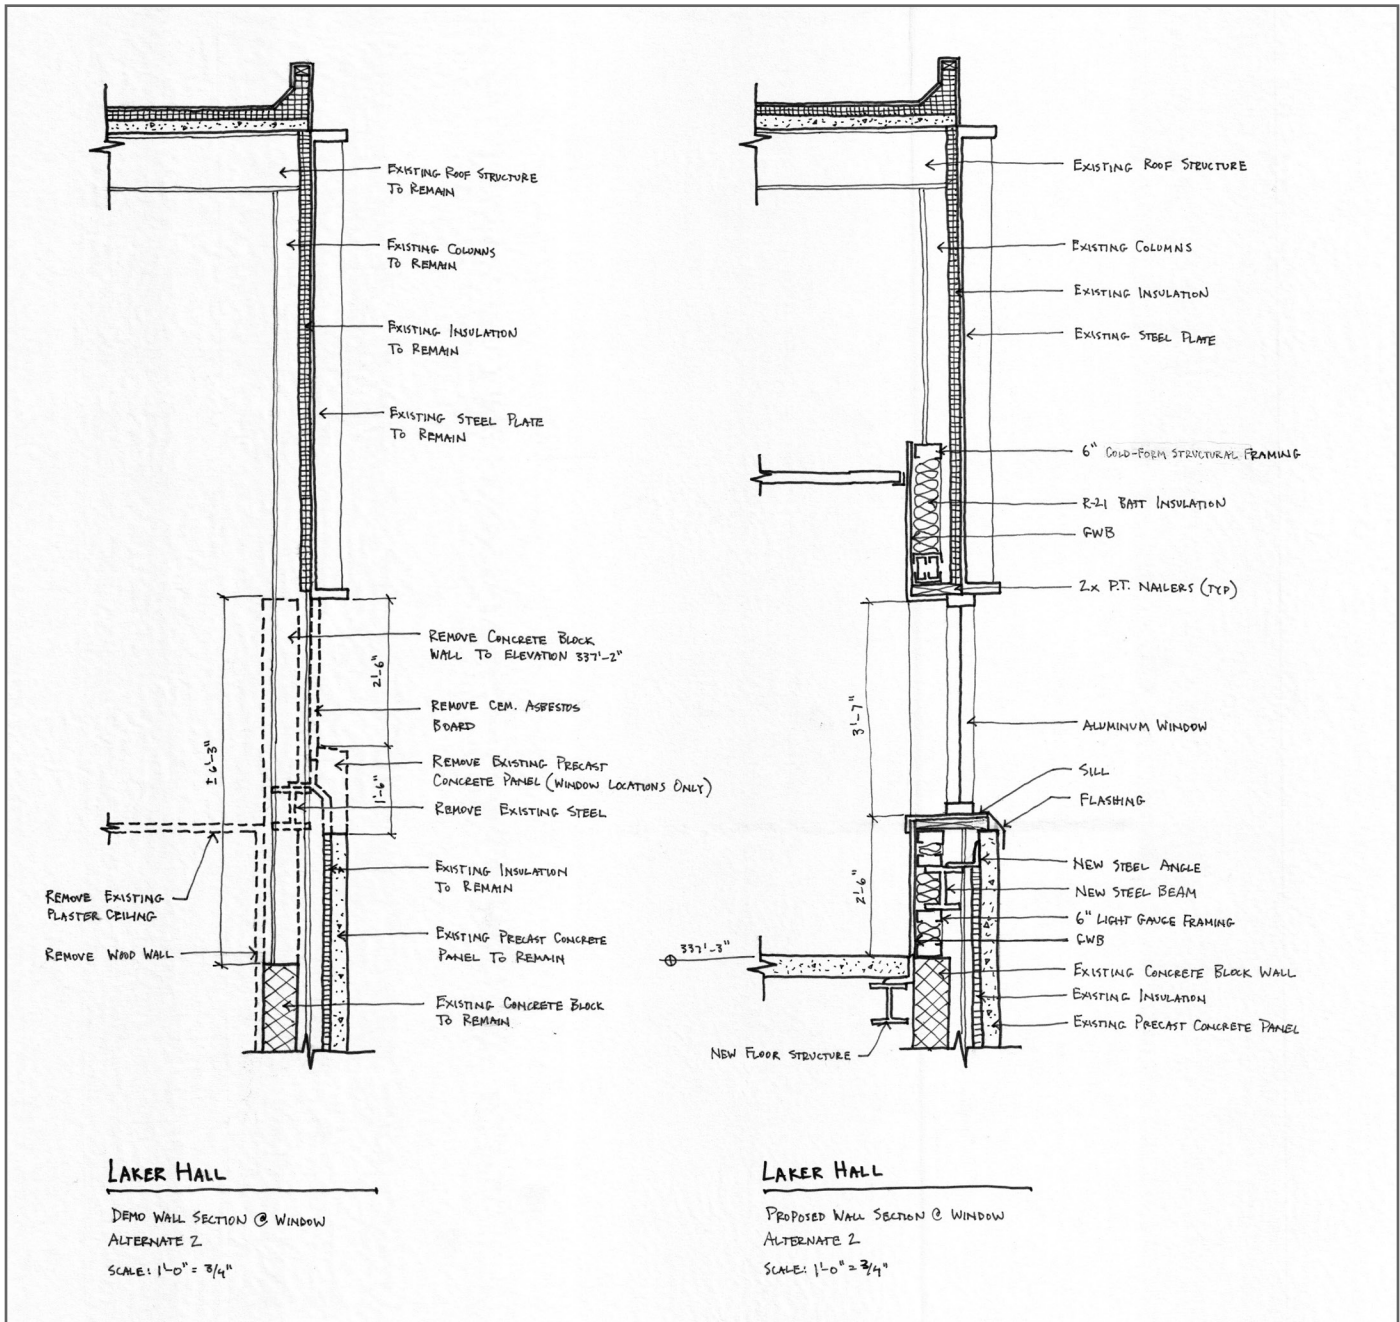
Option 2 - Proposed Exterior Wall Section

The cementitious exterior wall panel will also be removed in Option 2. In this option, however, the sill will be lowered to 2'-6" above the floor to provide a much larger window with views to the exterior. This will be achieved by removing a portion of the precast concrete panels and lowering the existing structural steel. This option will require detailed structural drawings for temporarily supporting the top of the concrete panels so the existing steel can be removed, installing a structural frame on the back of the concrete panels where the new windows will be located, and providing a new steel structure. The estimated cost for this work is \$205,000.

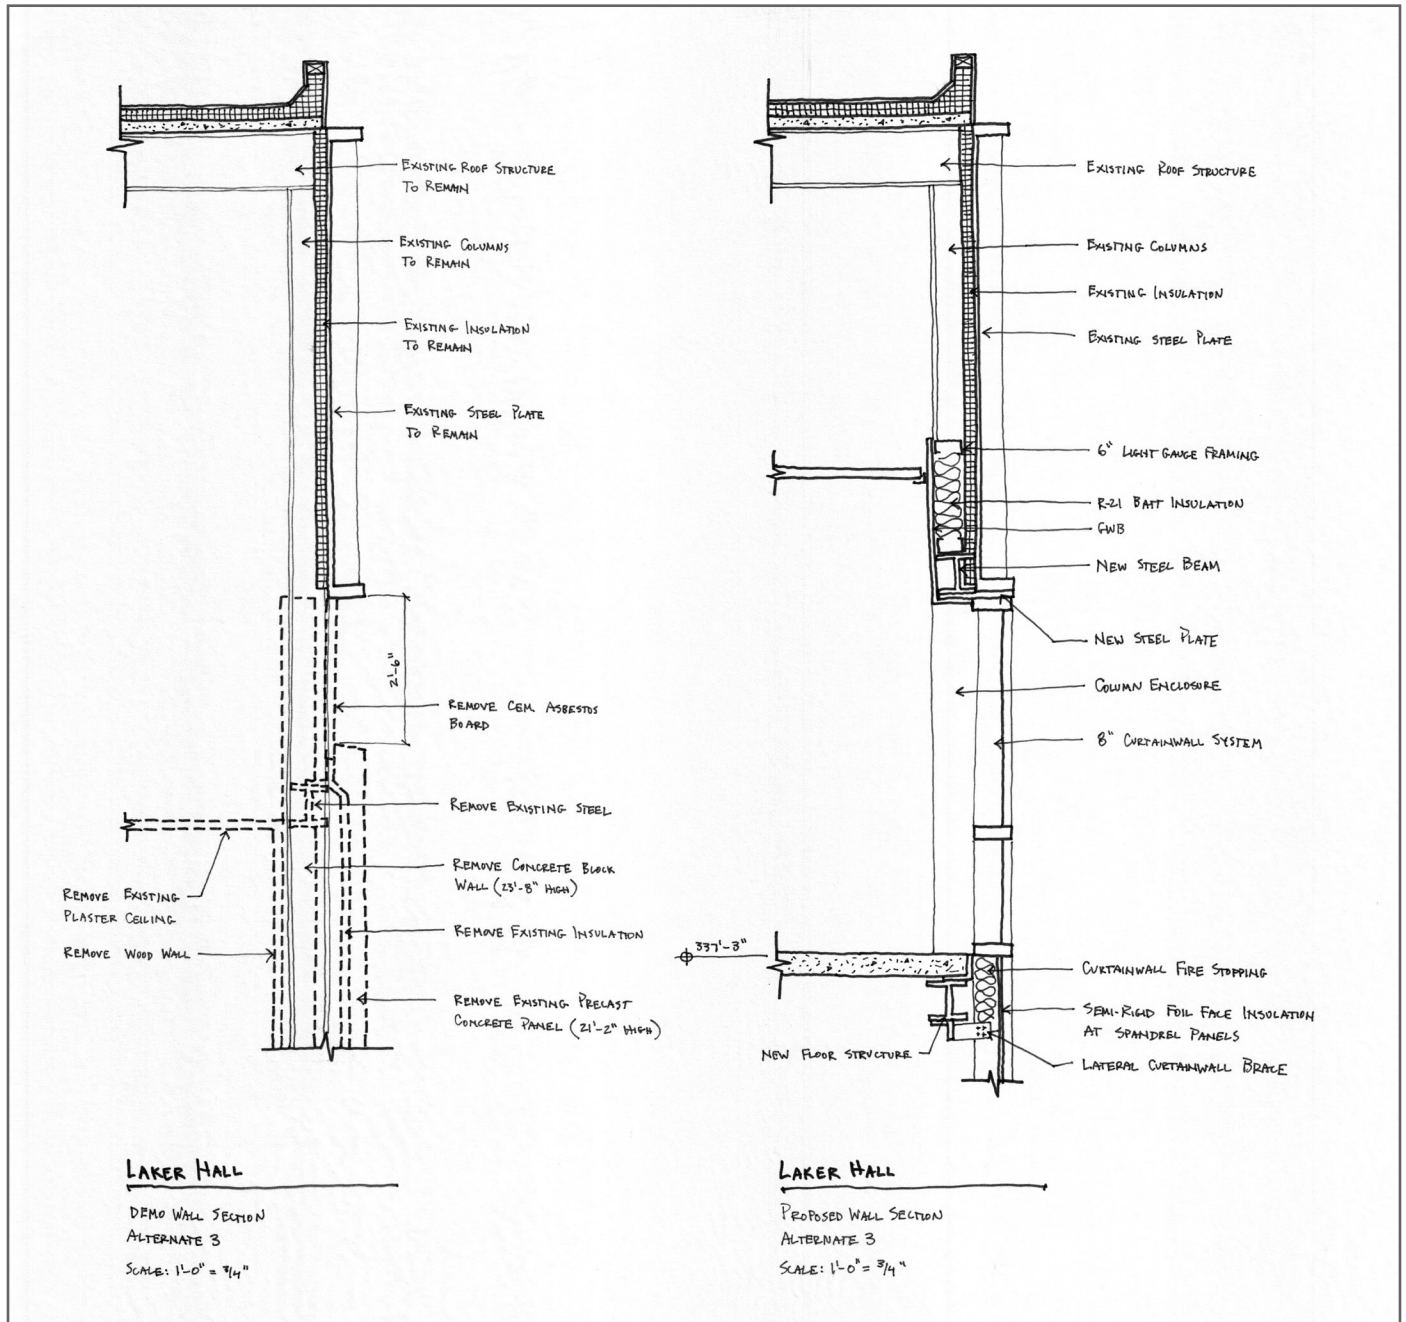
Option 3 - Proposed Exterior Wall Section

Option 3 includes the removal of the entire exterior wall assembly and installation of a new curtainwall system. This option will be the most expensive (\$525,000) but will have the most dramatic impact on the appearance of the building, provide the most flexibility in terms of the size and location of windows, and make it easier to renovate the interior spaces. **This is the option that was selected by the College.**

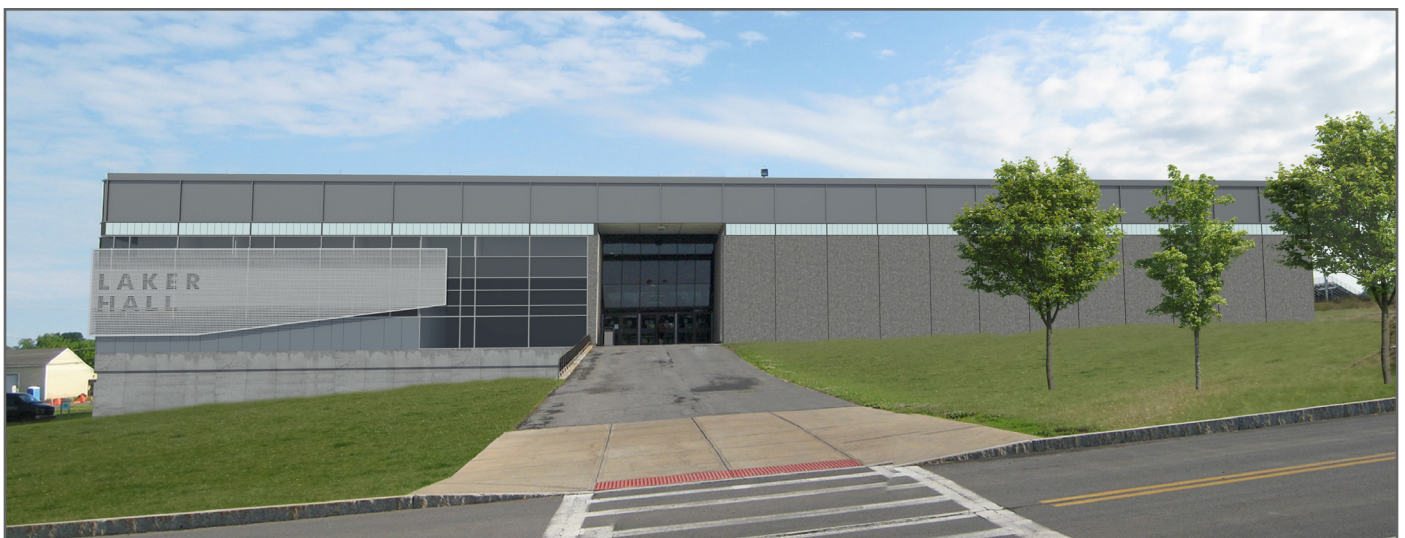
Proposed Main Entrance

Removing the wall assembly prior to the interior renovations will make it easier and less expensive to install the concrete foundations and structural steel that will be necessary for the second floor infill at the racquetball and squash courts. The new curtainwall system will provide an opportunity to improve the appearance of the building; engage the first floor student lounge with the main entrance; and provide natural light and views from first and second floor offices.

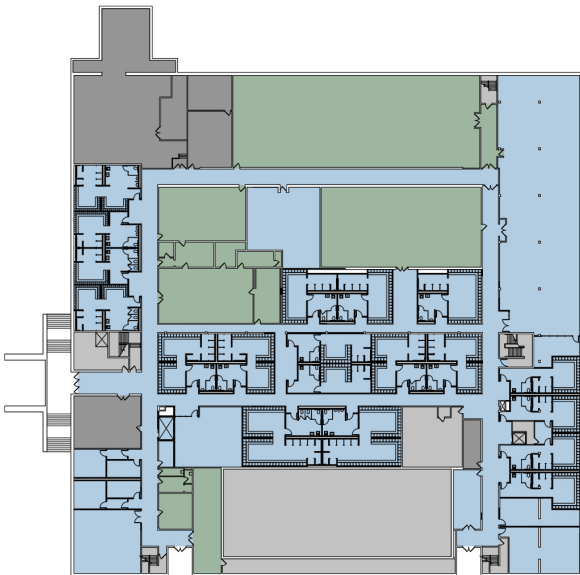
## Basement

Major Renovations: 35,890 GSF  
 Minor Renovations: 14,660 GSF  
 Mechanical Equipment: 6,090 GSF  
 Install Sprinkler System: 8,920 GSF

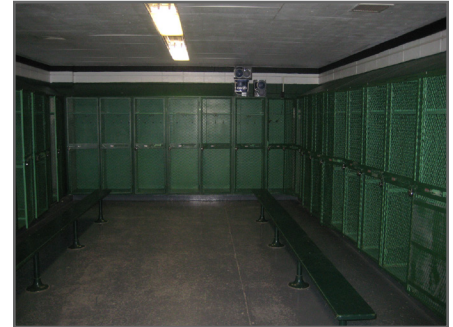
There are not enough locker rooms to support the number of athletic teams.

- The existing locker rooms were designed to support eight men's athletic teams. SUNY Oswego currently has 22 men's and women's athletic teams. The College intends to maintain the current number of teams and does not anticipate additional teams in the future.
- There are not enough locker rooms to accommodate the current number of athletic teams.
- There are currently no "All Gender" locker rooms or toilet rooms in the building.
- The locker rooms need a facelift - they are not included on facility tours for potential recruits unless they specifically ask to be shown the locker rooms.
- The general locker rooms are much larger than required. The number of lockers and showers could be reduced.
- Locker Rooms 7C, 7D, and 7E do not have toilets or showers, which reduces their functionality.

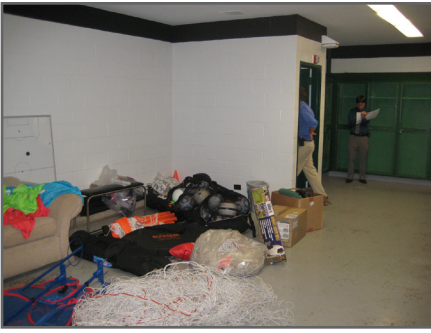
Additional storage space is required.

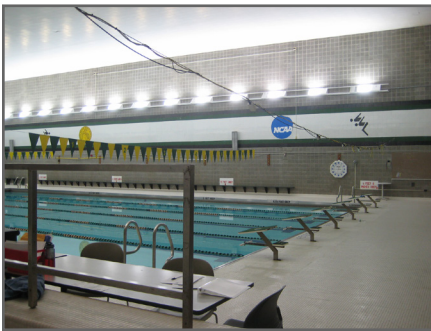
The swimming pool is in good condition.

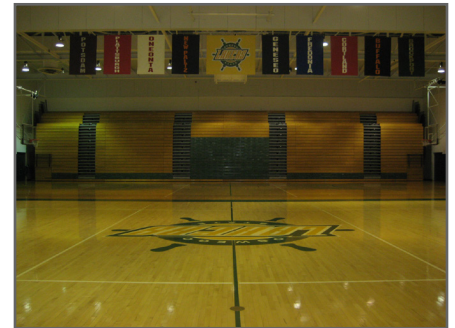
The operable partition and bleachers in the gymnasium should be replaced.

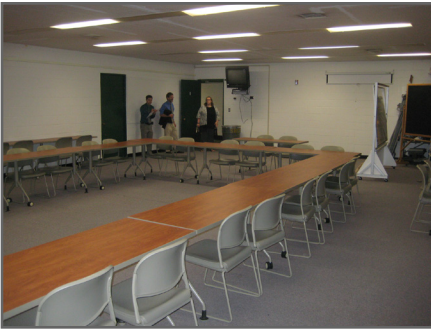
The classroom in the basement is used for meetings and viewing films.

- The classroom in the basement is used extensively for meetings and viewing films. A room that will accommodate up to 50 students and is equipped with projection equipment must be maintained. Staff indicated it would be helpful to have a refrigerator located near the classroom since the space is sometimes used for events.

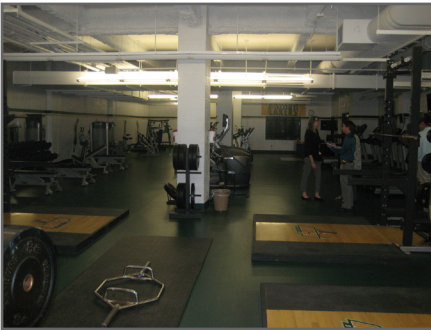
The fitness center should be expanded.

- The fitness center is near capacity between 2:00 and 4:00 PM. It should be expanded into the adjacent storage room. The functions in the physical fitness room could be moved into the expanded fitness center. The fitness center office should be moved to the end of the room to provide a more useful area for activities.
