5. Building Condition Survey

EXISTING BUILDING CONDITION SURVEY, PARK HALL

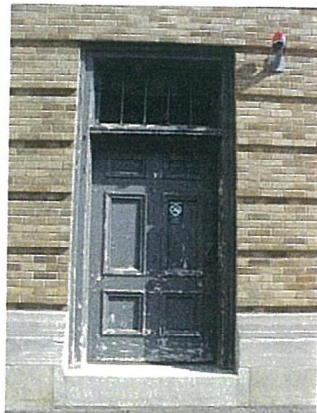
Park Hall - Exterior Doors

The exterior doors are wood doors with panic hardware that are in fair to poor shape and are of inappropriate sizes. The door closers do not meet foot pound pull requirements; they are difficult to open. In the short term, it is recommended that the doors be replaced with appropriately sized thermally broken handicapped accessible doors where appropriate with site conditions.

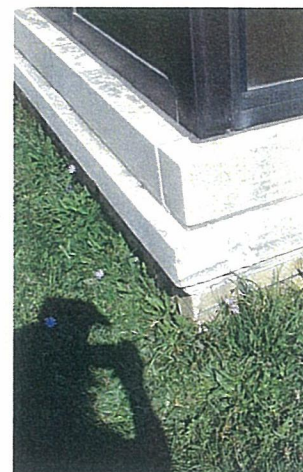
Limestone Condition

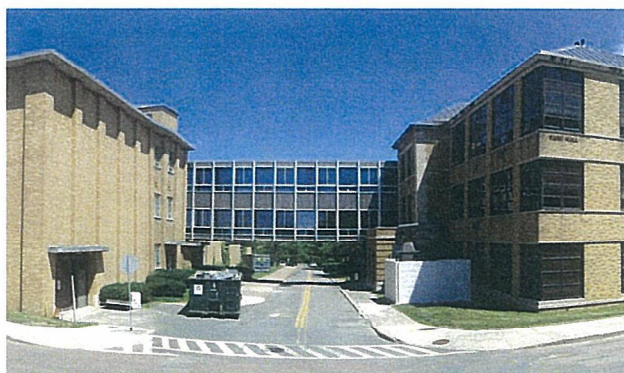
The concrete/macadam walks, curb, and grassy areas are in serviceable condition. The service driveway between Wilber and Park Halls is a hazard for students, and breaks the unification of the buildings. In the short term, it is recommended that the site be modified for a safer handicapped accessible means of access. Also, in the short term, it is recommended that the site be modified to enhance the unified School of Education in one facility.

Park Hall - Service Driveway

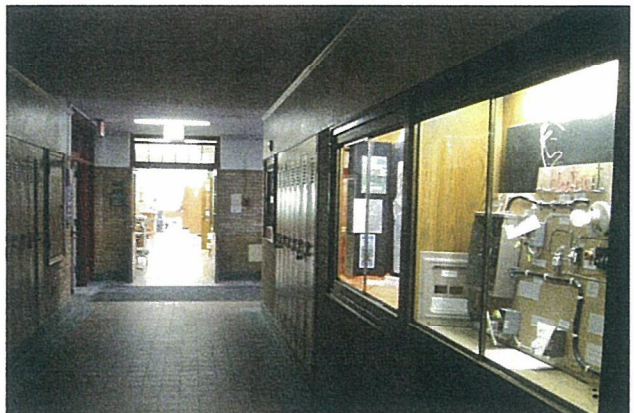
Ceiling
The z-spline ceiling is in serviceable condition with several areas of patch. In the short term, it is recommended that the ceiling system be replaced.

Park Hall - First Floor - Ceiling

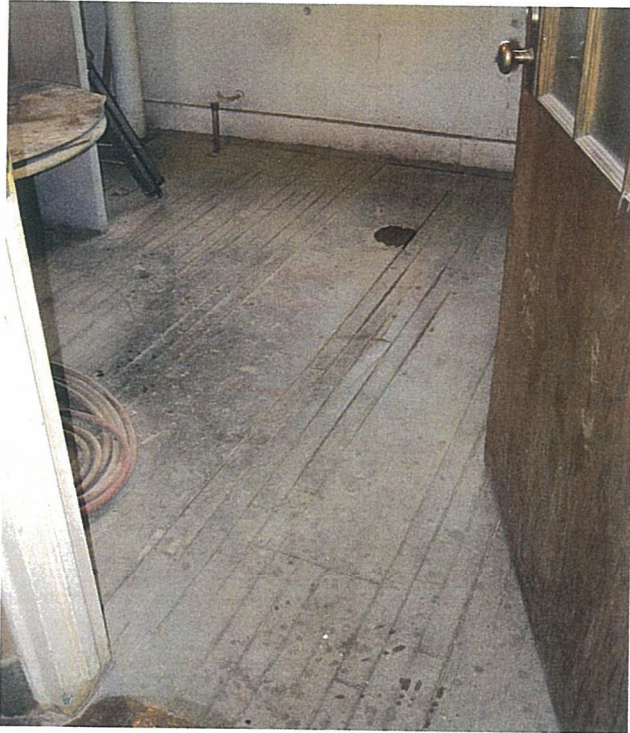
Park Hall - Room 101F - Wood Floors

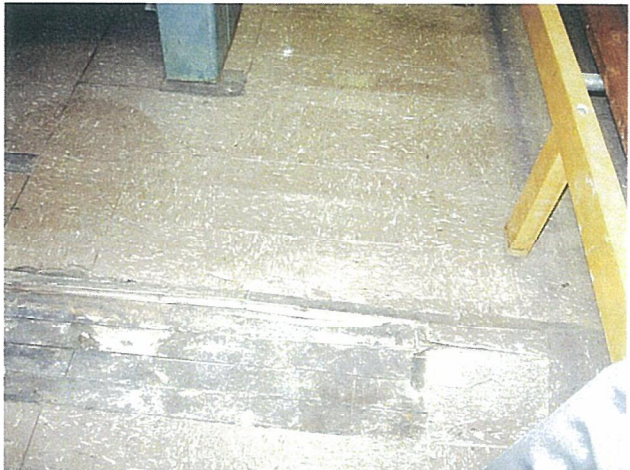
Park Hall - Room 103 - VCT flooring

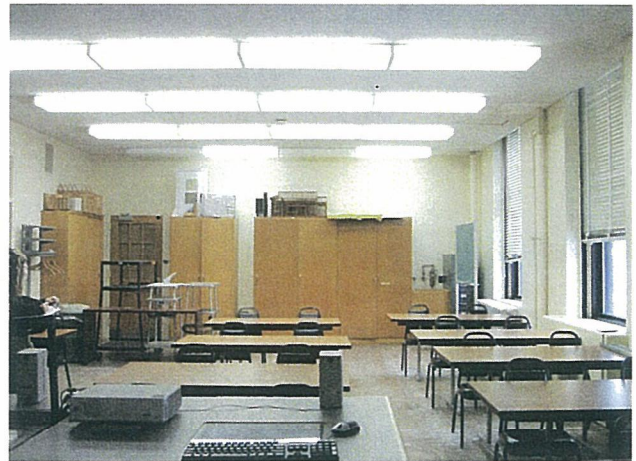
The ceiling is a 1x1 z-spline ceiling system and is in good shape with some damage near the west wall pipes. The walls are plaster and in good condition with a crack in the south wall. The floor is 9x9 vinyl composition tile and is in poor condition. The main entry double doors are wood with nine pane glazing and a painted metal panel at the transom set in metal frames and are in fair to good condition. The wood doors are chipping and cracking. In the short term, it is recommended that the damaged ceiling tiles near the west wall pipes be replaced, the south wall crack be repaired, the floor and sub-floor be replaced, and the wood doors be repaired.

Park Hall - Room 104 - Wood technology Classroom Lab

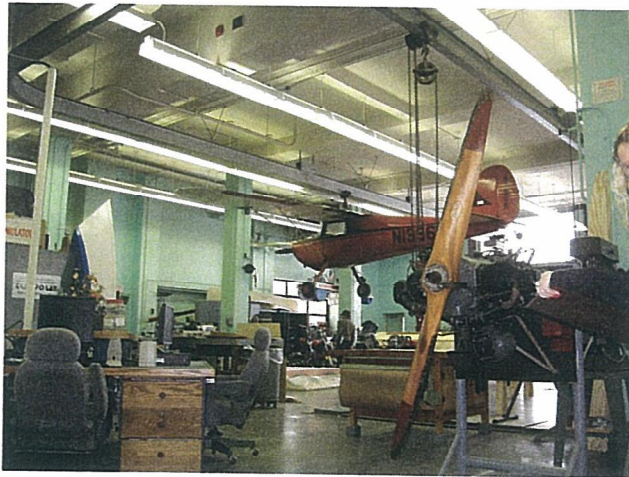
Park Hall - Room 105 -Main Room

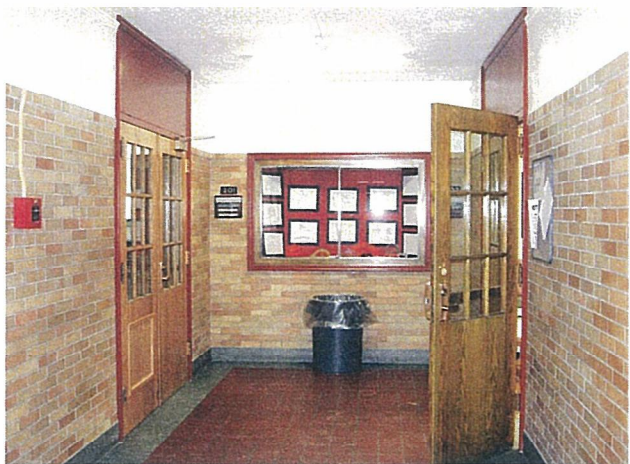
The room doors are wood with hollow metal frames and a metal panel as a transom. In the short term, it is recommended that the door hardware be adjusted/replaced as required with handicapped accessible hardware, and consider repairing and refinishing the doors and painting the frames.

Park Hall - Second Floor Corridor - Doors

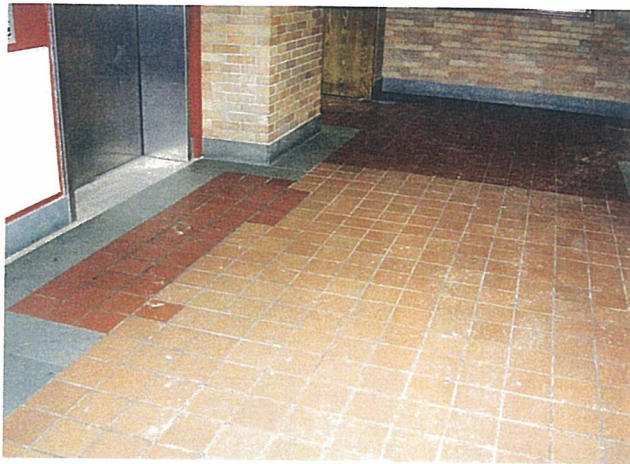
Park Hall - Second Floor Corridor - Floors

The floor is quarry tile with a field stone perimeter that is in good condition. The replacement quarry tile at the north end of the building is much darker than the original and was replaced in a random pattern. In the short term, it is recommended that the replacement quarry tile be removed and replaced with a better color and pattern.

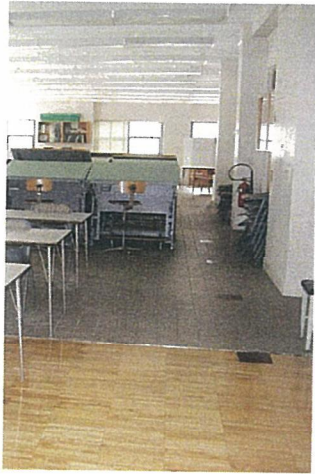
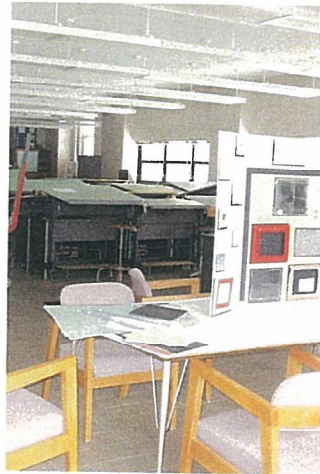
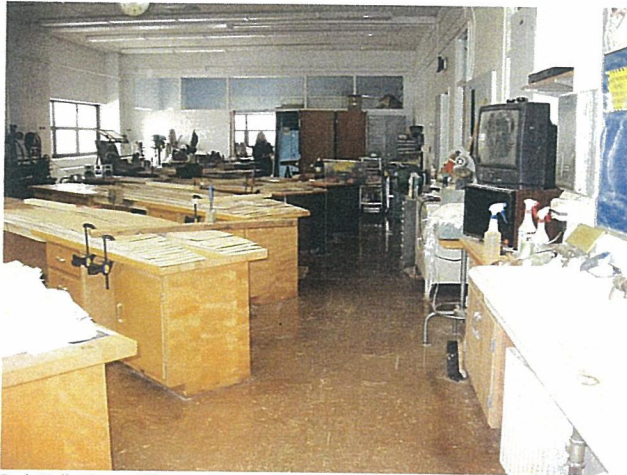
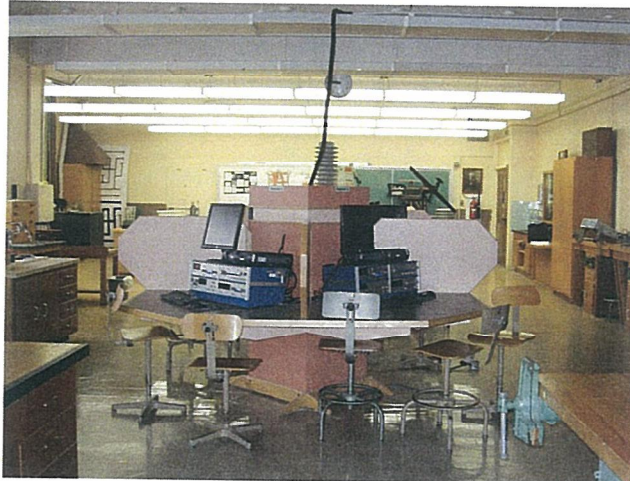
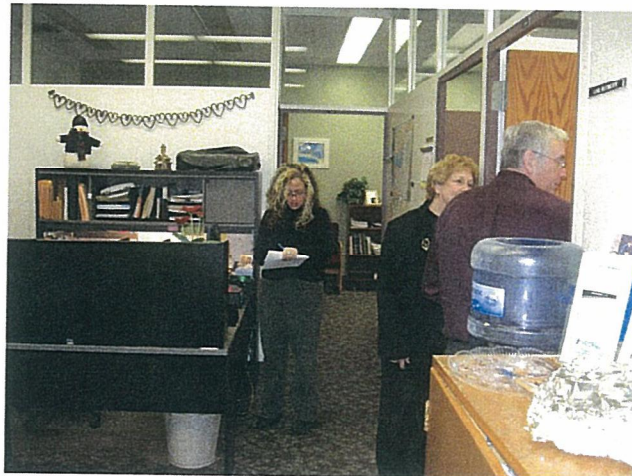
The ceiling is a 1x1 z-spline ceiling system and is in good condition. The walls are plaster and in good condition. There are GWB soffits behind spandrel glass windows; one soffit is water damaged at the corner window. The floor is quarry tile and wood and is in good condition. The base is painted field stone. The window sills are painted stone. The hopper windows work well. In the short term, it is recommended that the areas of previous plaster patch be resurfaced. It is also recommended that the GWB damage at the window be repaired.

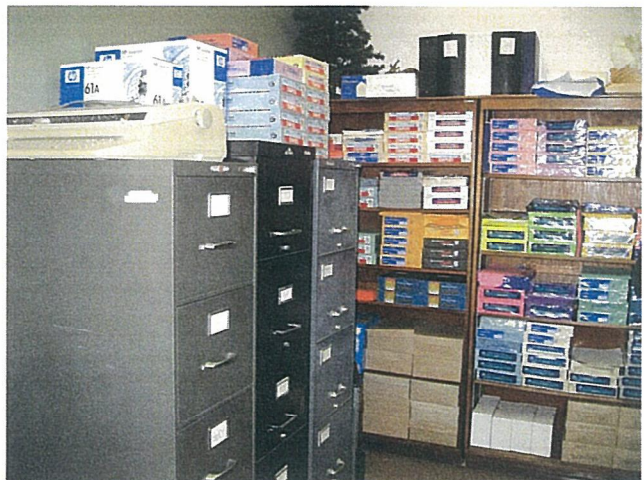
The ceiling is a z-spline ceiling that is in good condition, with plaster/GWB soffits. The plaster and GWB walls are in good condition. The door and frame are hollow metal and in good condition. The floor is 9x9 vinyl tile and is in poor condition. In the short term, it is recommended that the flooring be replaced (check for asbestos content).

Park Hall - Room 205 - Copy Room

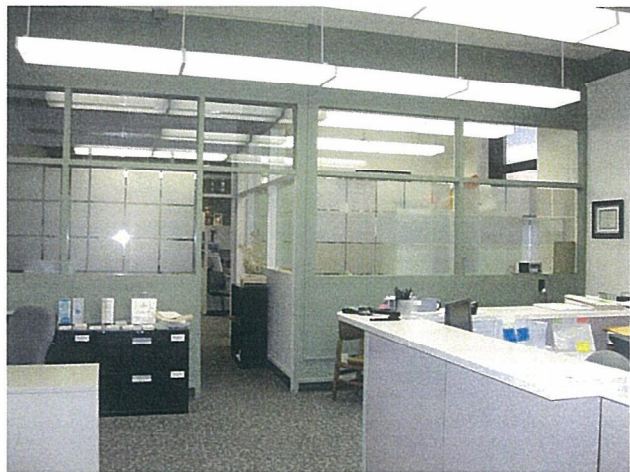
The z-spline ceiling is in good shape. At room 303F, there are several areas of ceiling replacement that are not secure, and the most northern room off of the coffee room has a large area of missing ceiling tile. There are plaster and GWB walls with hollow metal and glass windows at the hallway side of the walls that are in good condition. The sun shading black blinds are in good condition, but they let a good amount of

Park Hall - Room 303 - Education Administration

sunlight in when they are closed, depending on the time of day. The painted window sills are in poor condition. The new carpet and base is in good condition. The main doors to the suite are wood double doors with nine pane glazing and a large six pane wood transom above all set in a hollow metal frame. In the short term, it is recommended that the plaster be repaired where damaged, and areas of previous plaster repair be repaired with a more appropriate finish. It is also recommended that the window sills be refinished, the z-spline ceiling be secured where sagging, and the missing ceiling tile be replaced. It is also recommended that hardware replacement be considered.

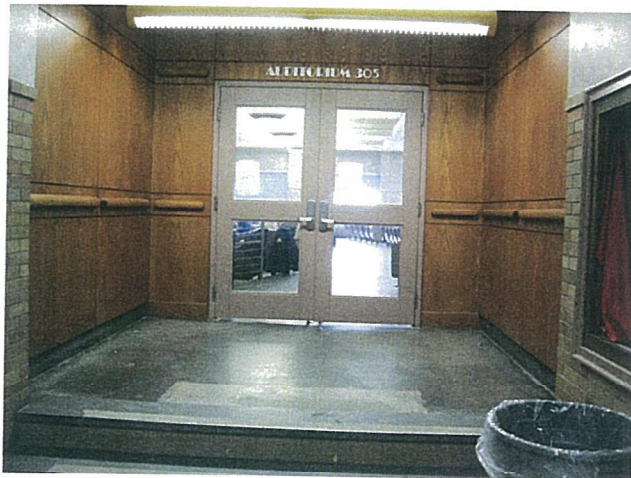
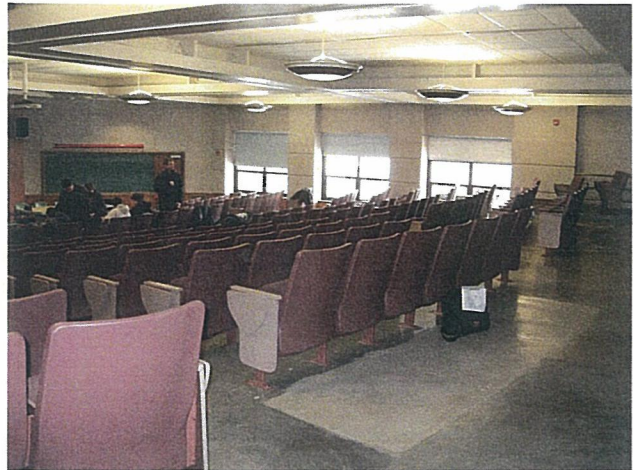
The ceiling is a new 2x2 suspended APC ceiling with GWB soffits that are in good condition. The plaster and GWB walls with wood accents are in good condition. The upper east floor is higher than at the perimeter wall; the radiators are set at the lower perimeter floor level. Also at the upper east floor is a painted steel floor access panel. The floor has several areas of patching due to chair replacement that were poorly infilled. The mauve chairs are in good condition. The window shades are in fair condition. The exposed concrete floor is in good condition, with a large crack near the lift. The main double entry doors are in good condition, with full glazing, panic hardware, and closers. In the short term, it is recommended that the two larger areas of floor patching on the upper east level be cut out and reinstalled again for a better color match and finish. It is also recommended that the window shades be replaced, the concrete floor crack be repaired, and a new concrete finish be installed as the old finish is worn.

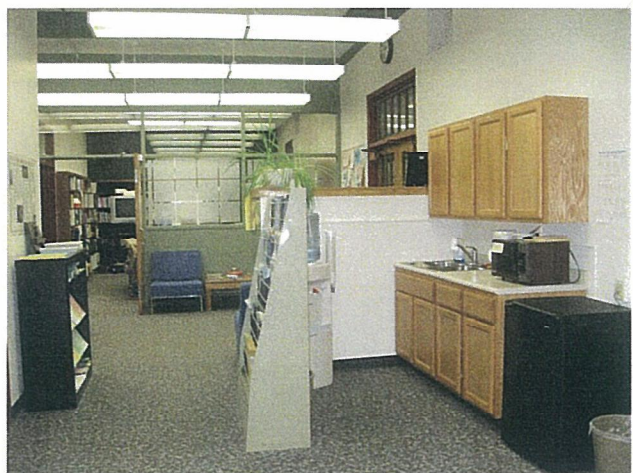
The ceilings are z-spline acoustical panels in the main open area, and plaster at the perimeter and room 307B that are in good condition. There is a new 2x2 suspended APC ceiling in the conference room, room 307A, 307E, and 307D that are in good condition. The walls are plaster and gypsum wallboard and are in good condition. The wall shared by the conference room and room 307A is glazed from approximately 3 1/2 feet above the floor to the ceiling and is in good condition. There is a large area of electric panels in the suite, and there is surface

Park Hall - Room 307 - Vocational Teacher Preparation

raceway in the rooms. There is a large millwork work surface that is concealing a decommissioned HVAC unit. The window sills are in good shape but need repainting. The office doors in the suite are of mixed configuration; solid wood, wood with nine panes, and wood with the upper half clear glazing with no mullions. The main door to the space is a wood double door with nine pane glazing and a six pane wood transom above that are set in a hollow metal frame; these doors are worn. The floor is carpeted and is in good condition. In the short term, it is recommended that the areas of previous plaster patch be sanded and re-plastered for a better finish, and the millwork concealing the decommissioned HVAC unit, and the unit, be removed and the area of removal be patched. It is also recommended that the window sills be repainted, the crack in the north plaster wall of the storage room be repaired, and the main entry doors be refinished and new handicapped accessible hardware installed.

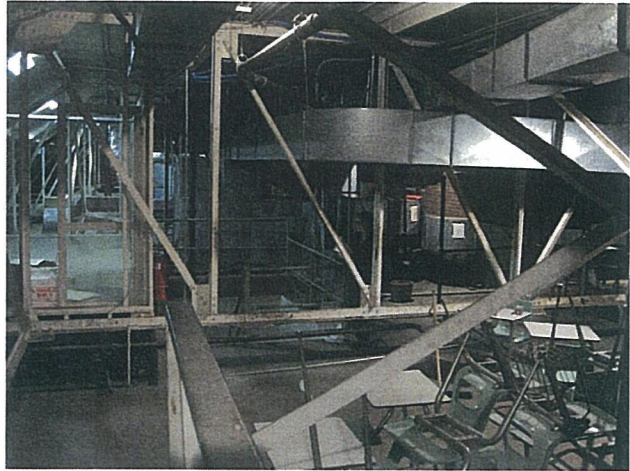
The access doors to the attic are wood double doors with nine pane glazing that are cracked. The stair to the attic is an open metal stair system and is in good condition. The roof structure is a steel truss system with wood planks supported by steel beams that appear to be in good condition. In the short term, it is recommended that the cracked glass in the doors be replaced. HVAC Systems Observations

Park Hall - Attic - Truss

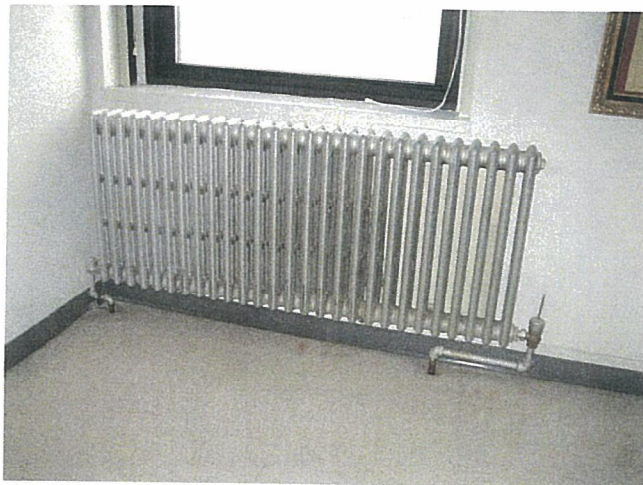
Park Hall - Steam Radiator

In the short term, it is recommended that the piping be inspected frequently for leaks and that steam traps be checked and serviced to maintain proper operation. In the long term, it is recommended that the steam system piping be replaced with a hot water system. To minimize construction costs, the replacement should occur concurrently with a major renovation project. The hot water system will operate more efficiently than the steam system and it will have less potential of overheating spaces during spring and fall months.

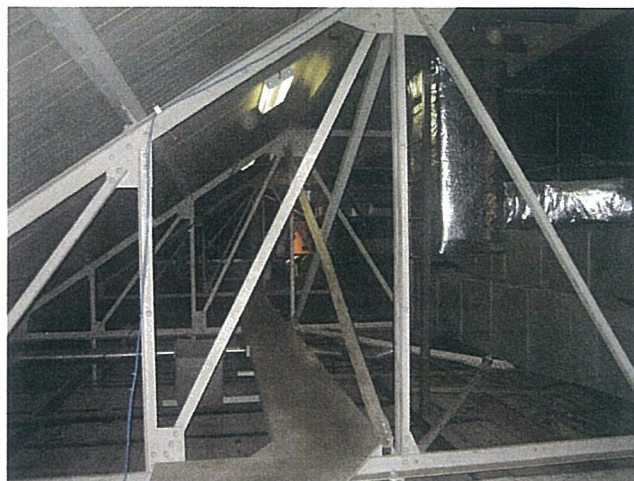
Park Hall - Attic Penthouse

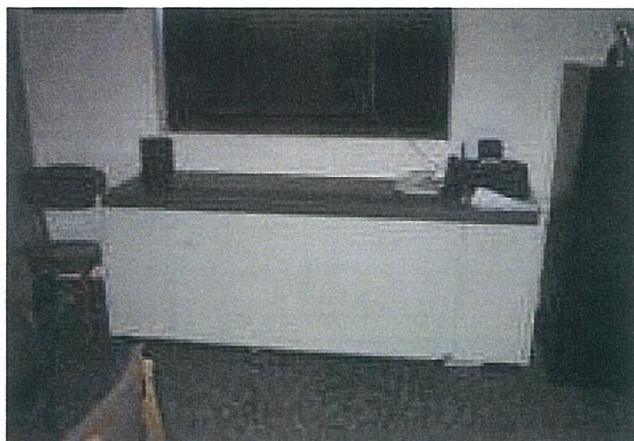
There appeared to be at least four vintages of classroom unit ventilators scattered throughout the building. All but the most recent units are obsolete and replacement parts are no longer available. Despite the building being occupied, many of the units had their fan motors off.

Park Hall - Unit Ventilator

In the short term, it is recommended that the units be inspected and serviced frequently in an effort to maintain reliable operation with limited downtime due to failures despite their age. In the long term, it is recommended that the units be replaced.

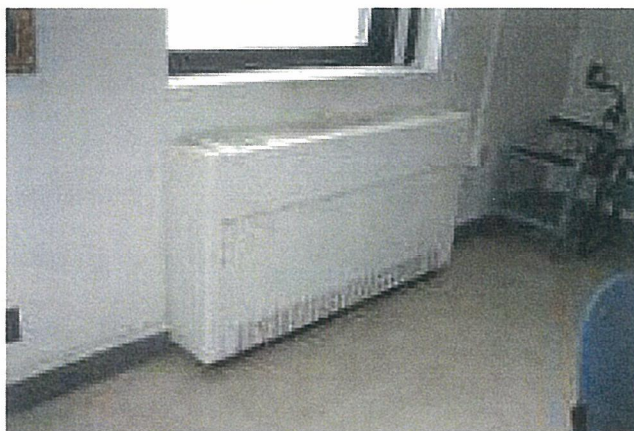
Park Hall - Unit Ventilator

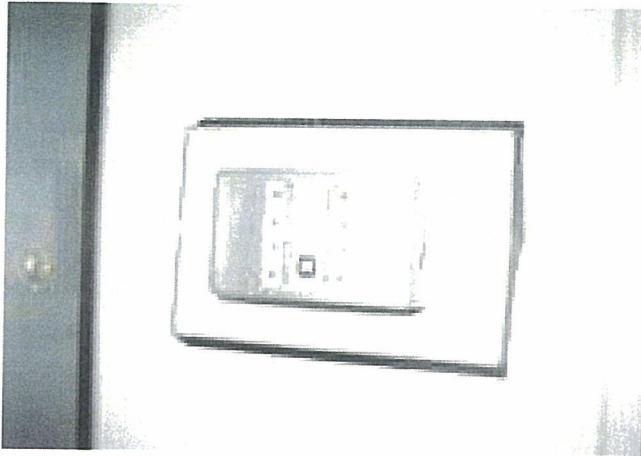
Park Hall - Pneumatic System

In the short term, it is recommended that the controls be inspected and serviced frequently in an effort to maintain reliable operation with limited downtime due to failures despite their age. In the long term, it is recommended that the conversion from pneumatic to DDC be continued as the equipment being controlled is replaced.

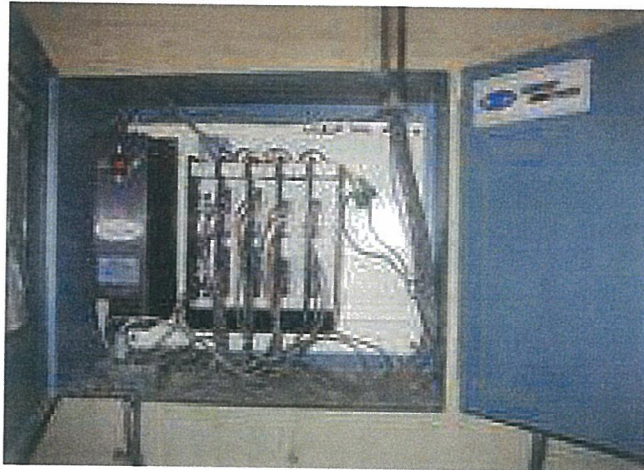
Park Hall - Direct Digital Controls (DDC)

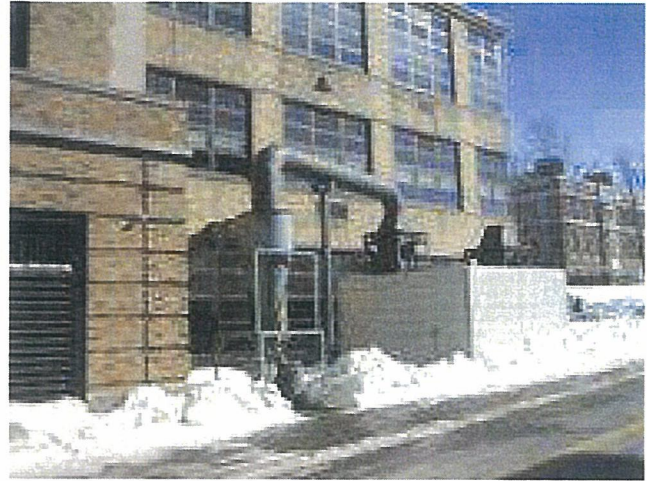
Certain areas of the building are served by one of two central dust collection systems. One dust collector is located outdoors along the west wall near the south end of the building. The second is located in the basement in a mechanical along the west wall near the north end of the building. Both units appear to be in good working order. Additional dust collection appears warranted in rooms such as Room 301 Energy Technology.

Park Hall - Dust Collection System

In the short term, it is recommended that the units be inspected and serviced frequently in an effort to maintain reliable operation. In addition, if the educational programs remain as is, the systems should be extended/rearranged or expanded to meet the current program needs. If possible, a more discreet location for the exterior unit should be developed in the future.

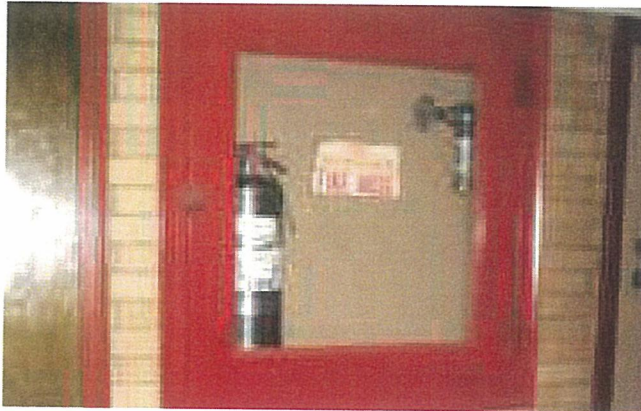
Park Hall - 1-1/2" Hose Valve and Fire Extinguisher Cabinet

In the short term, it is recommended to test the fire hose system to assure proper working condition and pressure. In the long term, it is recommended to provide a fire service entrance with backflow prevention, provide sprinklers throughout the entire building, and to disconnect the fire valve cabinet from the domestic water service and connect it to the new fire service. To minimize the construction costs, the fire protection work should occur concurrently with a major renovation project.

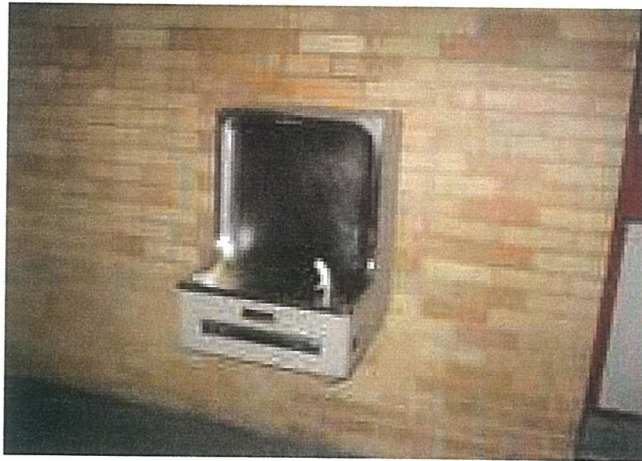
Park Hall - Toilet Room

Most plumbing fixtures and trim, including water closets, urinals, lavatories, water coolers, sinks, and janitor sinks are generally original construction (circa 1931) with modifications to accommodate subsequent renovations (circa 1950 and 1963). While no specific integrity problems were reported, and the fixtures and trim appear to be in good condition, they have exceeded their normally anticipated useful services. Most of the fixtures are not the "low-flow" type. The water closets are wall mounted with concealed, lever handle flush valves on the First and Third Floors. The water closet on the Second Floor is floor mounted with an exposed, lever handle flush valve. The urinals on the First Floor are wall mounted with exposed lever handle flush valve. The urinals on the Second Floor are floor mounted with exposed lever handle flush valve. The lavatories on all floors are wall mounted. Some have single lever mixing faucets and some have two faucets with "cross" handle. The janitor sinks are wall mounted with wall mounted faucets. There are electric water coolers located in the corridors. Some are floor mounted, some are wall-mounted. No toilet rooms appear to be fully ADA accessible (i.e., mounting heights of water closets, urinals, and lavatories).

In the short term, it is recommended that the faucets, flush valves, waste and water piping be inspected frequently for leaks and serviced to maintain proper operation. In the long term, it is recommended that fixtures be replaced with standard and accessible ADA fixtures; the flush valves be replaced with exposed sensor-operated flush valves; the lavatory faucets be replaced with sensor-operated faucets; and the electric water coolers be replaced with dual height, ADA accessible water coolers. To minimize construction costs, the replacement should occur concurrently with a major renovation project.

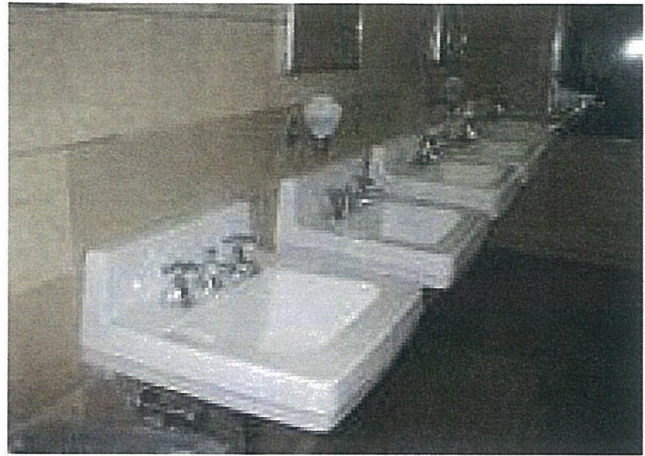
Park Hall - Toilet Room

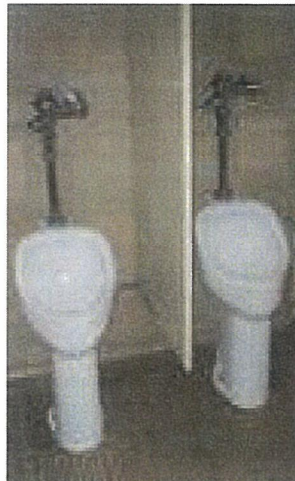
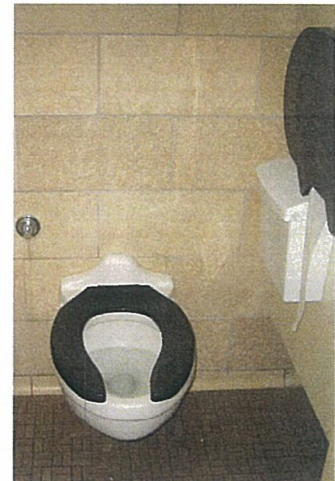
Park Hall - Toilet Room

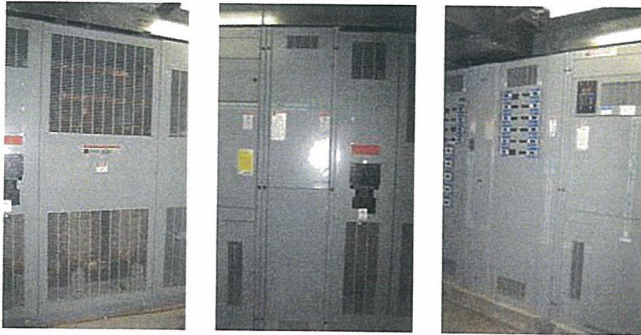
Park Hall - Building Distribution System

There is no short term recommendation. The long term recommendation is to replace the entire electric distribution system and enhance the distribution system to meet the needs of present day equipment.

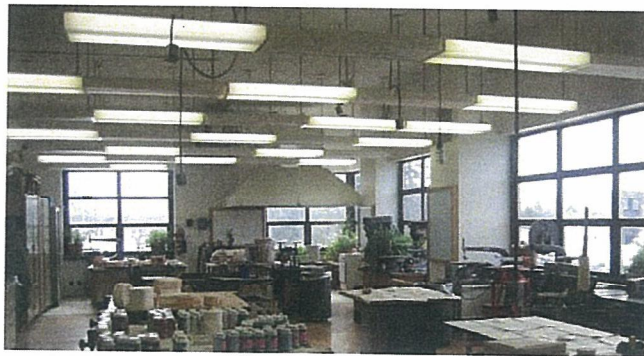
Park Hall - Fluorescent Lighting Fixtures

lighting levels with the exception of the main corridors. The main corridor lighting levels are below recommended lighting levels set by IES (Illuminating Engineering Society). A majority of the fluorescent lighting fixtures have yellowed acrylic lenses.

The short term recommendation is to replace nonfunctioning lamps/ballast as needed. The long term recommendation is to replace all lighting with high energy efficient type fluorescent lighting fixtures.

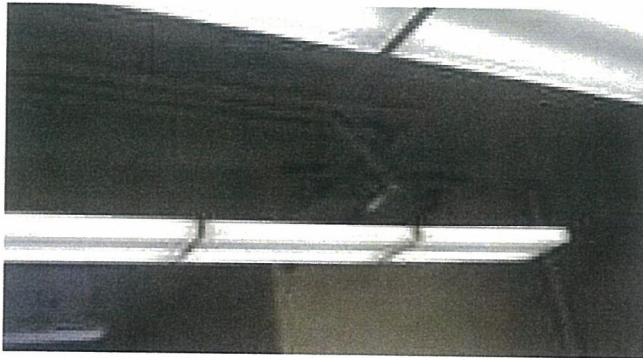
Park Hall - Fluorescent Lighting Fixtures

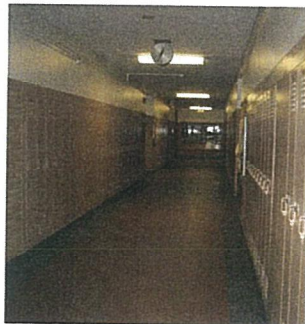
Park Hall - Fluorescent Lighting Fixtures

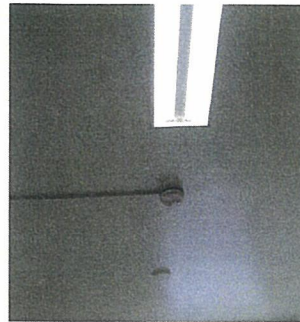
Park Hall - Fluorescent Lighting Fixtures

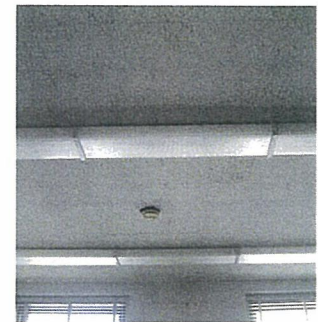
The building has emergency lighting and exit signage throughout and is supply by an emergency generator. The generator serves a life safety panel board which in turn supplies power to all the exit signs and emergency power. The operation of the emergency lighting system was not observed.

Park Hall - Emergency Lighting and Exit Signage

There is no short term recommendation. The long term recommendation is to replace all the exit signs with energy efficient LED type exit signs. Replace the emergency distribution system including generator, panel boards, feeders, branch circuits and devices.

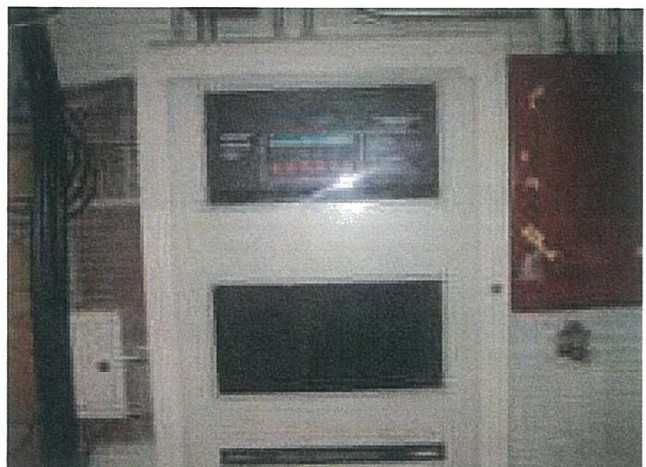
The fire alarm system consists of a main fire alarm panel located in the main electric room in the basement. The main fire alarm panel is a Simplex 4020 which was installed within the past five years. The building has horn type signaling devices, pull stations and smoke detection devices throughout. The pull stations do meet the requirements set forth by ADA for height. No visible signaling devices were observed. The elevator which was installed in 2000 has elevator recall with devices connected to the fire alarm system.

Park Hall - Fire Alarm System

There is no short term recommendation. The long term recommendation is to reuse the existing main fire alarm system, but replace all signaling and initiating devices throughout the building.

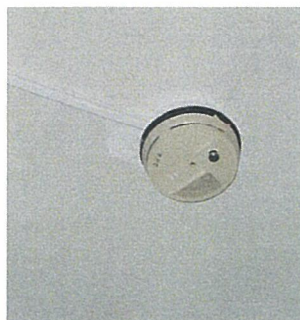
Park Hall - Fire Detection Device

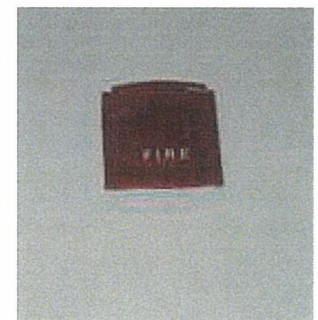
Park Hall - Horn Type Signaling Device

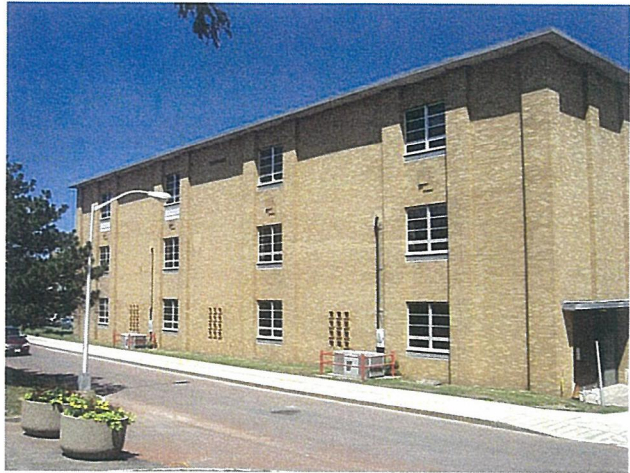
Wilber Hall - Windows

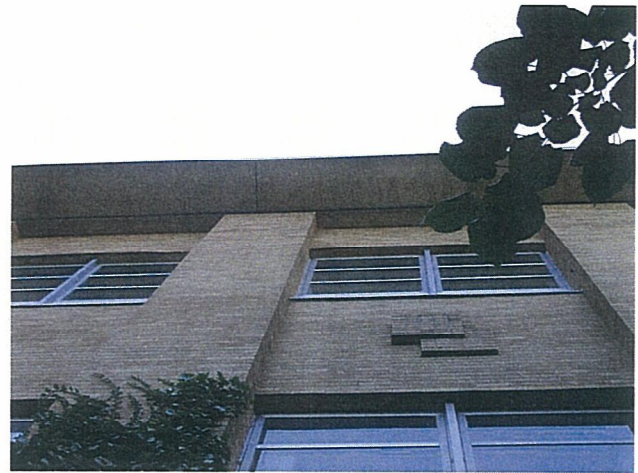
Wilber Hall - Soffit Panel

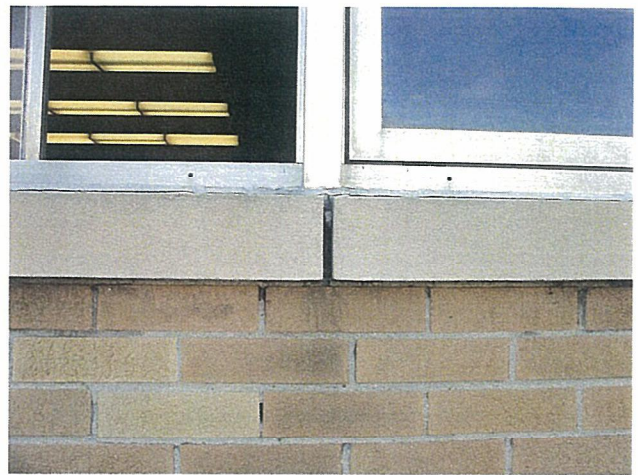
The brick wall is in good condition with minimal grout erosion here and there. The EIFS infill wall appears to be holding up. At the existing window, mortar is significantly cracked or missing at the limestone sill and brick below. There are four small holes in the brick near the service door. The existing original window has been cleaned but the window sealant is cracked. It is recommended that the mortar be repointed and sealant replaced at the limestone sill and brick, that holes in the brick be infilled, and that sealant be replaced at the existing original window.

Wilber Hall - Limestone Sill

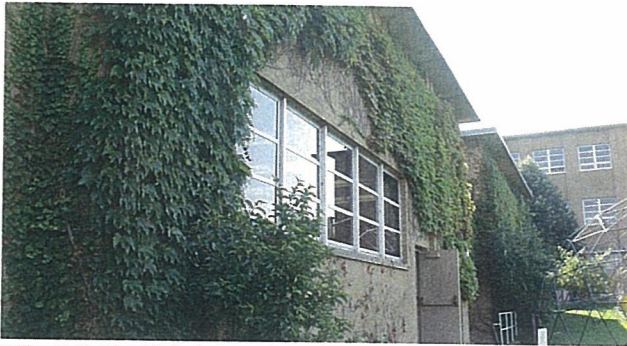
Wilber Hall - West Wall - Ivy Growth
