Feasibility Study for the

SAVAC Ambulance Garage (#L10708)

4/20/2007

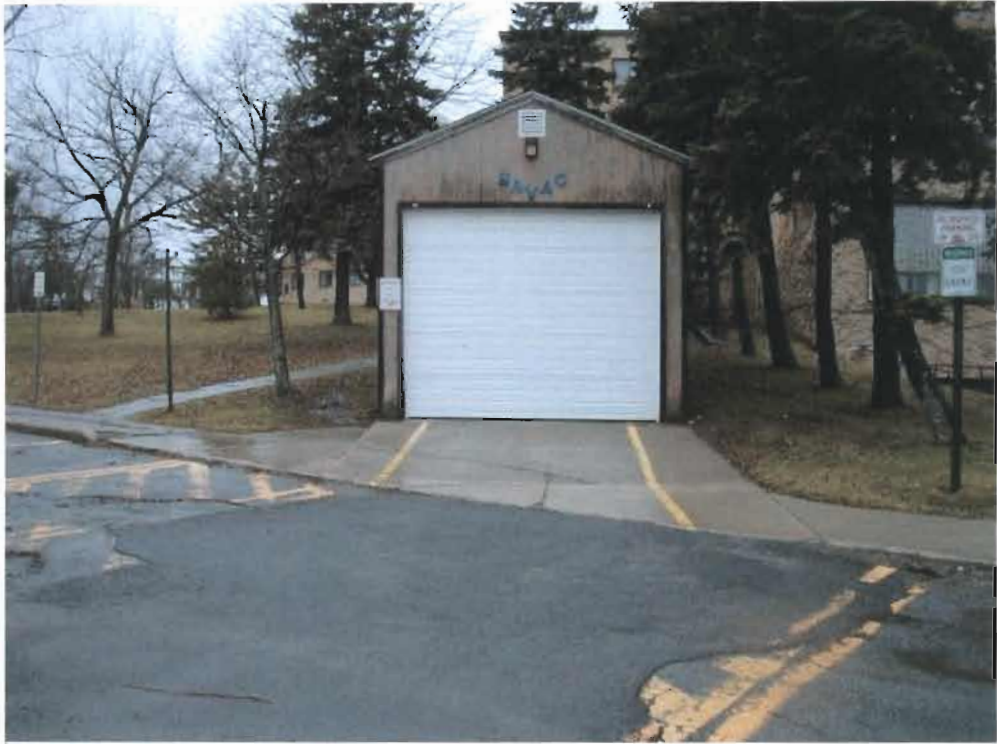
Front  
Elevation of  
Existing SAVAC  
Garage from  
Sixth Street

The existing SAVAC Ambulance Garage was built in 1988 as a temporary structure to house the SAVAC ambulance. It is a 14' x 28' unheated garage located to the east of Moreland Hall alongside Sixth Avenue. The existing garage is of wood construction on a pressure treated skid with partially earth embanked walls. Although temporary repairs have been made to the sidewalls, rotting and deterioration has continued. The existing garage also does not provide adequate space for the required use, as movement around the vehicle inside the garage is severely restricted and water for cleaning is not provided. The existing garage should be demolished and a new garage constructed.

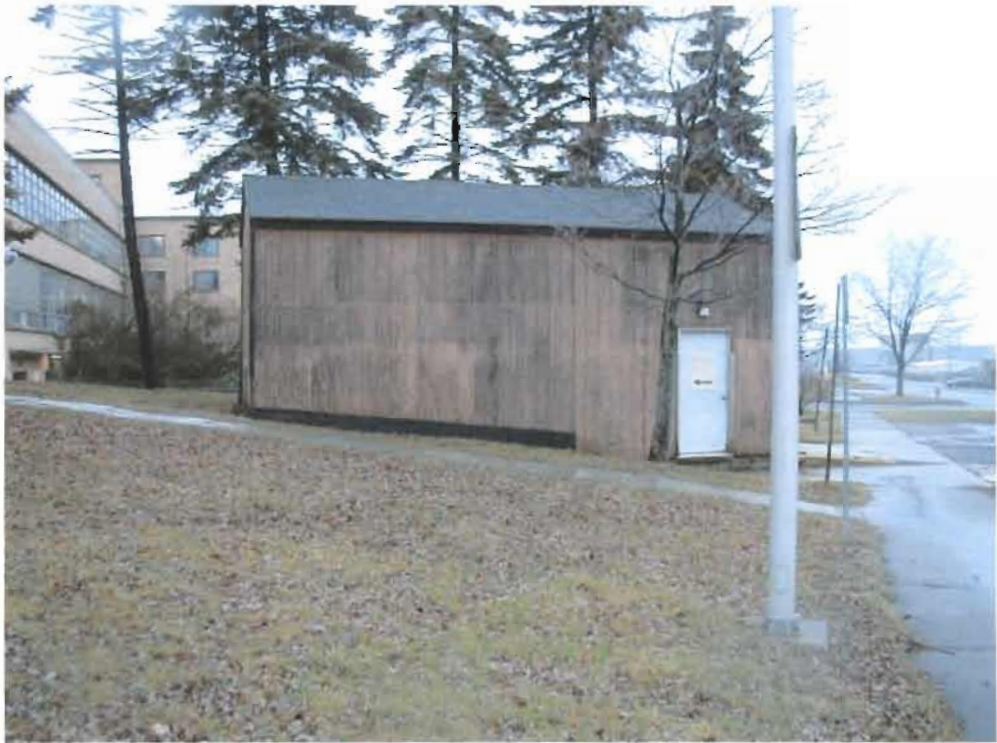
Side Elevation  
of Existing  
SAVAC Garage  
from Sixth  
Street

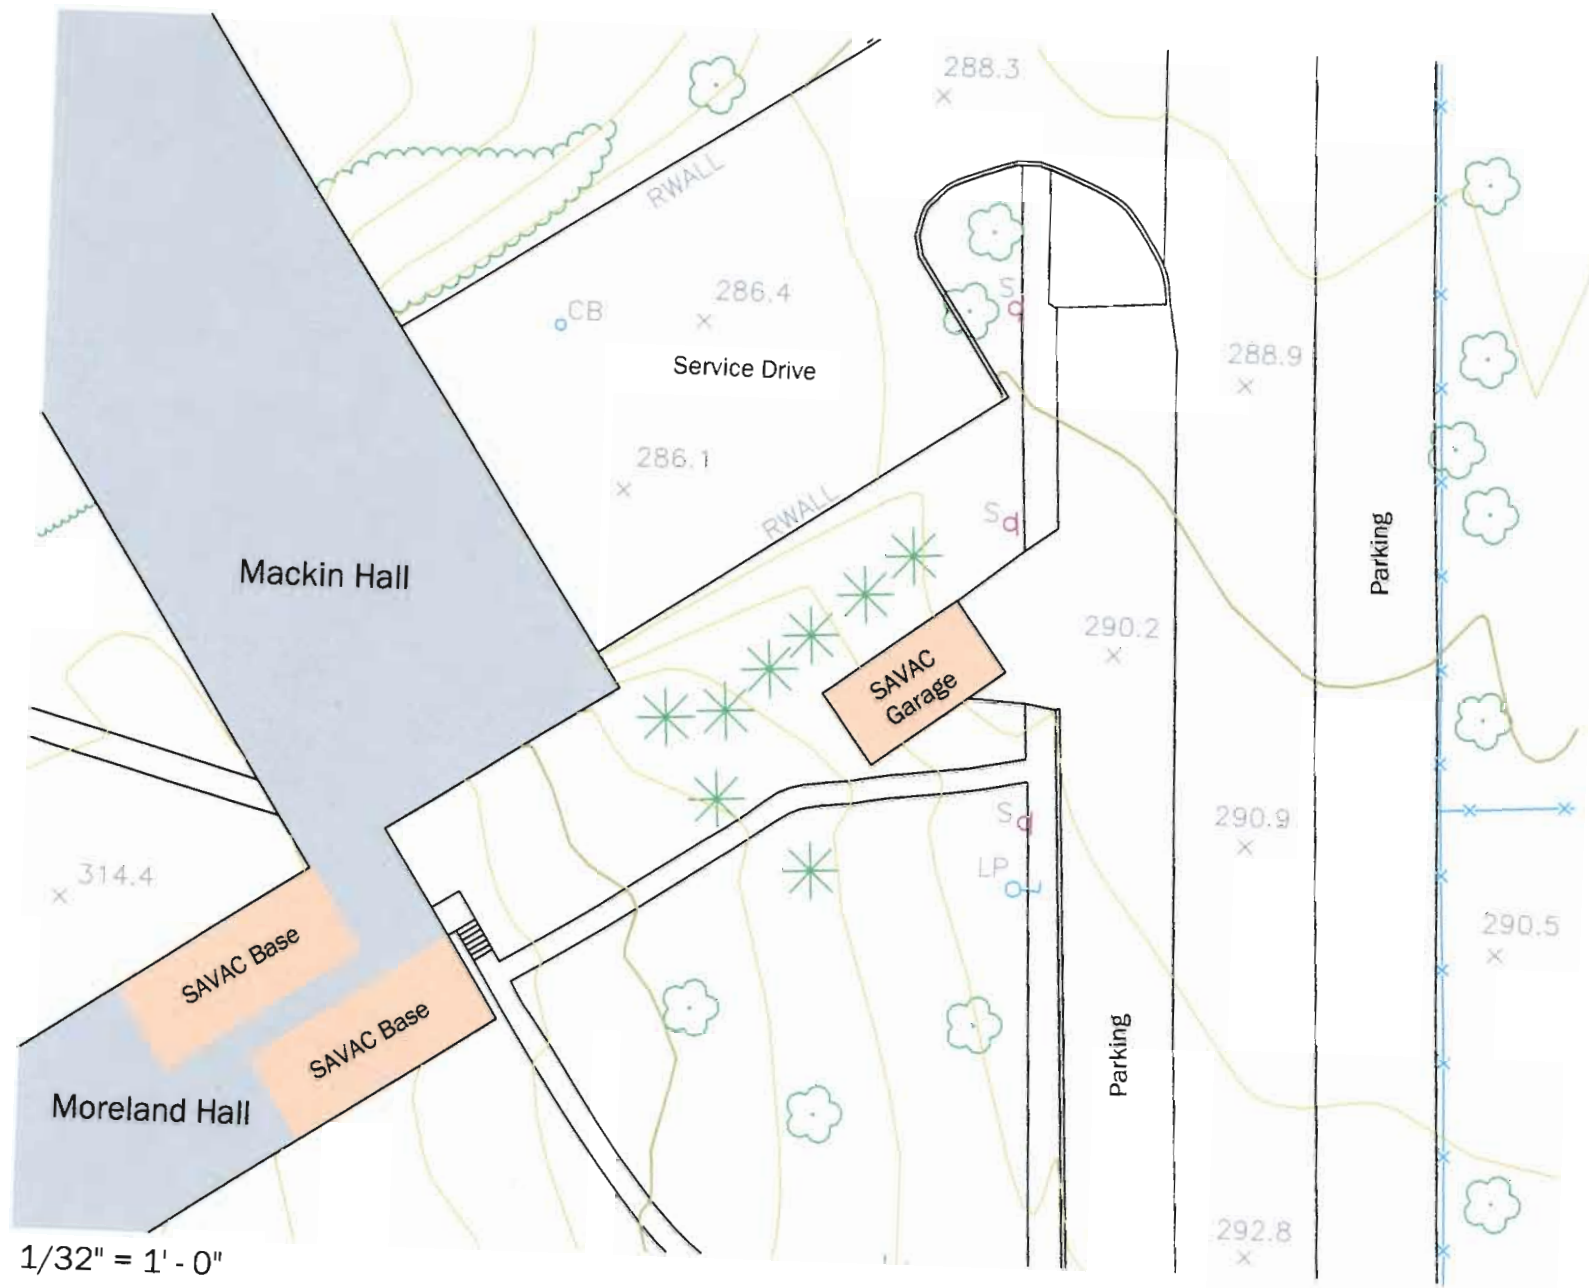
Existing Site Plan  
 SAVAC Ambulance Garage - SUNY Oswego

The garage's existing location near Moreland Hall provides the most desirable location for the new SAVAC Ambulance Garage. It is in close proximity to the existing SAVAC Base facilities (possible expansion discussed in Part VI of this study). There is ample space available at this location for a larger garage. A drive-thru arrangement could be facilitated by erecting the new garage parallel to Sixth Avenue with access from the Mackin Hall service drive and discharge onto Sixth Avenue south of the existing garage driveway (see Proposed Site Plan). One parking space in the Mackin Hall service drive would be eliminated. Parking spaces along Sixth Avenue would be relocated, but no spaces would be lost.

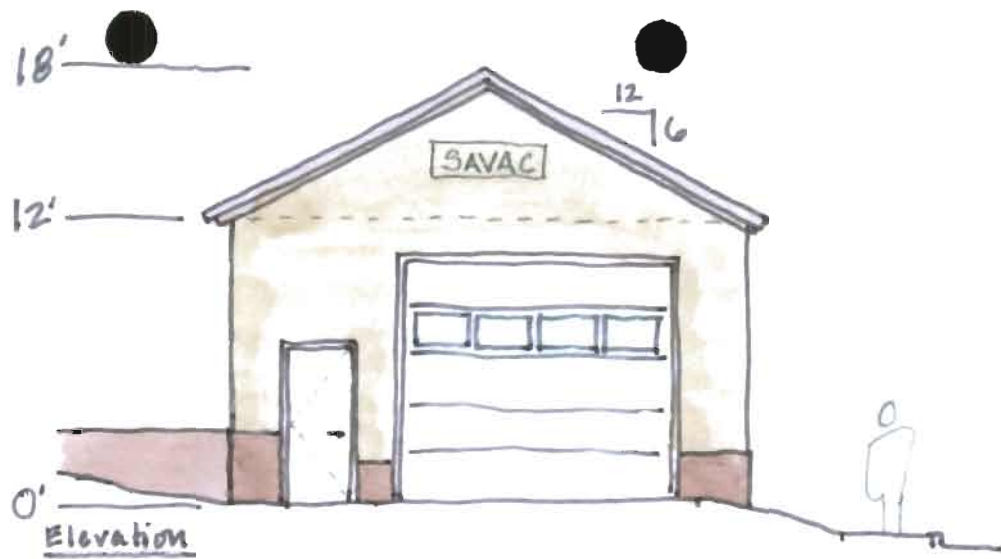
# SAVAC Garage Conceptual Drawings

1/8" = 1'-0"

The new 704sf SAVAC Ambulance Garage would be 1½ bays in size to allow for one full drive-thru ambulance bay, service space around all sides of the vehicle and space for sinks and vehicle related storage.

The 22'w x 32'd garage would have a poured concrete footing, foundation wall and low height concrete stub walls around the perimeter of the garage. These stub walls would increase the durability of the garage and allow for the side nearest Moreland Hall to have an earth embanked condition to allow for building on a slope without introducing the rotting and deterioration that the existing garage has experienced. A concrete slab-on-grade floor would be sloped in the direction of both overhead doors. Any accumulated water in the garage will flow towards the doors and can be pushed out. We feel that floor or trench drains would add complexity and cost for minimal benefit.
