Residence Hall and Academic Facilities Master Plan Update

December 2023

SUNY Oswego

JMZ Architects and Planners, P.C.

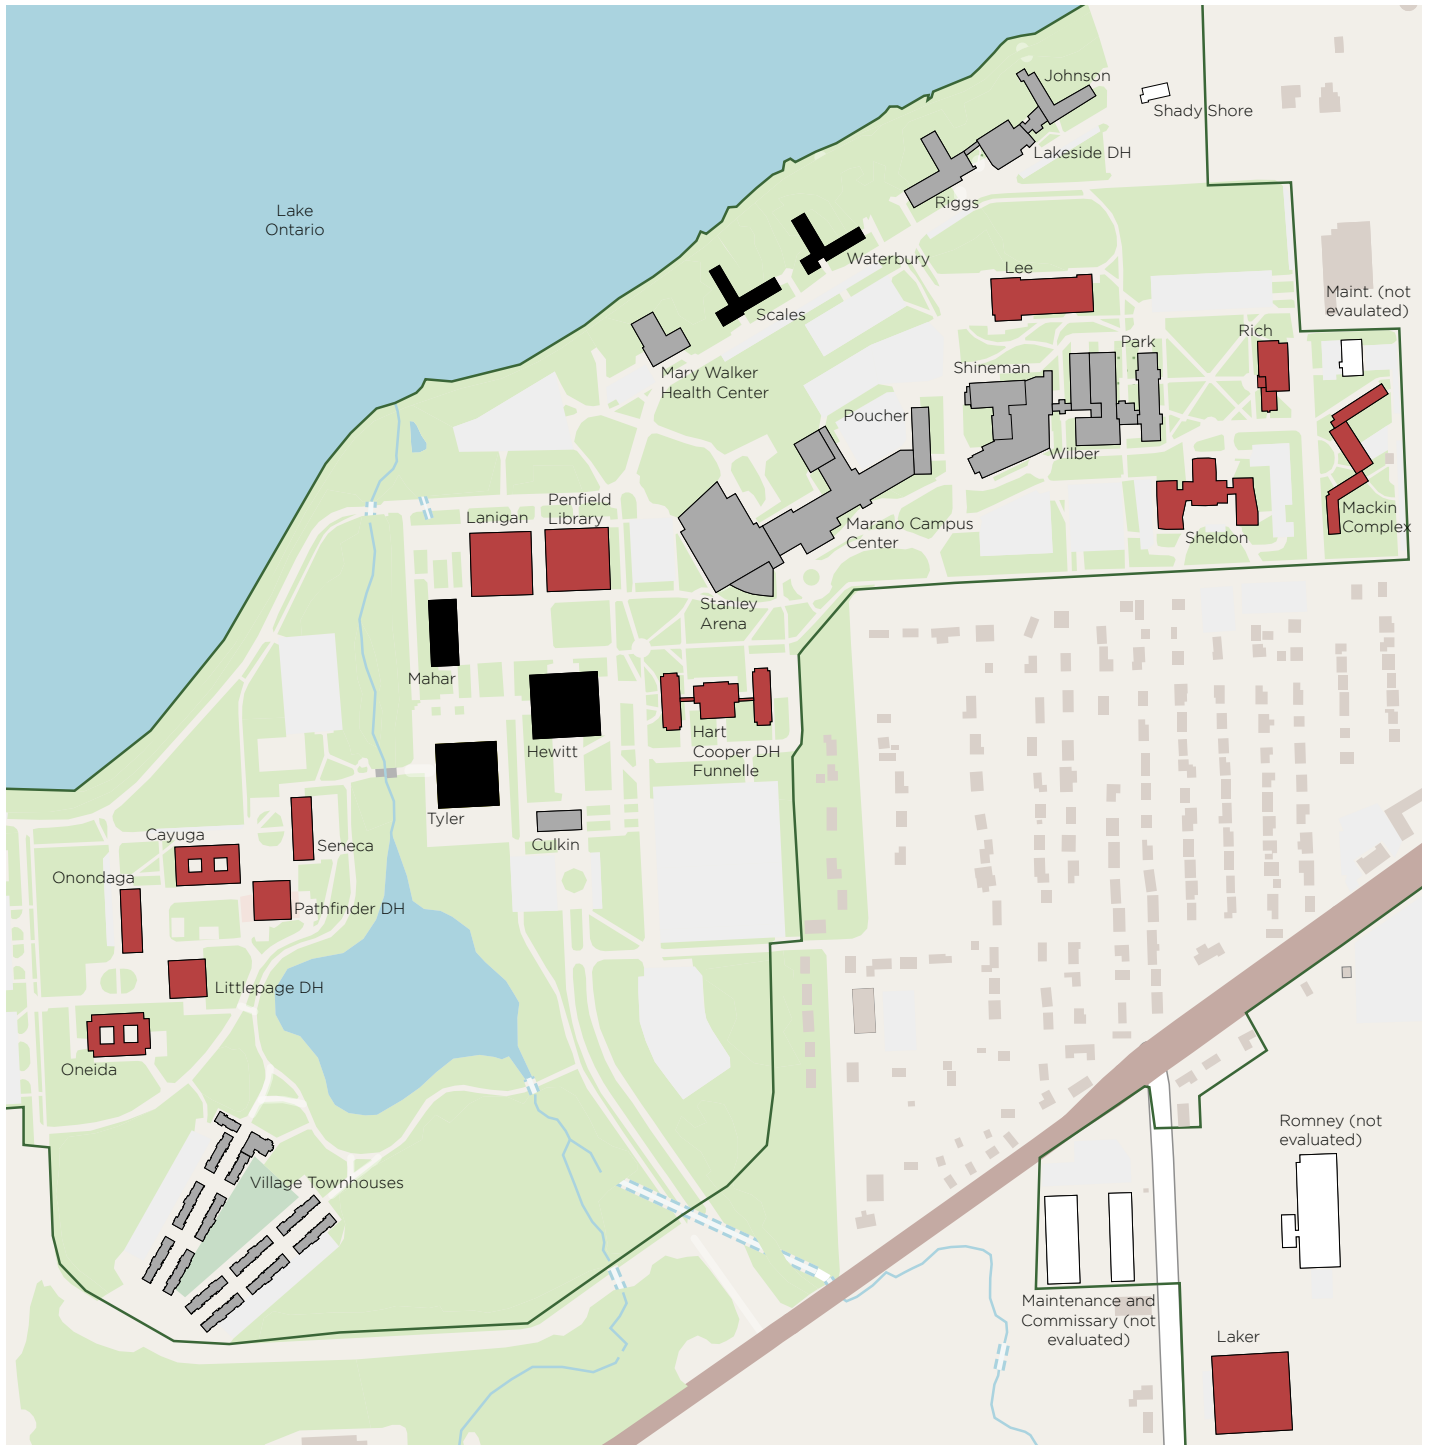
N
 BUILDING CONDITION
 NTS

Like New
 Good Condition
 Multiple deficiencies

Four buildings have been renovated in the past decade and are in like-new condition: Tyler Hall, Hewitt Hall (reopening in 2024), Waterbury Hall, and Scales Hall. Mahar Hall, a classroom and faculty office building, is scheduled for renovation in the mid-2020s, and is assumed, therefore, to be like new for the purposes of this plan.

Buildings constructed or renovated in the 2000s and early 2010s are in good condition. Using building automation system data, predictive maintenance can help maintenance staff plan system upgrades.

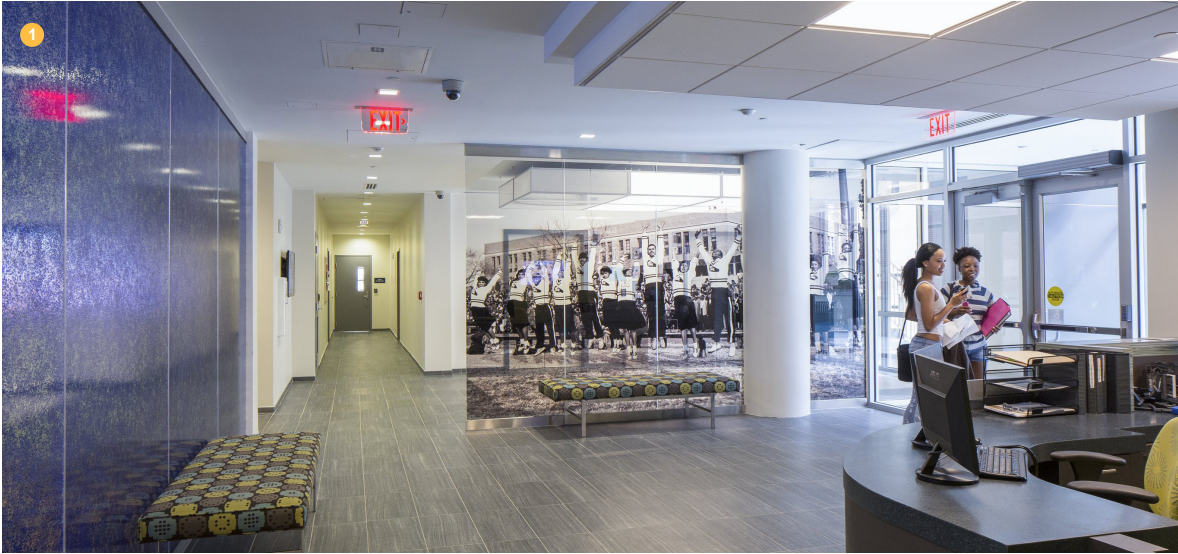
Residence hall lobby at Howard University that includes fresh, modern finishes and University heritage graphics

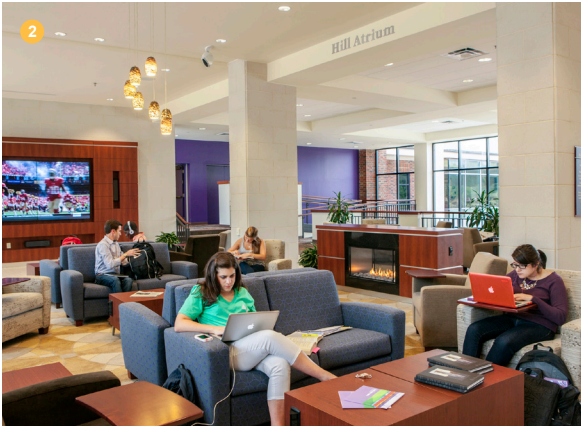
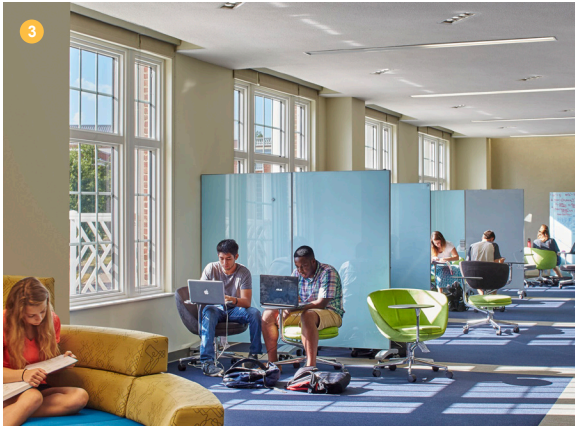
Options to divide the space in the large main lounge into functional areas for multiple activities.

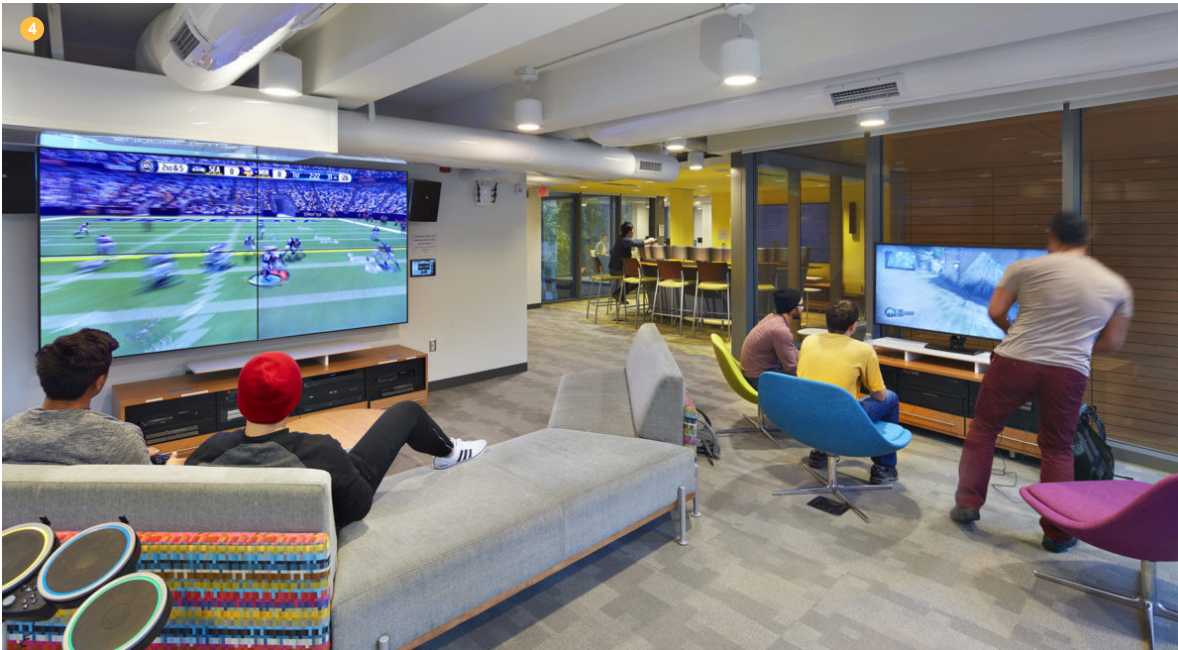
Insert a games area in one corner of the main lounge.

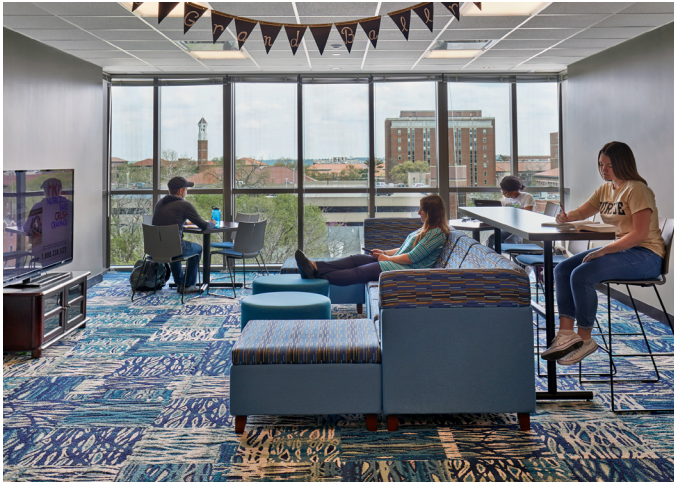
Upgrade lounges on student residence floors.

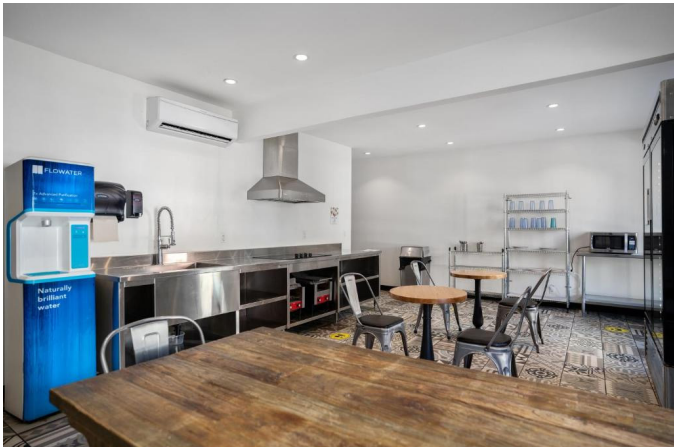
Create an enclosed kitchen to improve exhaust and create a community social space. This industrial style could complement the basement location of Funnelle's kitchen.

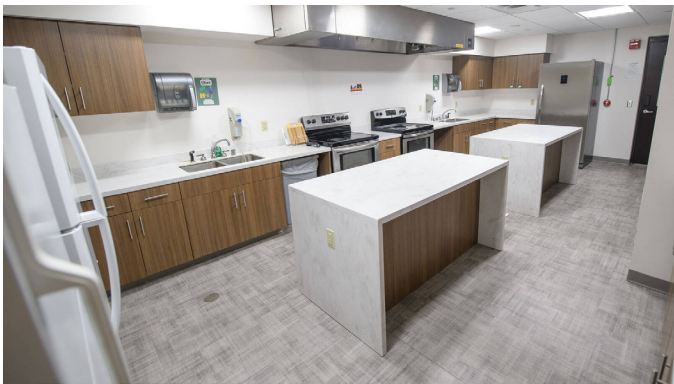
A modernized residence hall kitchen at the University of Wisconsin-Eau Claire

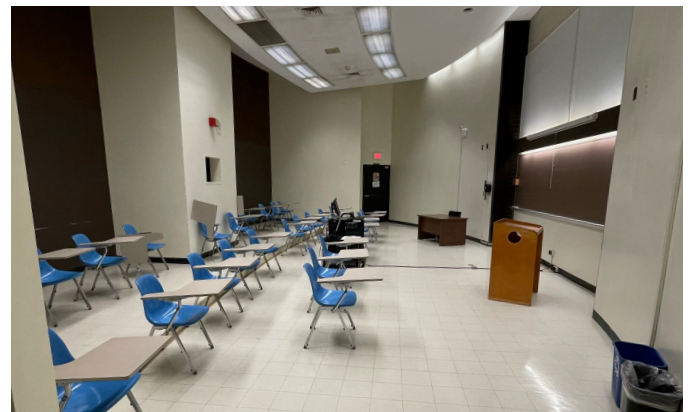
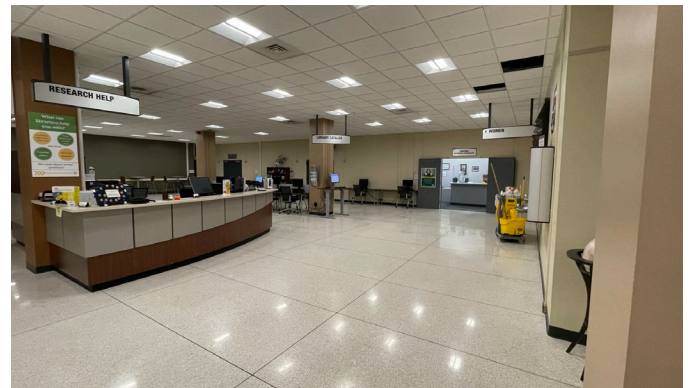
Above, an outdated lecture room in Lanigan Hall. Below, the interior of Penfield Library.

- Lanigan Hall finishes, fixtures, and furnishings are in very poor condition. It makes a bad first impression.
- Both buildings have potential asbestos in their floors. Based on building age, asbestos could be present elsewhere in the building.
- Neither building has a prominent main entrance.

Both Penfield Library and Lanigan Hall have a sufficient amount of space to have lively student areas. Finishes and furniture are in poor condition, and the spaces are not inviting. Penfield Library's Lake Effect Cafe, 24-hour study lounge, and Writing Center are busy destinations, yet the buzz of activity in each is completely self-contained. There is little energy evident on Penfield's first floor. Lanigan Hall is an inhospitable building. In its current state, none of its features invite people to linger.

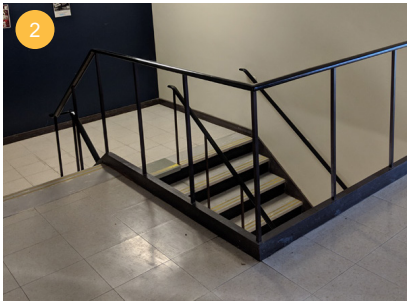
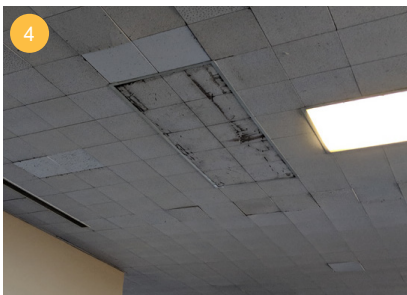
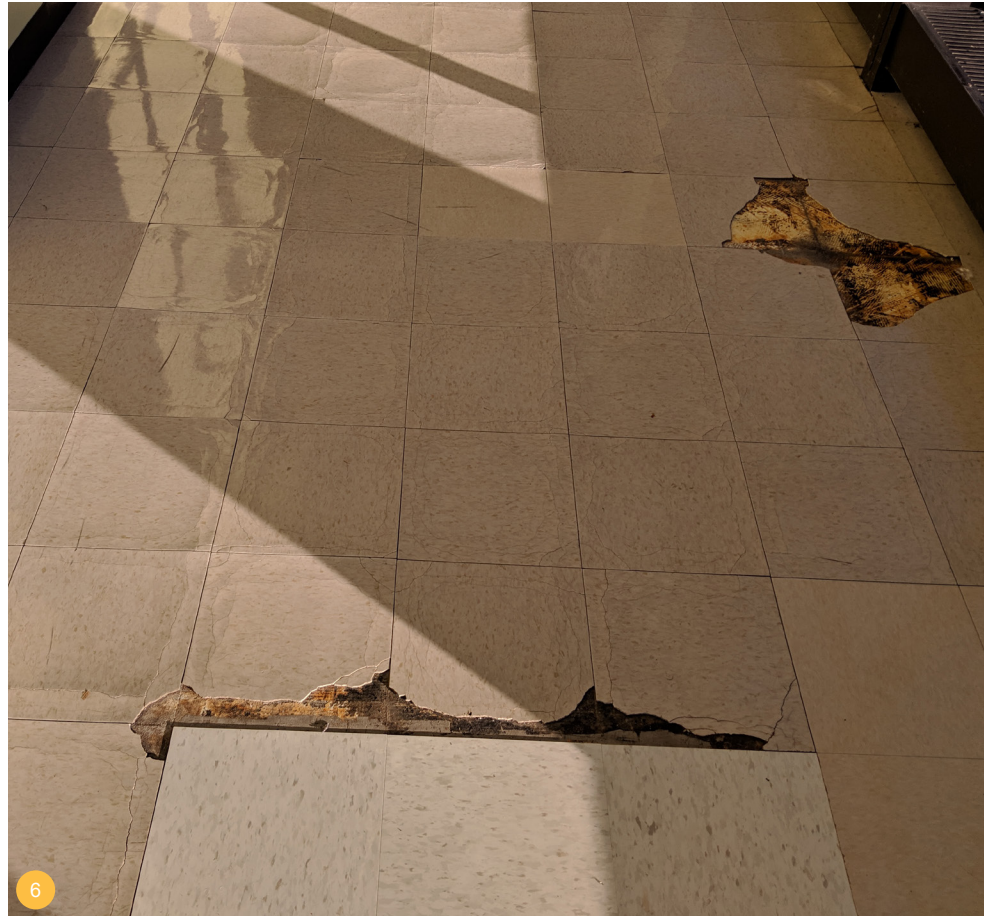
Penfield Library Existing Conditions

The building envelope is in need of repair, cleaning, and modernization. New windows and exterior doors should be installed and the concrete facade should be cleaned and sealed. Portions of the concrete facade are spalling. The entrance is barely distinguishable on the south facade of the building. (Pictures 1, 2, 3, 4).

On the first and second floors, some areas have modern finishes and lighting. In contrast, the stacks and study areas have finishes in poor condition (picture 7). The basement staff areas are dated and dismal. Many basement areas are unprogrammed and are occupied by miscellaneous storage. Efforts have been made to improve accessibility, but many deficiencies are present, among them:

HVAC and plumbing systems are comprised of mostly original components and require replacement (pictures 8, 9). The electrical service was updated in 2000 and is in good condition, but panelboards are original and require replacement. Lighting condition varies throughout the building. Fixtures in unrenovated areas require replacement. Fire alarms are in good condition.

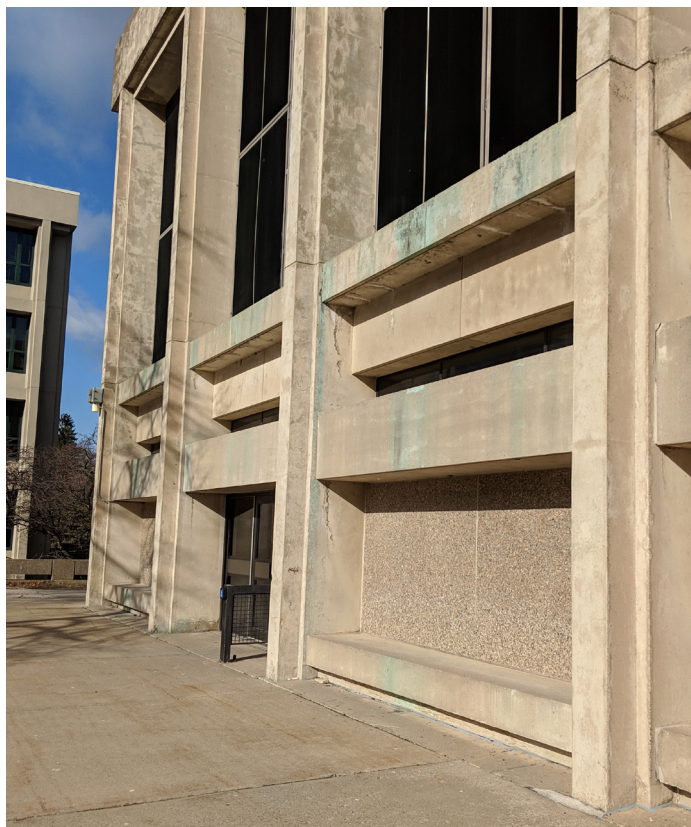
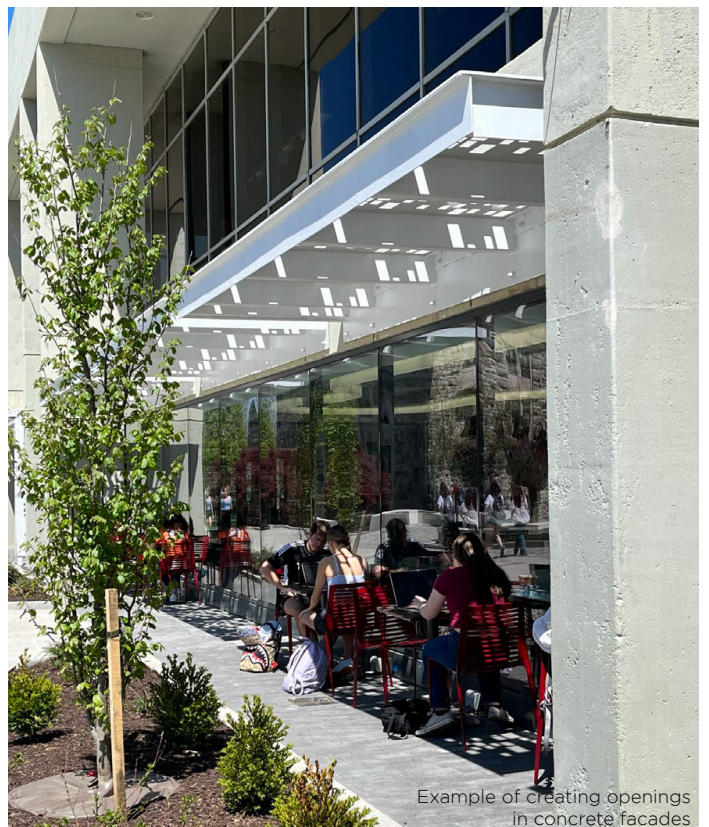
Example of creating openings
in concrete facades

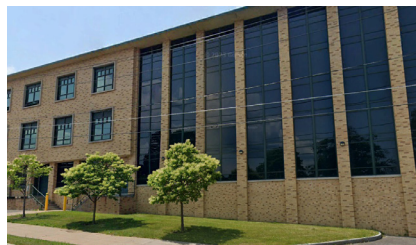
Spandrel panels on the east facade of Rich Hall prevent seven classrooms from receiving natural light.

Vision Glazing and Classroom Upgrade - Restore vision glazing in seven east-facing classrooms. Upgrade finishes and lighting in affected classrooms.

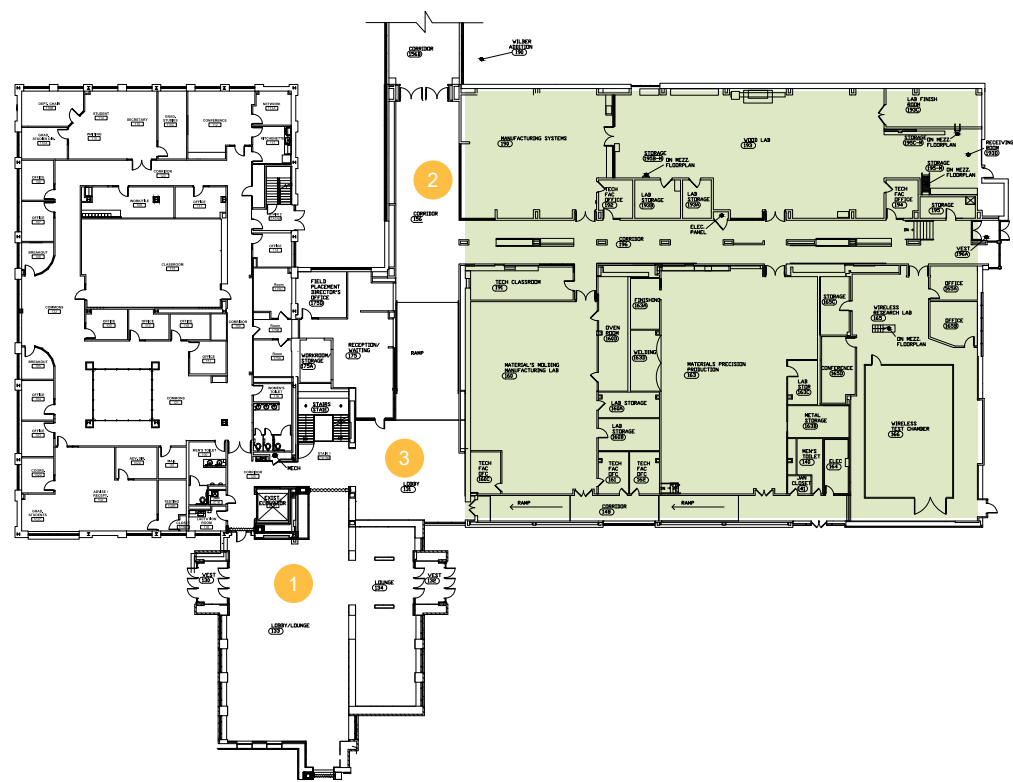
Wilber Hall North Wing

Wilber Hall's north wing is connected to Shineman Hall and Park Hall by a wide, long corridor. This space has a vibrant mural and displays of Technology projects. The setting is ideal for additional elements of Oswego Heritage. The scale of the corridor is appropriate for soft seating arrangements and art.

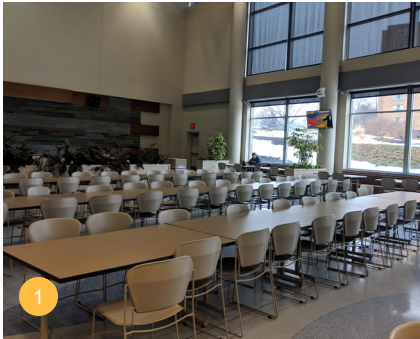
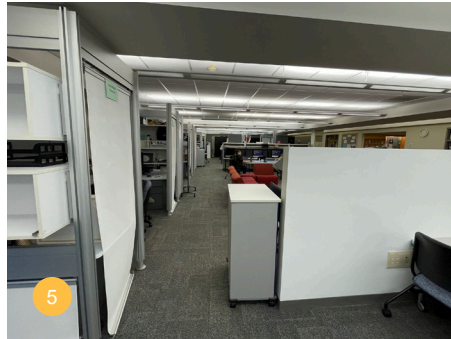
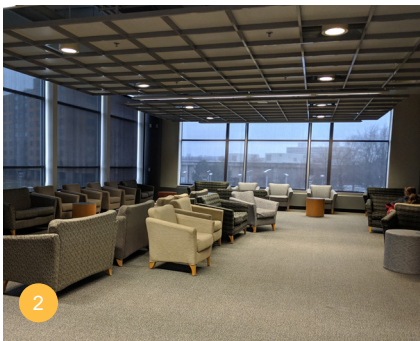
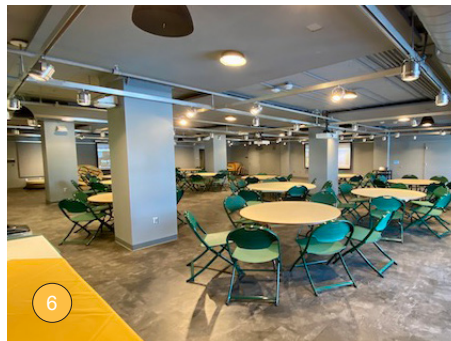
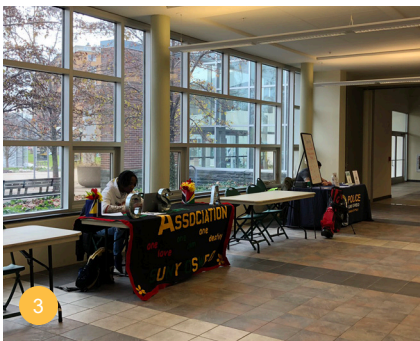
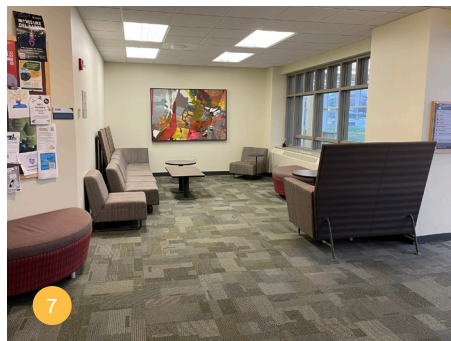
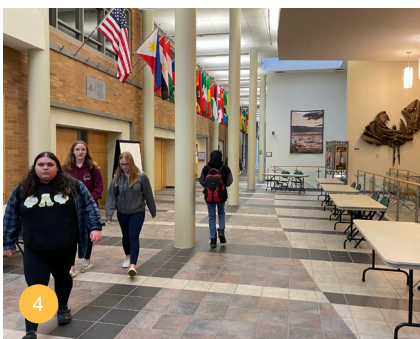
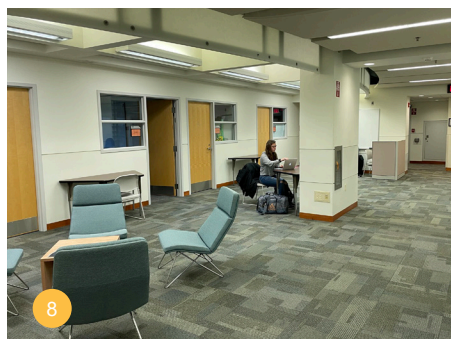
Lower Level and
First Floor NTS

1. A dining hall is located at the arena ground level.
2. The Hearth Lounge has a fireplace and views of Campus. Its furniture arrangement is crowded; the pieces are too heavy to easily rearrange.
3. Student clubs have a tabling area along the interior walk connecting East to West Campus.
4. The corridor widens at the lecture hall and creates more space for student club use. Elements of Oswego art and culture adorn the east wall outside the lecture hall.
5. The Point is the home for student clubs. SUNY Oswego recently added large storage lockers which helped keep the area neater.
6. The Space is a student performance venue on the northern ground level of Swetman Hall.
7. A pocket lounge in Marano Campus Center. Oswego art is on display.
8. Faculty offices in Poucher Hall have seating and study areas nearby.

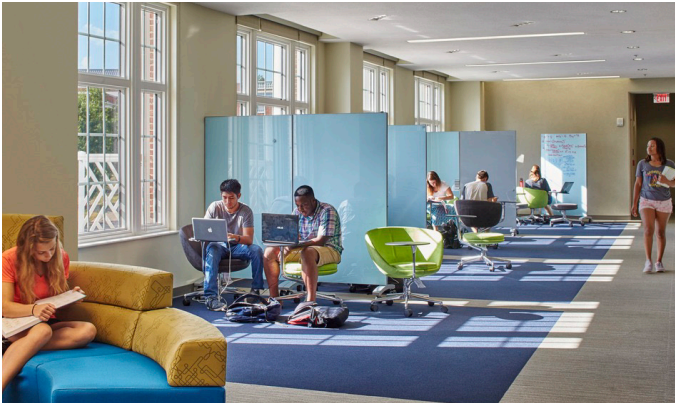
Space dividers and changes in finishes could differentiate zones in the Academic Commons, Marano 200N1 and 200N2 to.

Marano 200N1 and N2 form an academic commons with a wide open floor. Incorporating zones of varying finishes, furnishings, and ceiling heights will help divide the space into small-group and individual scales. Consider adding glass partitions to create quieter study spaces.

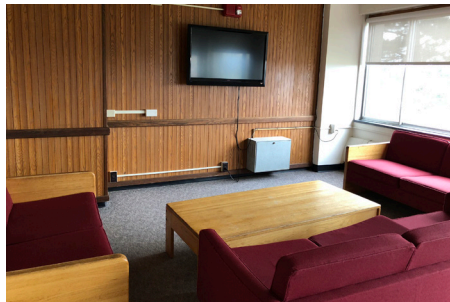
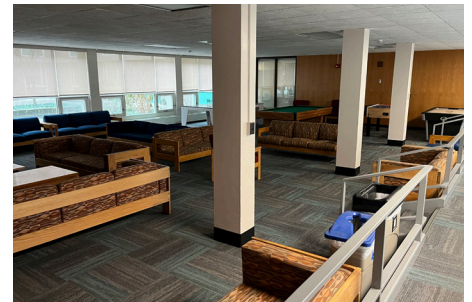
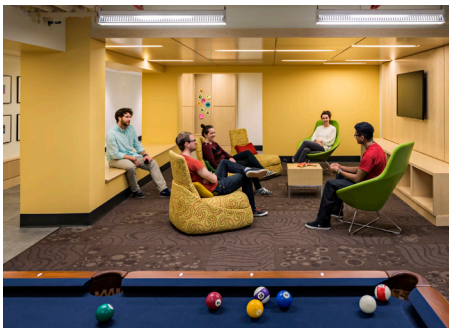
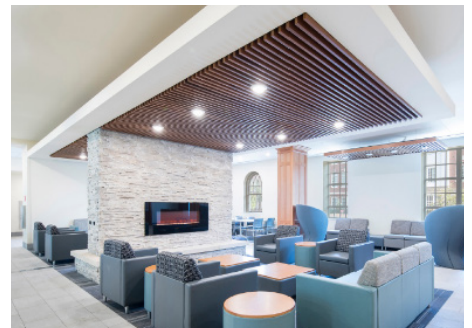
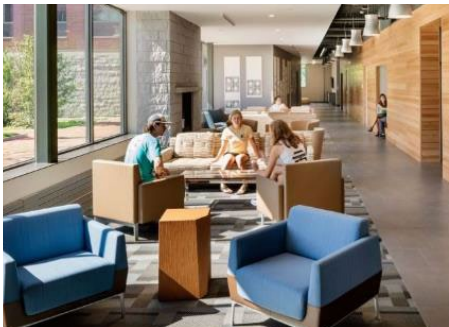
Above, existing lounges have inflexible furnishings and outdated finishes. Below, upgrades and reconfigurations in varying degrees.

Some of Oswego's residence halls and academic buildings have sufficient lounge space to create rooms-within-rooms. Building enclosed rooms allows more activities to take place at one time, increasing potential utilization.

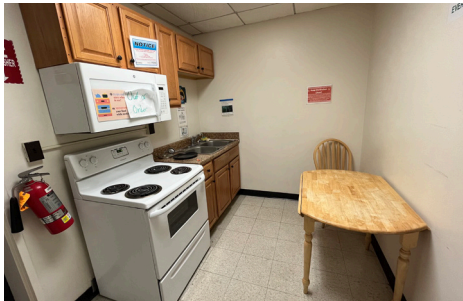
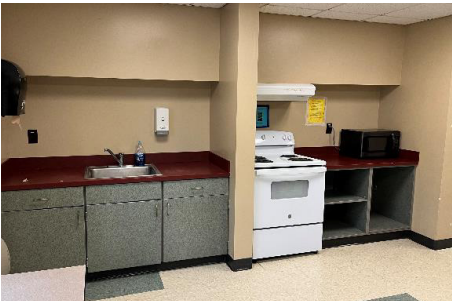
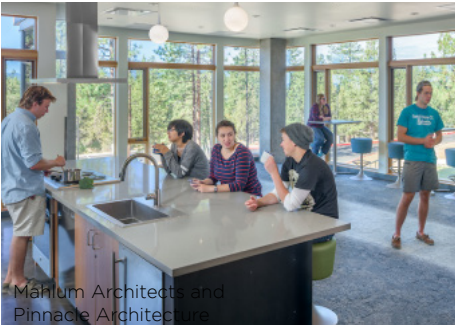
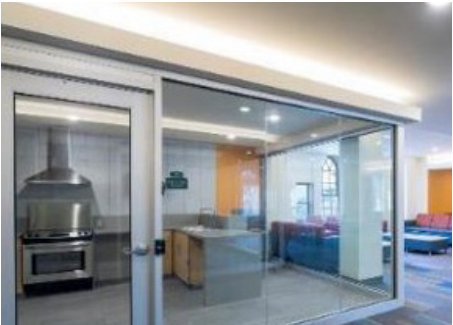
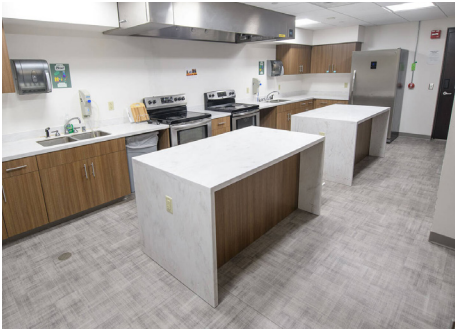
Above, existing kitchenettes on residence hall floors are small and do not include dining space. Existing community kitchens (typically on basement levels) require upgrades. When new kitchens are created, vacant kitchenettes can be converted to small study rooms (below).

After a residence hall receives a new or updated community kitchen, repurpose small existing kitchenettes on every floor as enclosed study lounges. Cap kitchen utilities. Replace finishes and lighting. Provide power and data for study.

Creating community kitchens enables creation of small study lounges from existing kitchenettes. Existing study lounges within the residential room blocks could be converted to revenue-bearing student rooms.

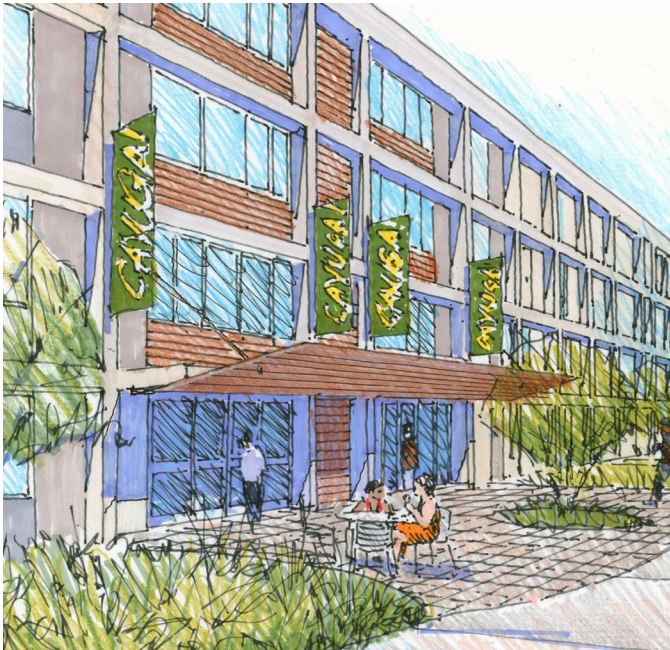
Add new canopies, lighting, landscape plantings, colorful signage, and entry systems to emphasize building approach. Add an area of rainscreen exterior finish in the area surrounding the entrance to further accentuate the entrance.

Entrance enhancements with a canopy, colorful signs, and landscape do not require interior reconfiguration.

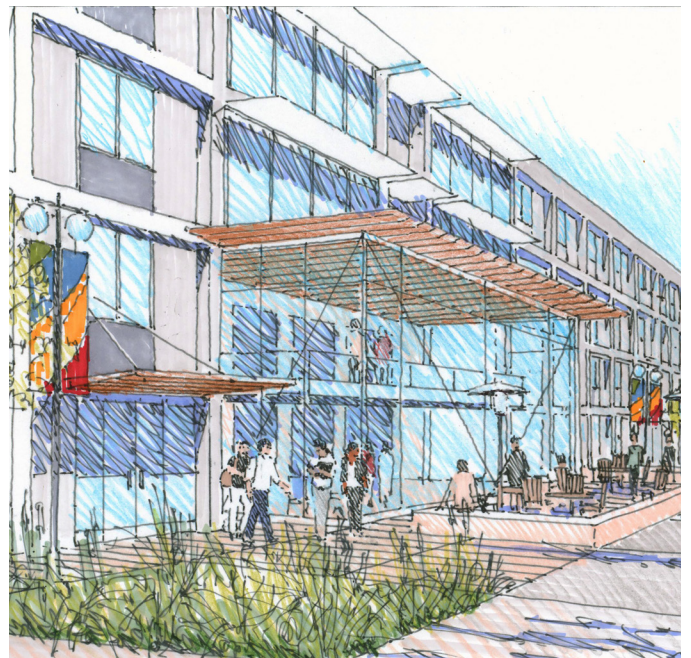
As an alternate to enhancing residence hall entrances, create a new two-story lobby. This approach adds approximately 600 SF of social space that would serve as an all-season "front porch." When illuminated at night, these entrances would be beacons for students' homes on-campus.

A modest addition can further transform building entrances.

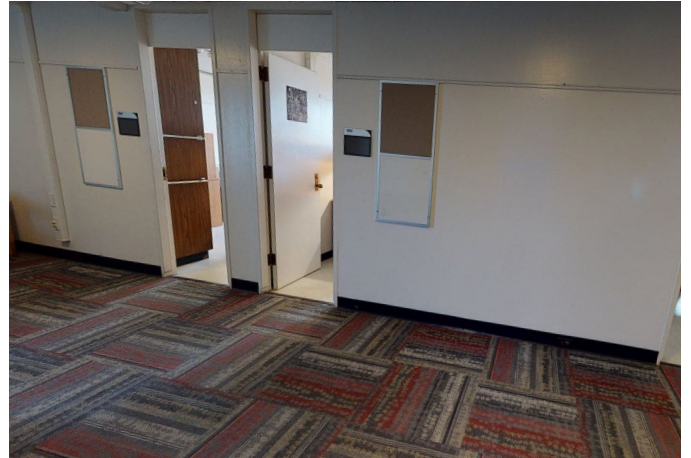
Door openings are too narrow in most residence halls to meet ADA accessibility guidelines. Many rooms have knob hardware. Fixed casework within student rooms intrudes upon the clear floor area required by ADA for accessible doors.

- Widen door openings. Install new doors with accessible hardware.
- Replaced fixed casework that encroaches on clear floor area on door pull side.

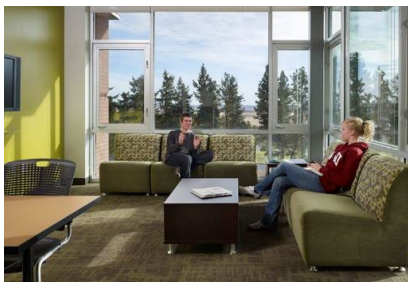
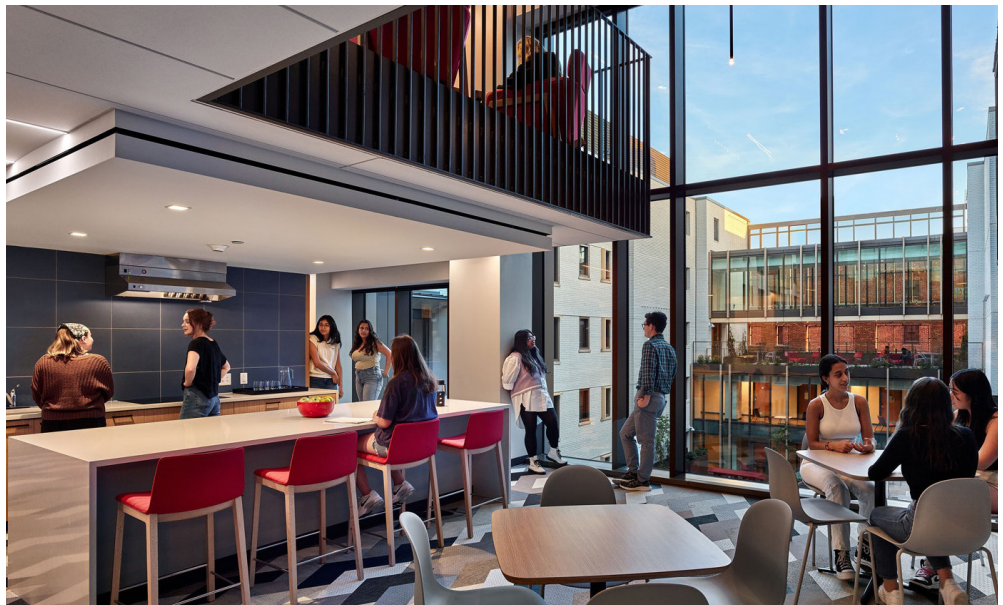
Floor lounges could be created from two student rooms in Cayuga Hall. Prefabricated music practice rooms can augment Oswego's tradition of placing pianos in lounges. A renovation with reconfiguration could create a two-story lounge in Onondaga Hall.

Residence halls have multiple pianos each, located in lounges. This feature invites community gathering around music. Students who need to practice piano, or another instrument, require less-public spaces. With moderate reconfiguration, renovate existing spaces to enable installation of prefabricated music practice rooms.

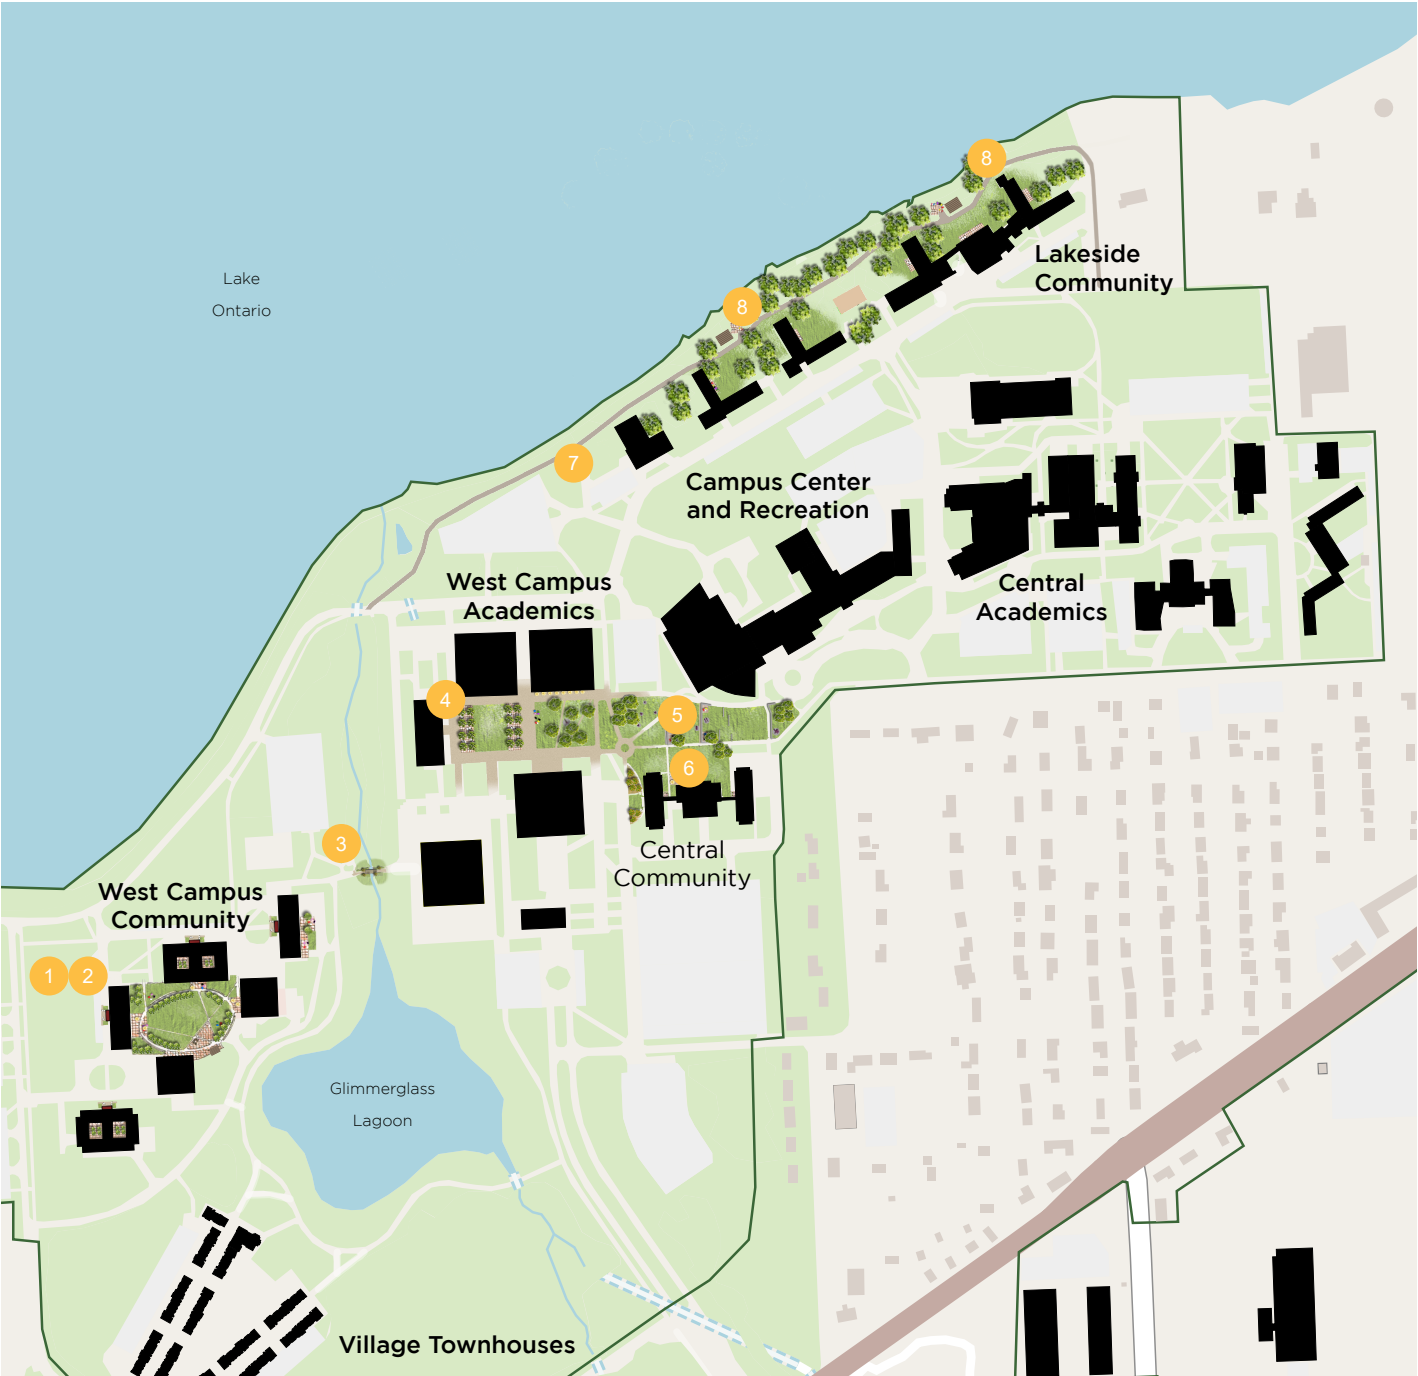
Landscape Enhancement Projects

1 West Residential Quad, Part 1

Provide patios outside residence hall lounges.
Option: Covered patios for extended seasonal use.

Replace the bridge and include pedestrian amenities. Add shade/wind protection, plantings. Add landscaping and upgraded paving at bridge approaches. Improve views to the lagoon and creek by clearing out brush.

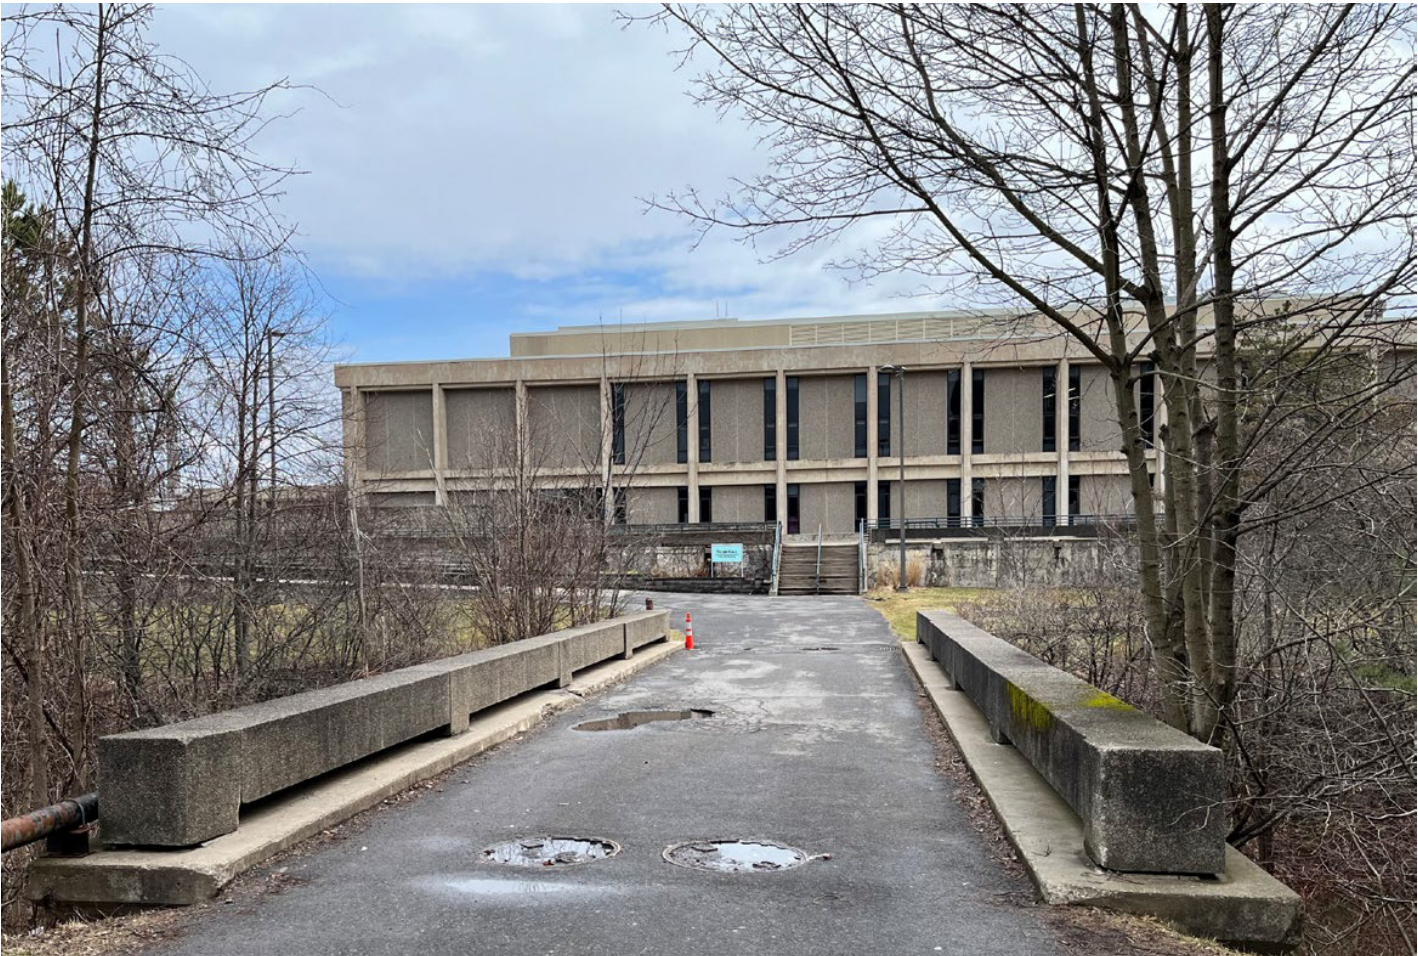
West Campus Bridge

The existing concrete and asphalt bridge is not a welcoming gateway to or from West Campus housing.

A simple footbridge could engage nature.

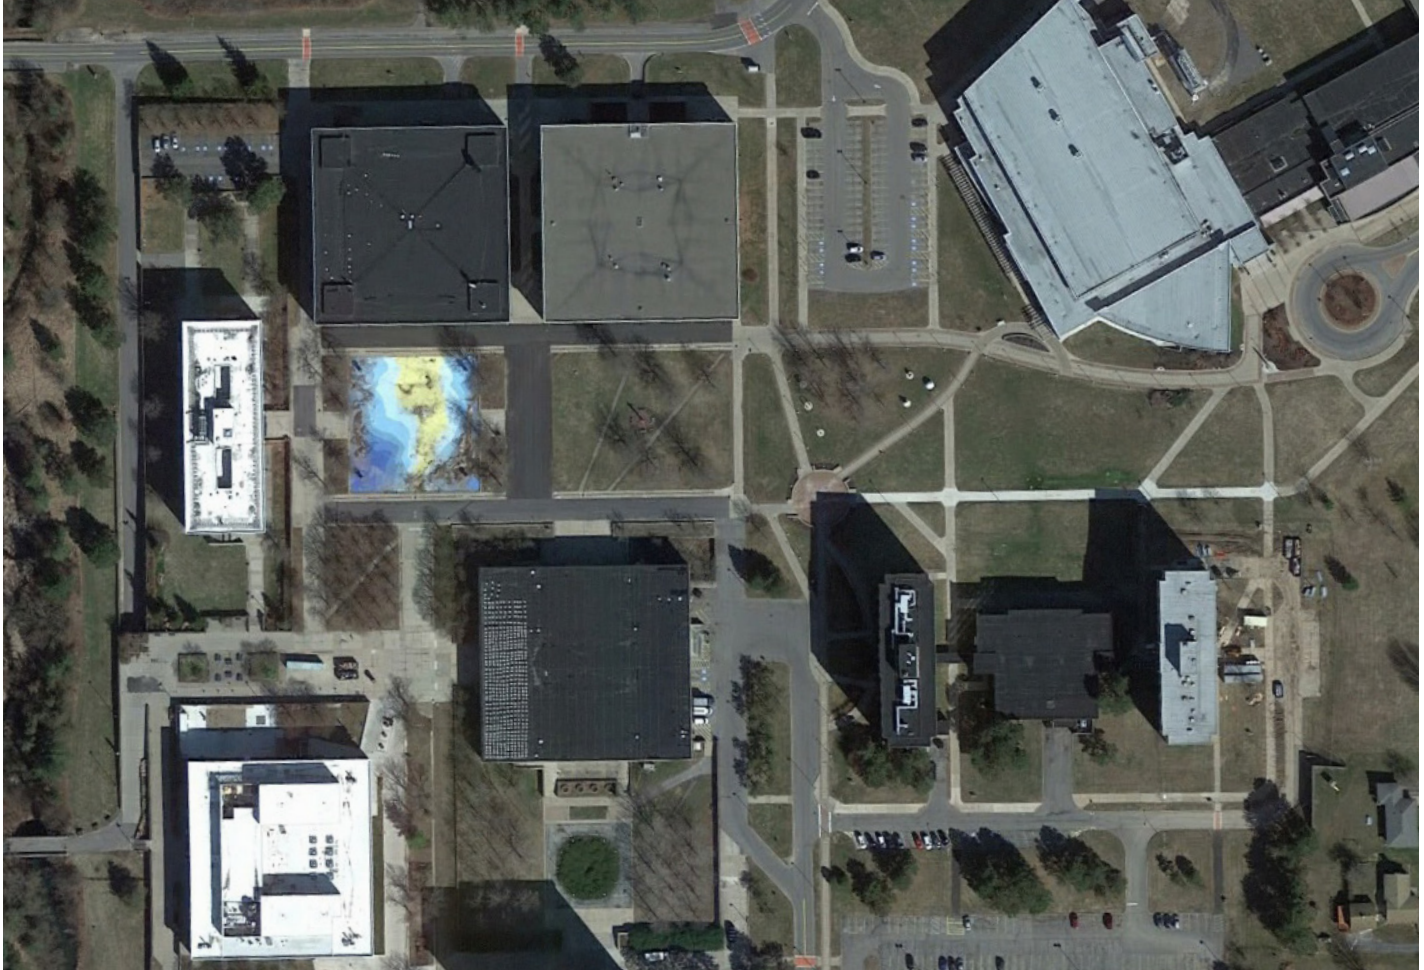
West Campus Academic Plaza

Over the years, the West Campus plaza has lost its crisp edges. Shade trees have softened the hardscape, but there are no features that encourage individuals to stay and enjoy a sunny day.

Building entrances are not celebrated; they are virtually invisible. Concrete in poor condition has been patched with asphalt. The original fountain is no longer used and was painted to bring color to the blank concrete expanse.

Renovating the plaza can create a space for large outdoor events, informal gatherings and games, or just quiet rest. The redesign should address building entrances and offer seating, landscape improvements, and signage to guide people to front doors.

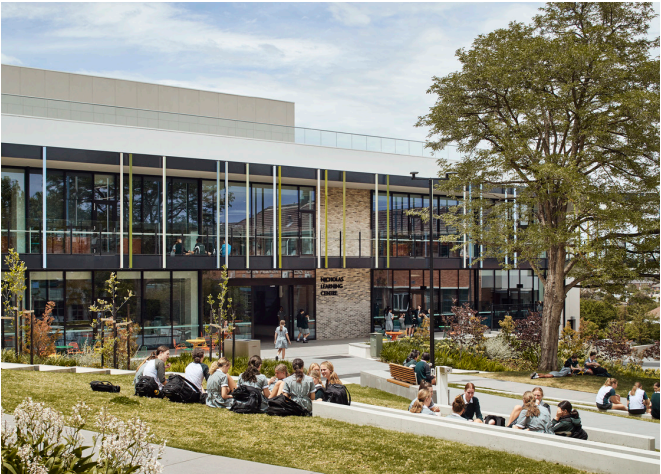
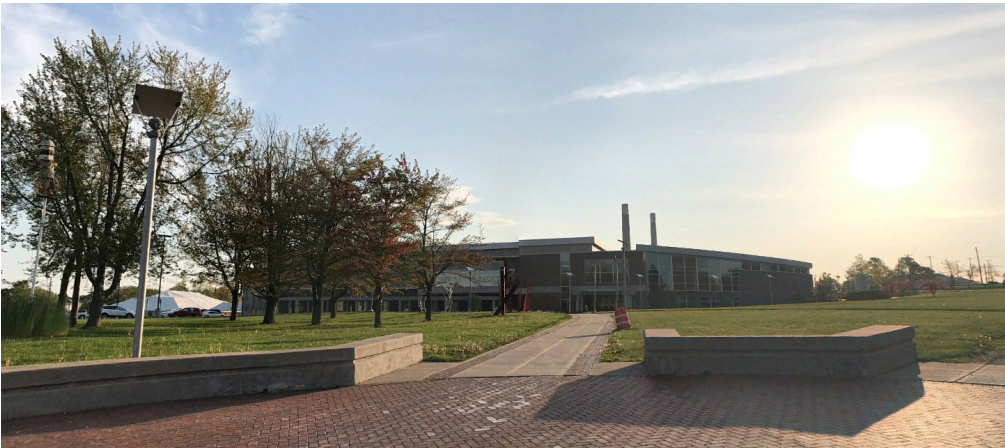
Extend Sculpture Garden

The formal design of West Campus loses its rigor on its eastern edge as walks extend uphill toward Marano Campus Center and Swift Street. Organizing the lawn into terraces and providing level seating areas can increase use of this green space.
