Residence Hall and Academic Facilities Master Plan Update

December 2023

SUNY Oswego

JMZ Architects and Planners, P.C.

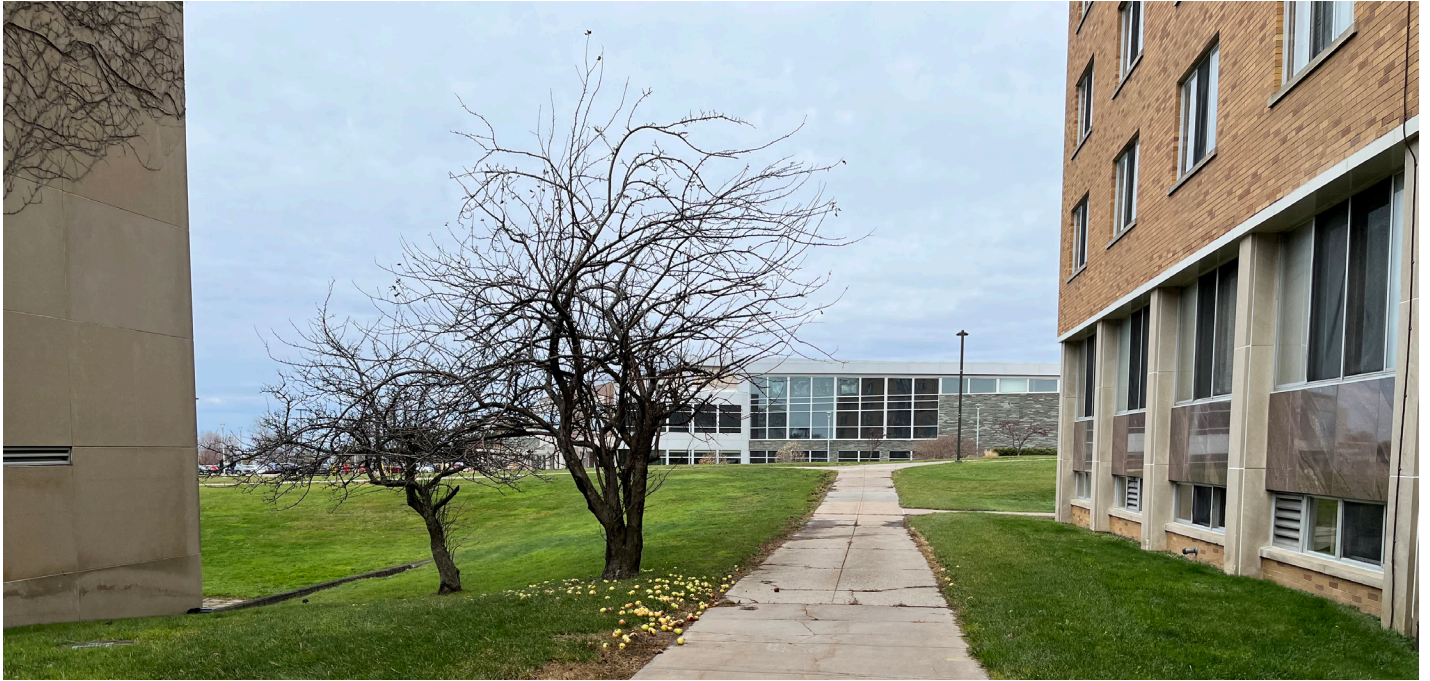
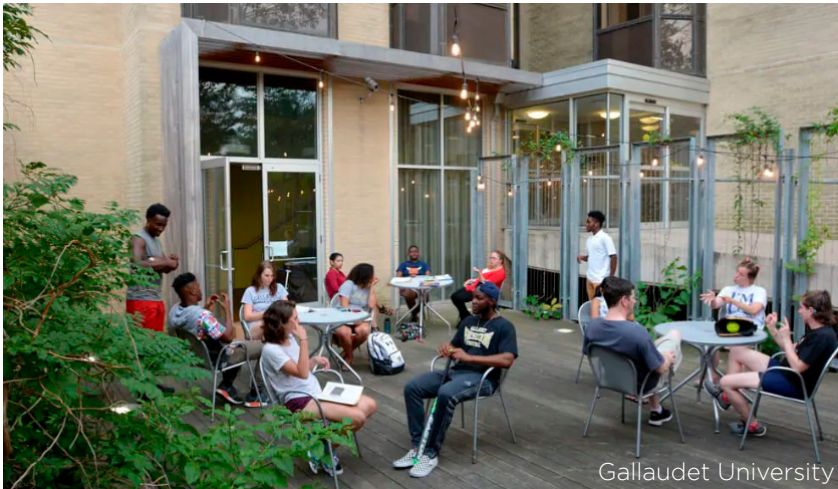
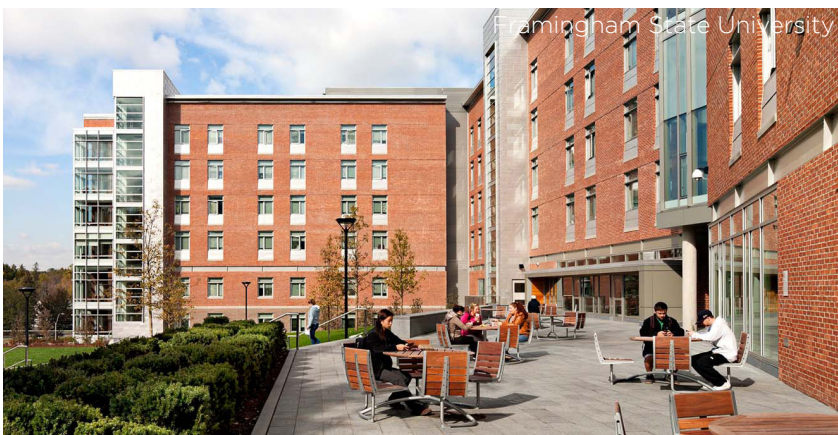
Hart/Funnelle Landscape Upgrade

Shady alleys between Cooper Dining Hall and its twin neighbors, Hart and Funnelle, could be turned into outdoor retreats for student residents.

Around the corner, the northern edge of the Hart, Cooper, and Funnelle buildings could contain a seating area that overlooks the sculpture garden, Marano Campus Center, and Lake Ontario in the distance.

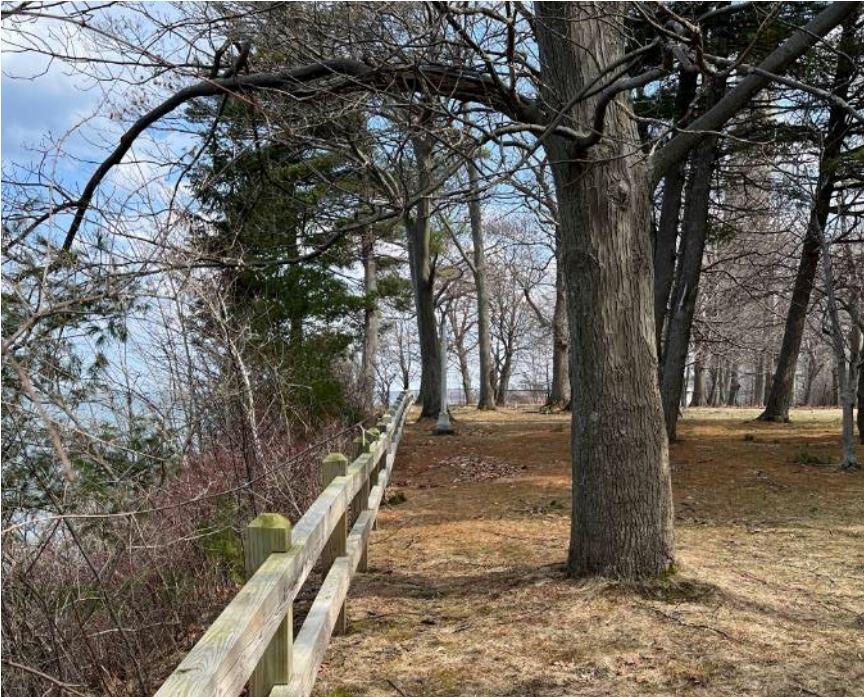
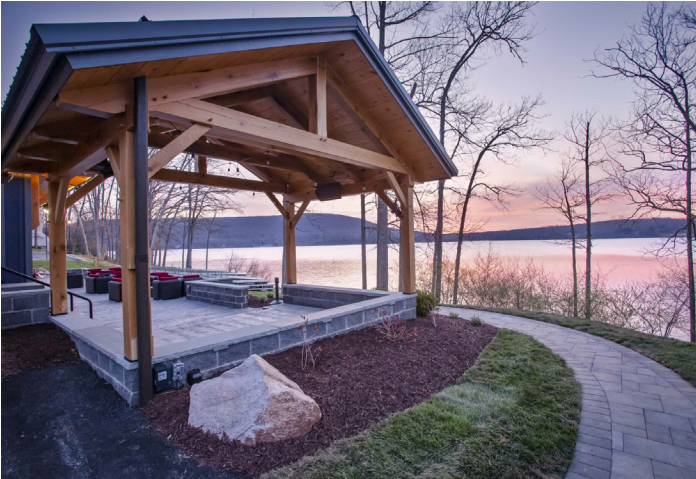
Lakeside Path and Pavilion

Along Lake Ontario there is a barrier fence in good condition and a clear area of lawn for strolling. The space is not accessible for all, however, and lacks amenities.

Adding a graded crushed gravel path, with optional patios or covered seating areas, would invite students, employees, and the community to enjoy Lake Ontario.

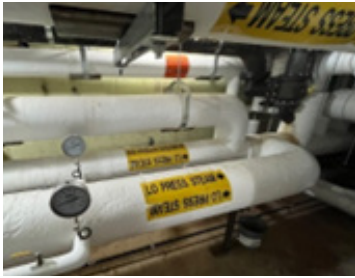
Pressure reducing valves in Funnelle

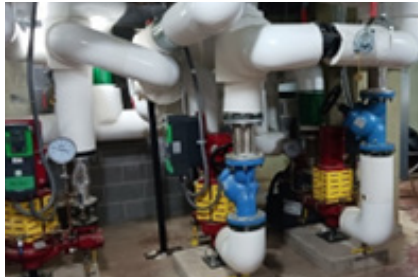
Hot water pumps in Funnelle

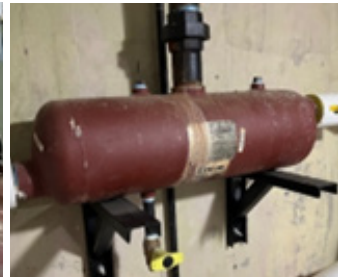
Heat exchanger in Funnelle

Medium-pressure steam from the central heating plant provides heat to the Central Residence Hall community. Heat exchangers, pumps, and dual condensate receivers are very old in Hart and Cooper and should be replaced. Funnelle's heating components were replaced in a 2020 renovation.

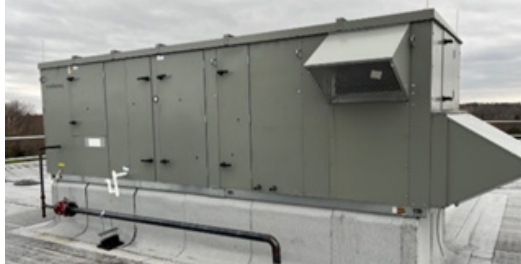
HRU on roof, Funnelle

In Hart and Funnelle, student residences are served by hot water convectors. Common areas are heated, cooled, and ventilated by two rooftop heat recovery units. The convector system provides reliable heating, but lack of individual controls leads student rooms to be too hot in shoulder seasons. (Operable windows help students control room temperature.) The HRUs are in good condition.

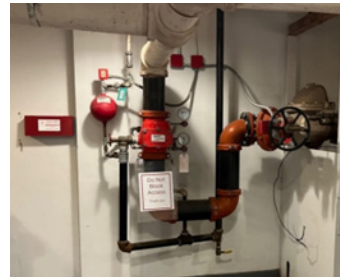
Funnelle fire protection check valve, OS&Y valve, fire alarm check valve, and spare sprinkler valve box. Sprinkler system incomplete in Funnelle, therefore inactive.

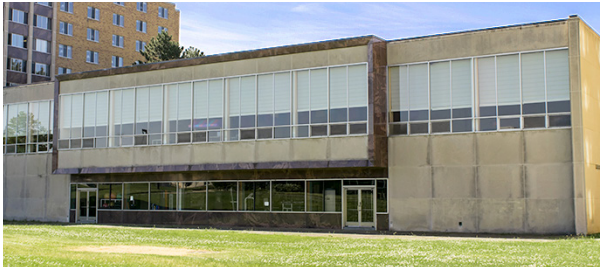
Cladding at Cooper DH shows signs of moisture infiltration.

Cooper Dining Hall has not had exterior finish or window upgrades. Its panelized cladding system shows signs of water infiltration.

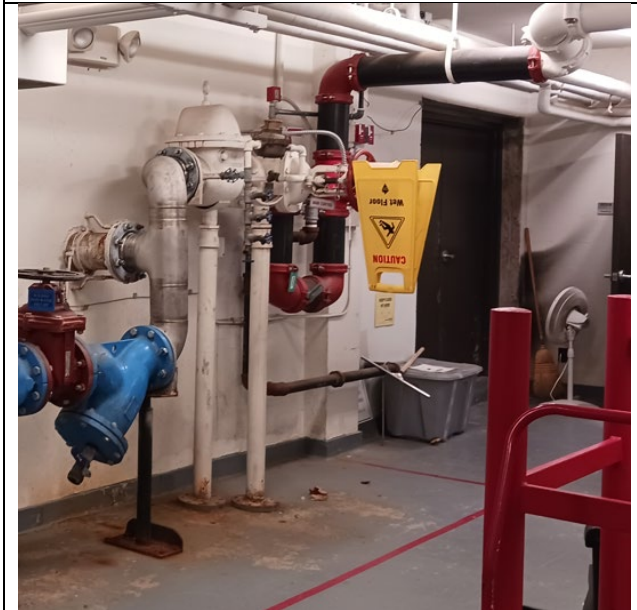
Picture 14: Combined domestic and fire water incoming service with a single check valve backflow preventer on the fire water side

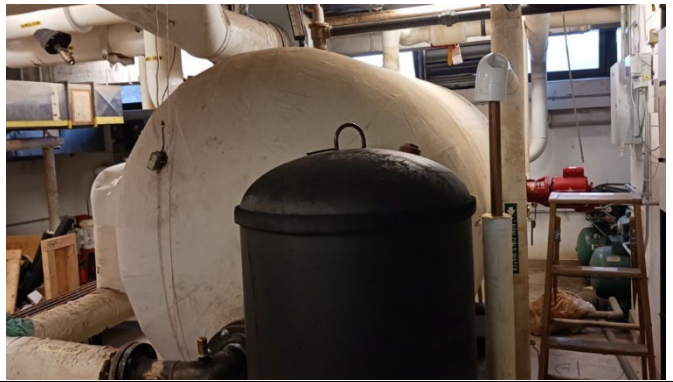
Picture 15: Domestic HW Tank

- Two gas fired water heaters with 350 gallon external tanks. In fair condition.
- One 1500 gallon Domestic hot water steam bundle storage tank installed in 1997. In fair condition.
- Inline 1/3 hp hot water circulation pump. in fair condition.
- 3-way pneumatically controlled hot water mixing valve. In fair condition.
- One duplex ground water sump pump with 3 hp pumps. In fair condition.
- 6" Domestic water backflow preventer assembly. In good condition.

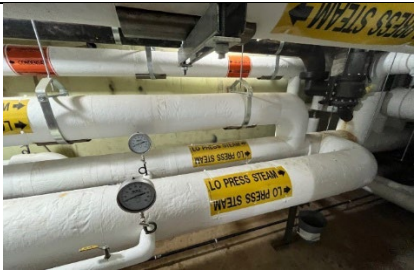
Picture 1: Pressure Reducing Valve Station

- Medium pressure steam from the central heating plant, pressure reduced for service by pressure reducing valves in the basement mechanical room.
- A shell and tube heat exchanger (2020) provides hot water to convectors, heating and ventilating units (HV), and unit heaters.
- (P-1 through P-5) 7.5HP inline centrifugal hot water pumps circulate hot water to building heating equipment. Good condition, built in VFD on each pump, less than 10 years old.
 - Hot water supply temperature reset based on OA temperature. Turned on at OA less than 60F.
 - 180F at 20F OA
 - 110F at 50F OA
- A separate shell and tube heat exchanger serves HW for the resident director apartment suite.
 - Hot water pump P-6 with constant speed motor circulates to HW convectors.
 - 180F HW at 0F OA
 - 110F HW at 60F OA
- Duplex condensate receiver units (2020).

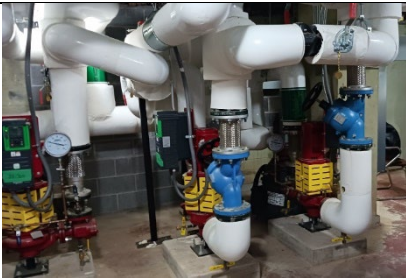
Picture 2: Hot Water Pumps

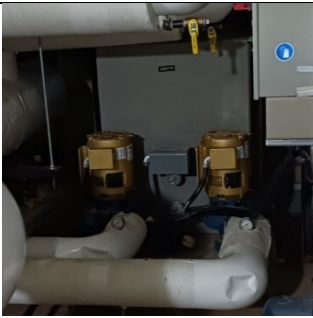
Picture 3: Condensate Receiver Unit

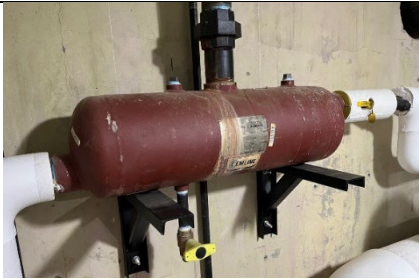
Picture 4: Heat Exchanger

The heat exchanger was installed in 2020 and is in good condition. There appears to have been a leak that rusted the exterior of the heat exchanger. The condensate receivers were also installed in 2020 and are in good condition.

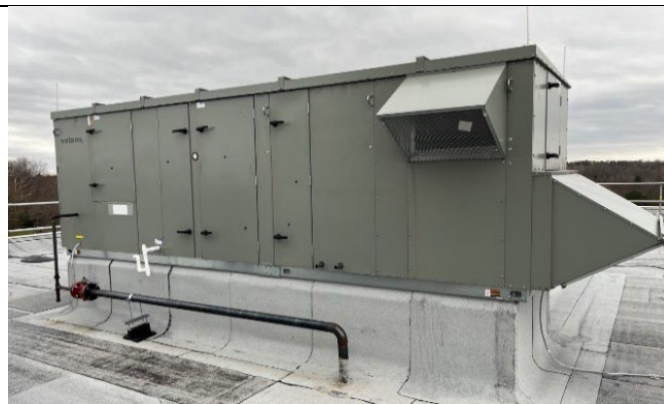
Picture 5: HRU

Student residences are served by hot water convectors, while common areas are heated, cooled, and ventilated by two rooftop heat recovery units (HRU). The convector system provides reliable heating, but lack of individual controls leads student rooms to be too hot in shoulder seasons. (Operable windows are present to help students control room temperature.) The HRUs are in good condition.

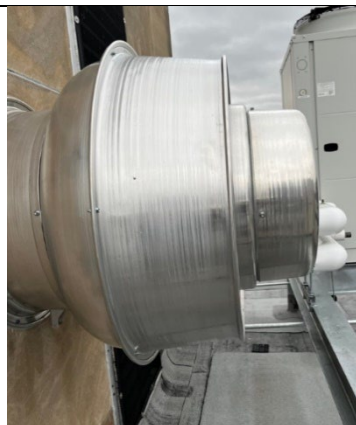
Picture 6: Exhaust Fan

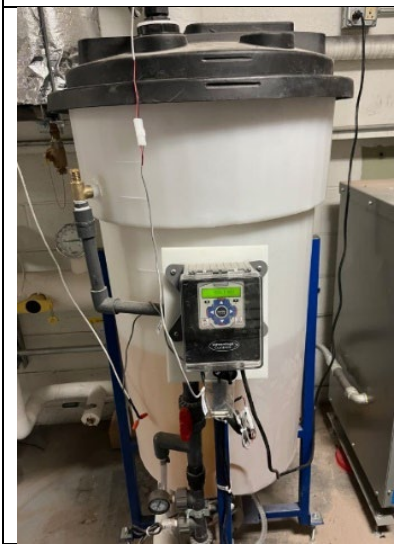
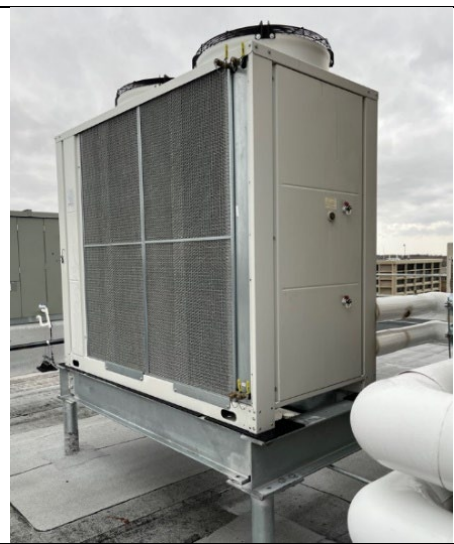
Picture 7: Glycol Feeder Tank	Picture 8: Air Cooled Chiller

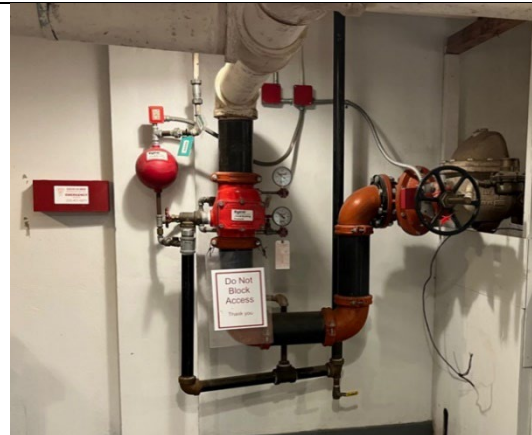
Picture 14: Detector Check Valve (gold color), OS&Y valve with tamper switch, and the fire system Alarm Check valve (red color). Spare sprinkler valve box to the left.

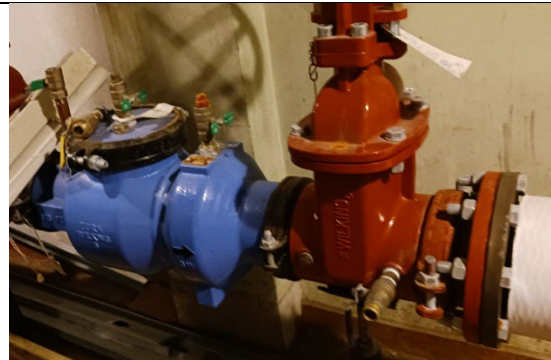
Picture 15: Backflow Preventer

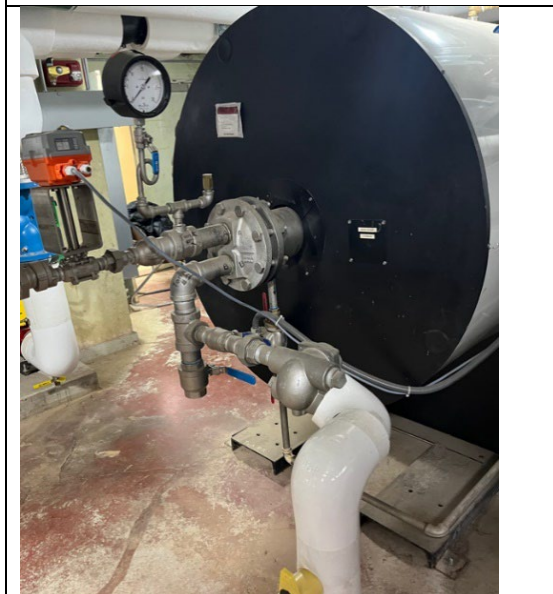
Picture 16: Domestic HW Tank

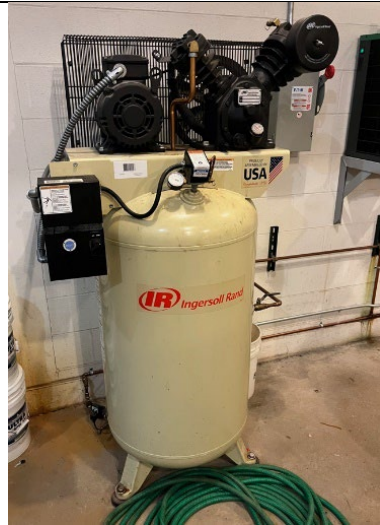
Picture 3: Air Compressor

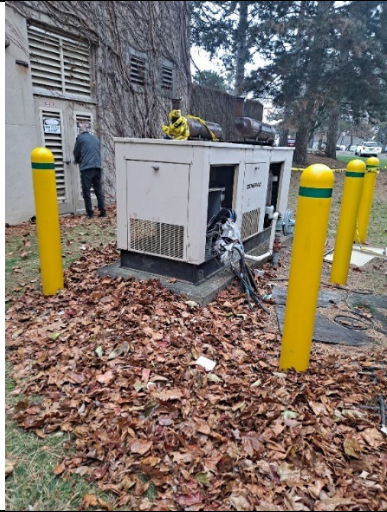
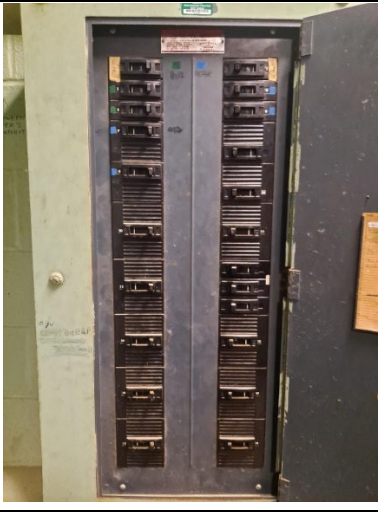
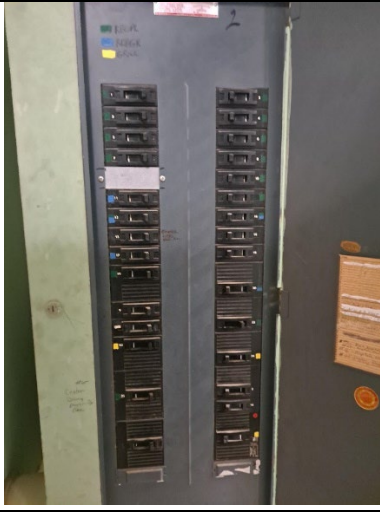
Picture 4: (Emergency Generator)	Picture 5: (Panelboard PP-D):	Picture 6: (Panelboard PP-B):

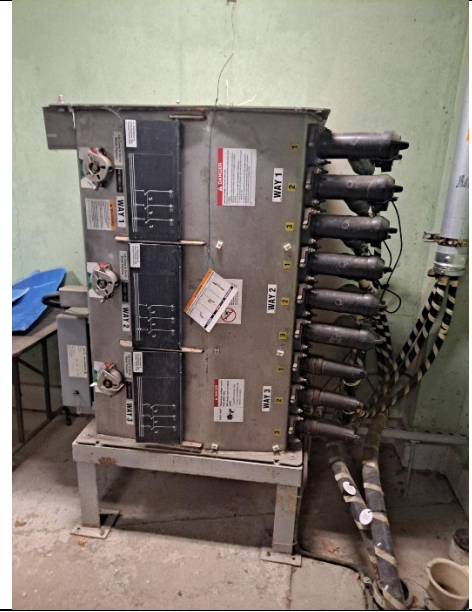
Picture 7: (Switchgear):

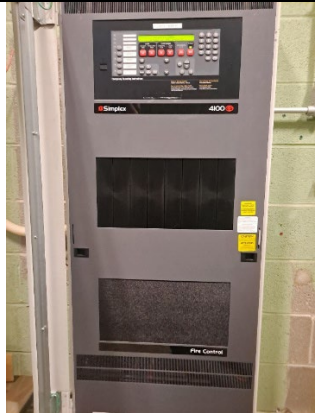
Picture 8: Fire Alarm Control Panel (FACP)

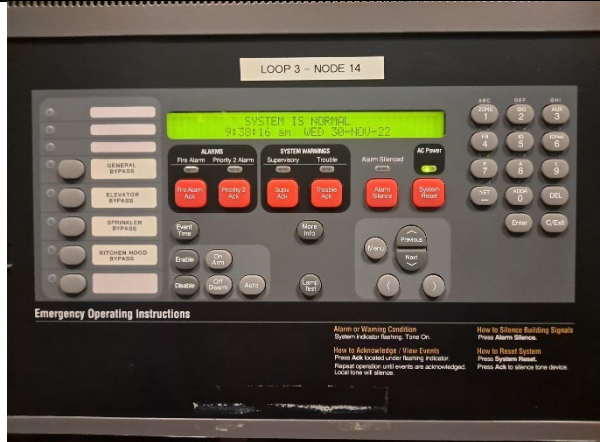
Picture 9: Annunciator Panel

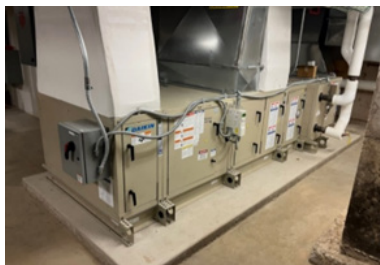
HV-1 in Waterbury. HVs serve common areas in Waterbury.

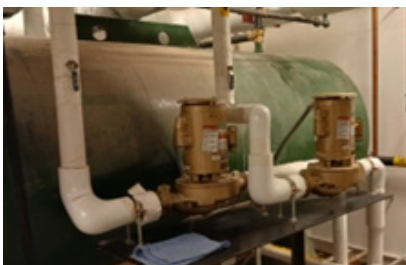
Hot water circulators in Scales

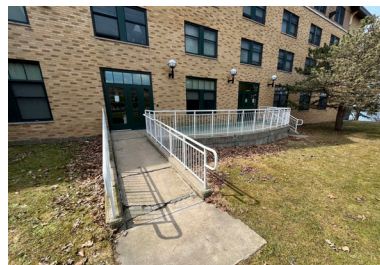
A ramp to the lawn from Riggs Hall requires repair.

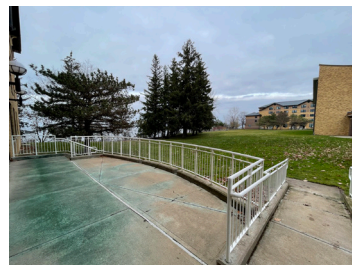
Riggs Hall patio surface requires cleaning. Railings need to be repainted.

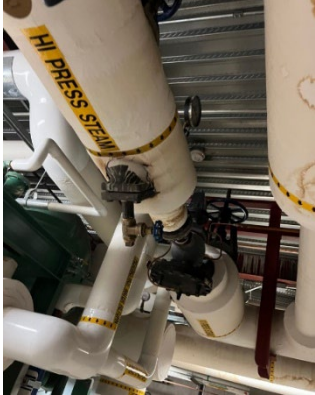
Picture 1: Pressure Reducing Valve Station	Picture 2: Hot Water Pump	Picture 3: HW Pump VFD

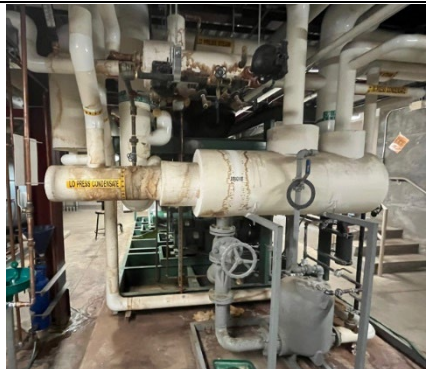
Picture 4: Heat Exchanger

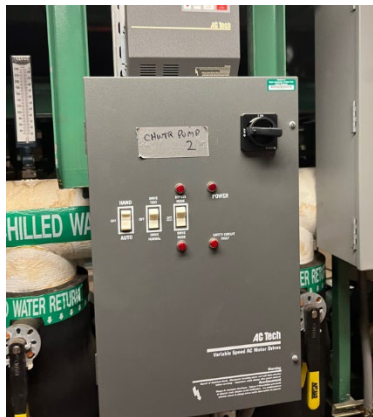
Picture 6: CHWP-2 VFD

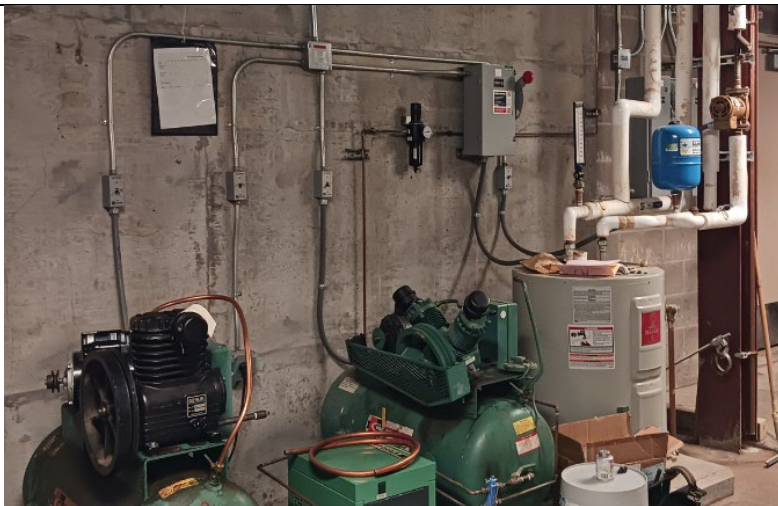
Picture 7: Air Compressors

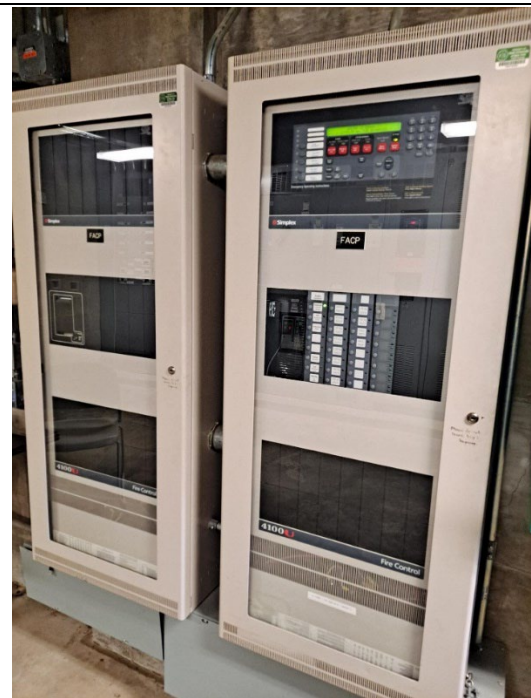
Picture 11: Fire Alarm Control Panel

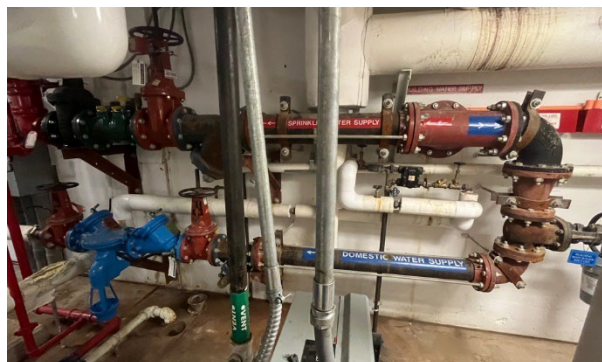
Picture 13: 6" Fire Main

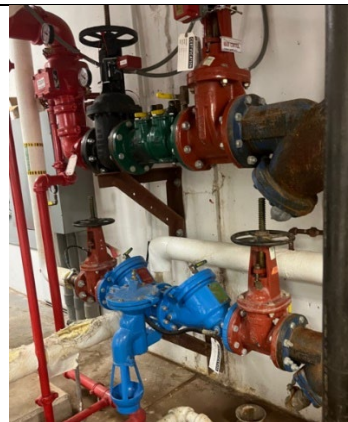
Picture 14: Check Valve

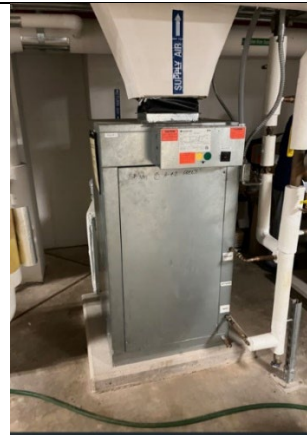
Picture 5: FCU-R-1

- Replace cooling coils (and controls where needed)
- No major equipment replacement necessary.

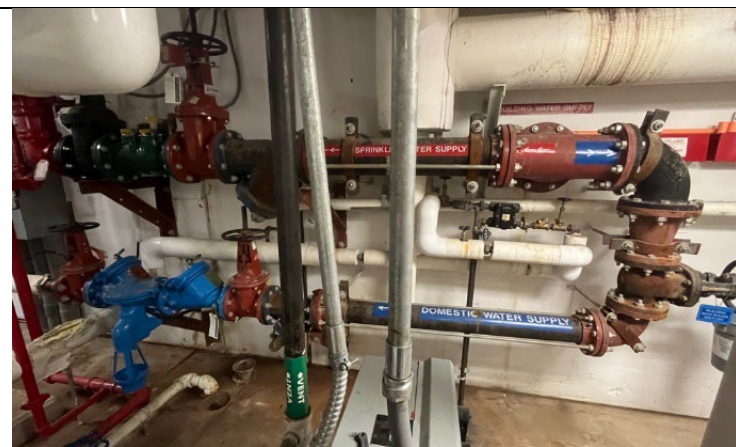
Picture 15: 6" Fire Main

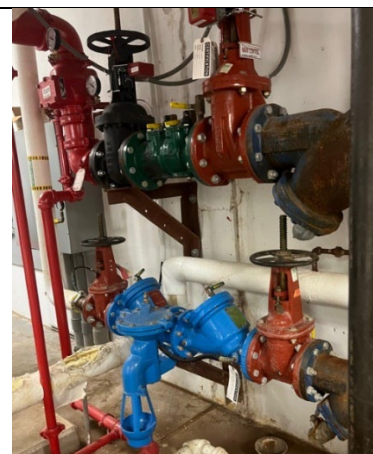
Picture 16: Check Valve

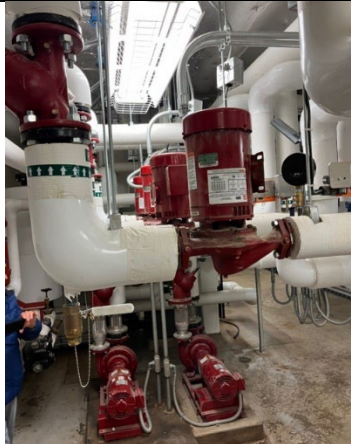
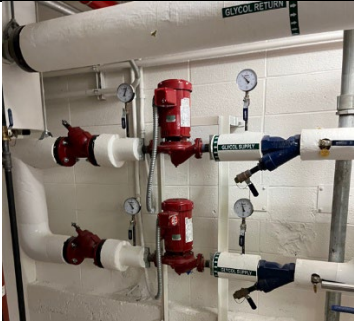
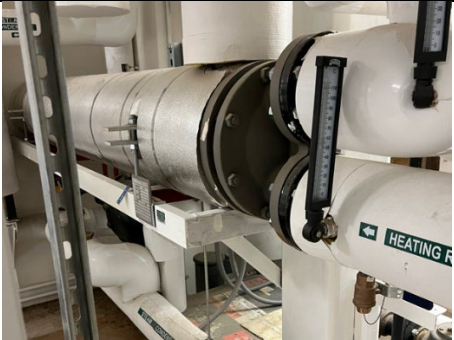
Picture 1: Primary and Secondary HW Pumps	Picture 2: Glycol Pumps	Picture 3: Shell and Tube Hot Water Converter

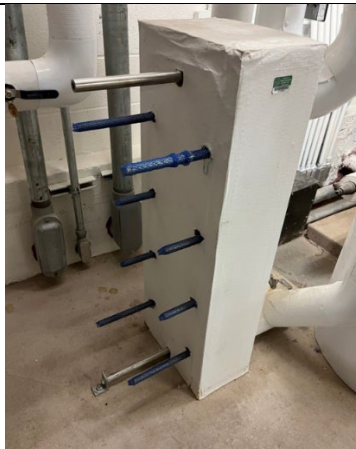
Picture 4: Plate and Frame Heat Exchanger

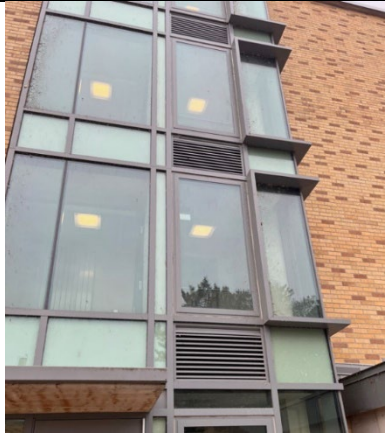
Picture 5: Corridor Exhaust Louvers

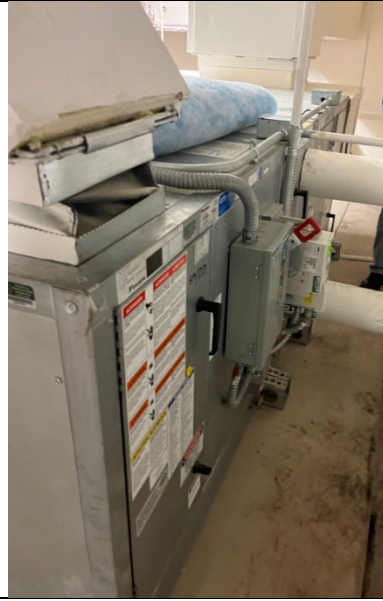
Picture 6: HV-2

Scales Hall HVAC is served by a combination of fin tube radiation (FTR), HV units, one BCU, and a VRF system with six air conditioners. The FTR system provides heating to the student dorms. Ventilation in the student dorms is provided by operable windows. The HV units serve common areas including the first floor lounge, corridors, and lobbies. The BCU provides makeup air to the laundry room. And the six VRF ACs serve the director's and assistant director's apartments, meeting room, mechanical rooms, and data closets. Exhaust is provided by 11 exhaust fans with constant speed motors for the bathrooms, janitor closets, mechanical rooms, and corridors. All equipment was installed in the 2017 renovation and is in good condition.

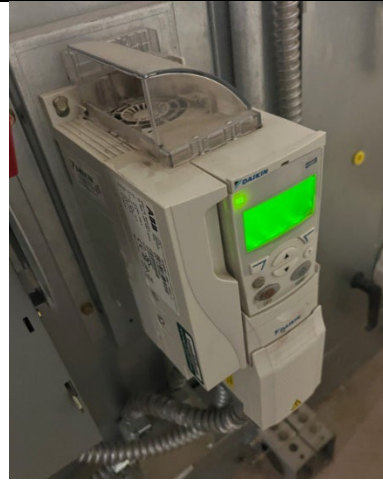
Picture 7: Supply Fan VFD

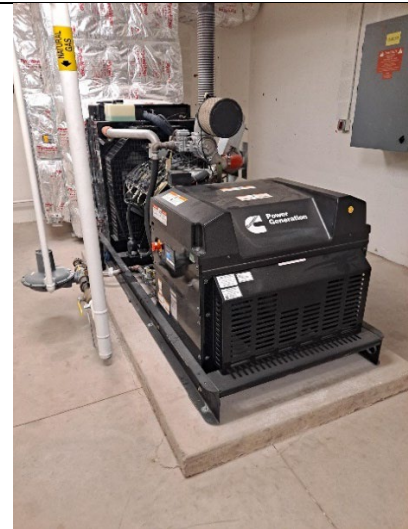
Picture 8: (Emergency Generator):

Emergency Power is supplied by a 100kVA 120/208V 3 phase Cutler Hammer emergency generator installed in 2017 which is located inside this building and is in very good condition.

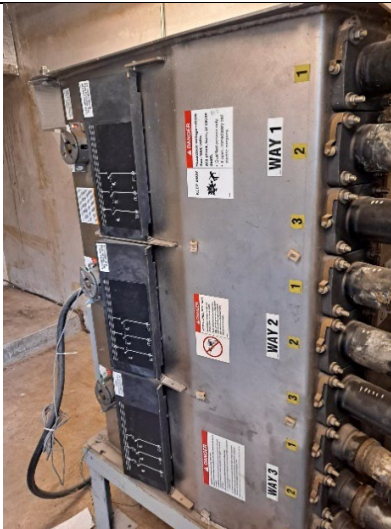
Picture 9: (Switchgear):

Electrically, this building is fed from the 13.2kV campus feeder loops. The 13.2kV feeder feeds a 13.2kV S&C switchgear located inside the electrical room that was installed around 1998 and is still in good condition. There is a 800A 120/208V 3 phase 4 wire Cutler Hammer switchboard installed around 1998 which is in good condition and located inside the electrical room. The majority of the General Electric (120/208V 3 phase 4 wire) electrical panelboards were recently installed and are in great condition.

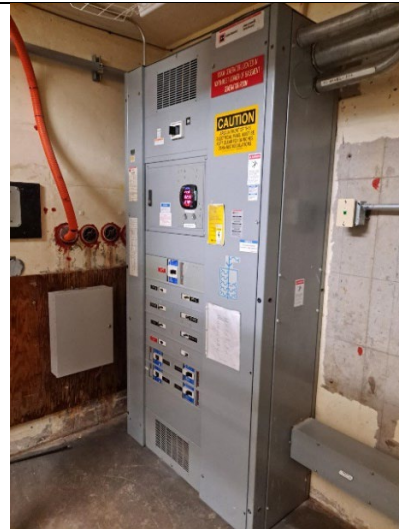
Picture 10: (Switchboard):

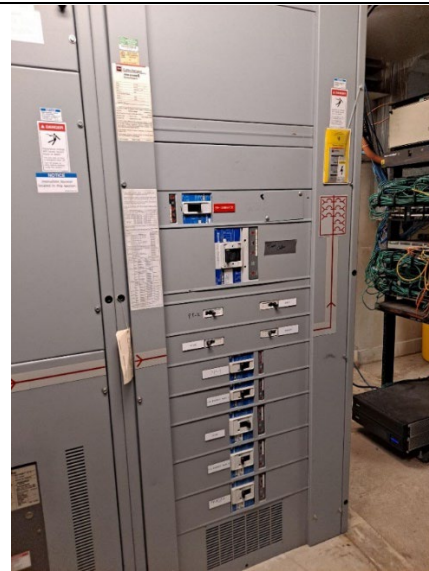
Picture 11: (Switchboard):

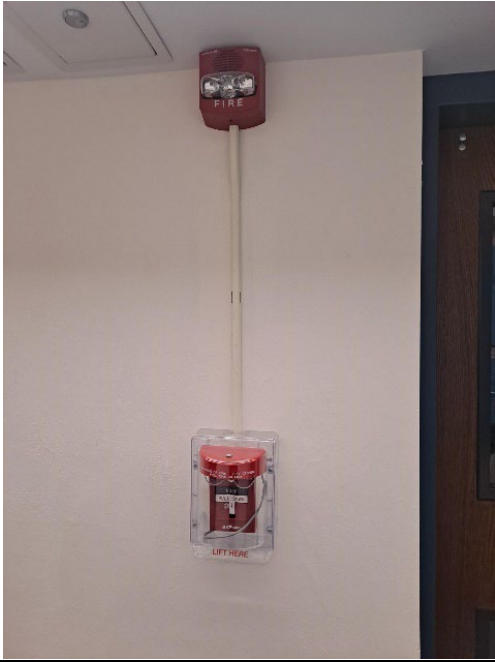
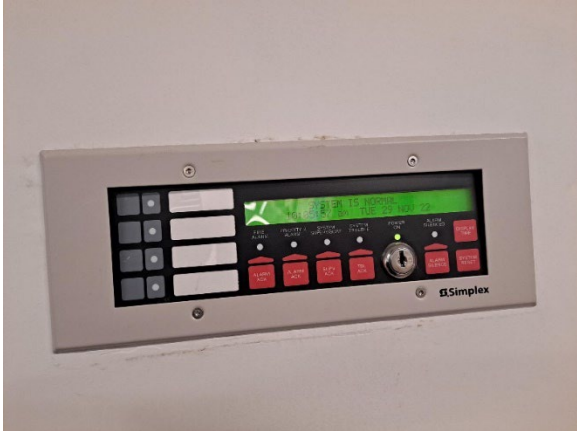
Picture 12: Pull Station & Horn/Strobe	Picture 13: Annunciator Panel

Fire Alarm system for this building was updated back in 2017. The Fire Alarm Control Panel (Simplex 4100-U) contains battery backup and all of the Fire Alarm equipment connected to this system is in good condition.

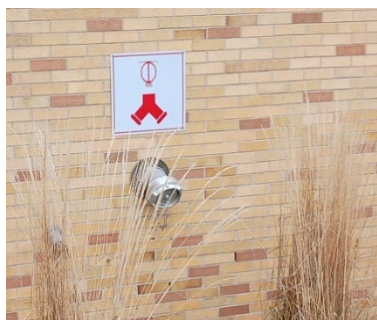
Picture 15: 5" Storz FDC

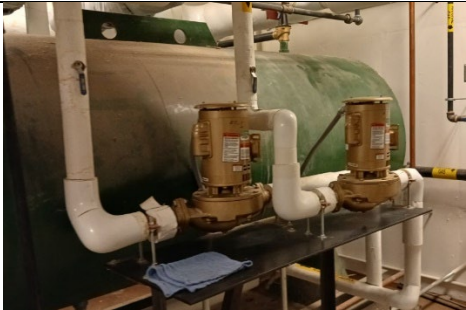
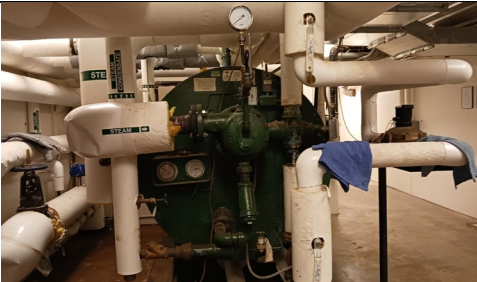
Picture 16: Hot Water Circulators	Picture x: Domestic Steam-Fired Water Heater	Picture 10: Electric Water Heater

- Replace domestic hot water storage and steam-fired heat exchanger.
- Provide a new sump pump – 1-1/2 hp, 85 gpm @ 20’ head.
- Install Low-Flow or Ultra Low-Flow showerheads.

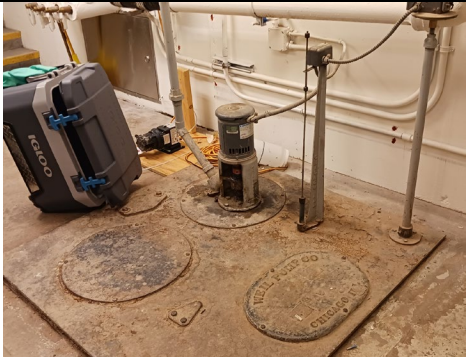
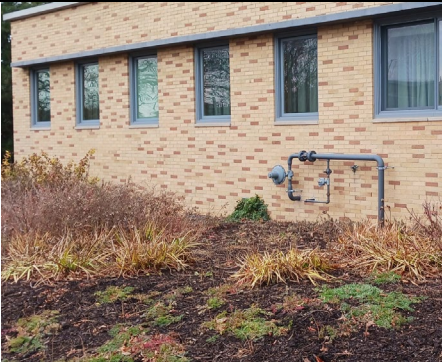
Picture 11: Sump Cover and Pump Assembly	Photo 12: Gas Service Assembly

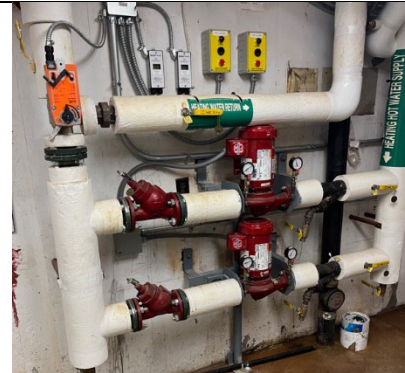
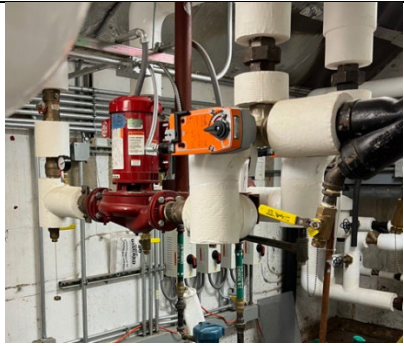
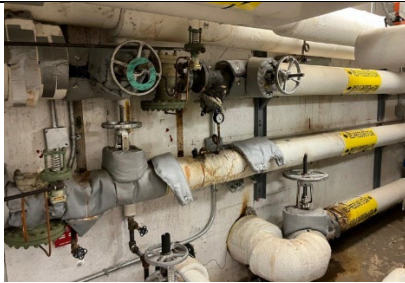
Picture 1: Primary HW Pumps	Picture 2: Secondary HW Pumps with VFD	Picture 3: PRV Station

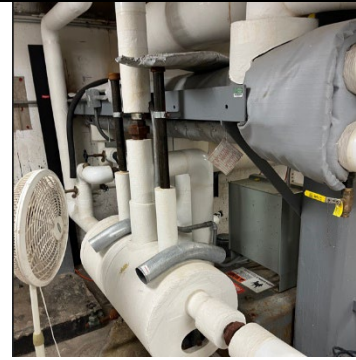
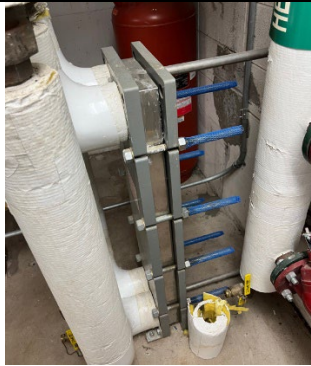
Picture 4: Shell and Tube Hot Water Converter	Picture 5: Plate and Frame Heat Exchanger

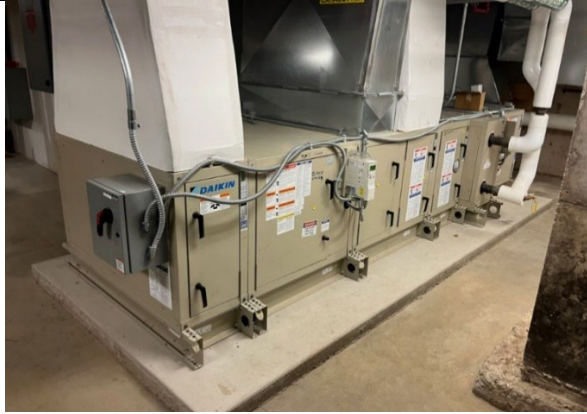
Picture 6: HV-1

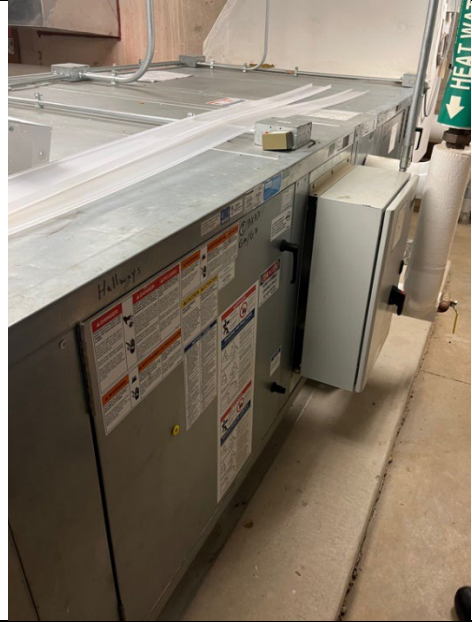
Picture 7: HV-2

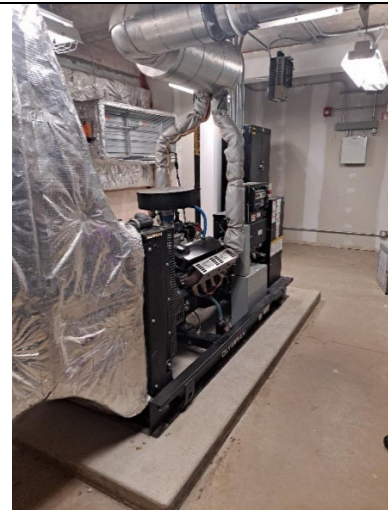
Picture 8: (Emergency Generator):

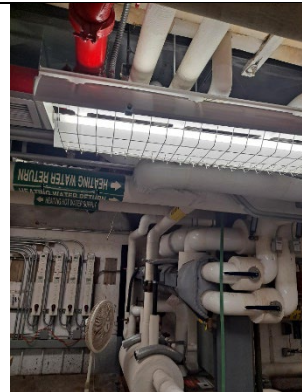
Picture 11: Light Fixture

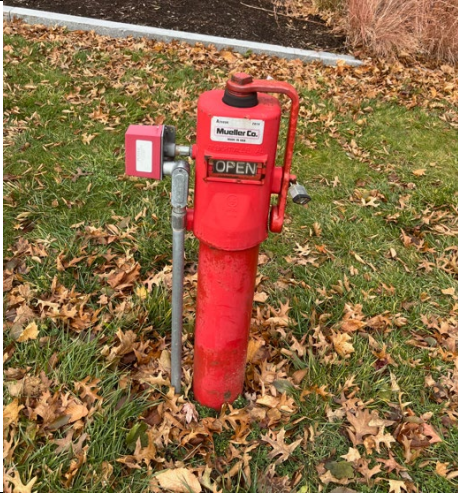
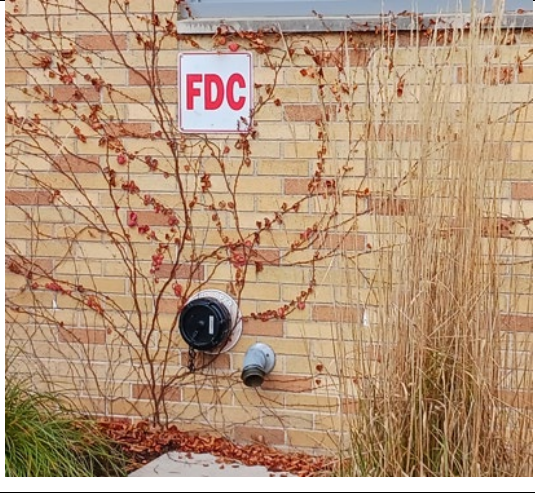
Picture 12: Post Indicating Valve with Tamper Switch	Picture 13: FDC

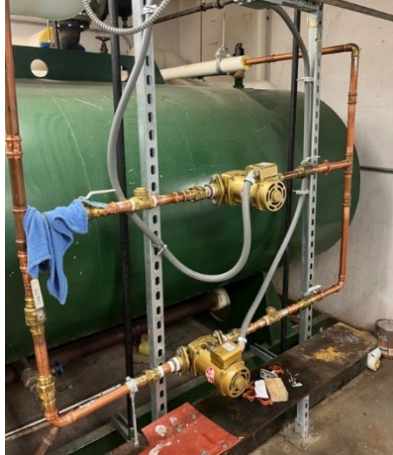
Picture 13: Domestic HW Tank with
Inline Pumps

- Replace DHW tank.

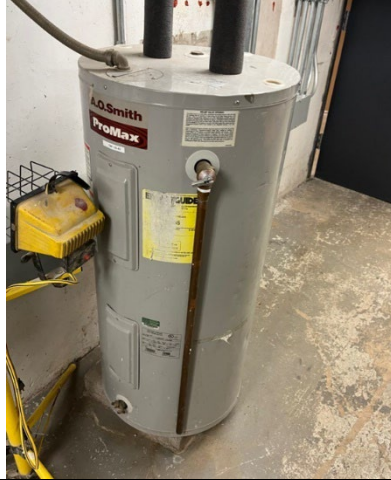
Picture 14: Electric Water Heater

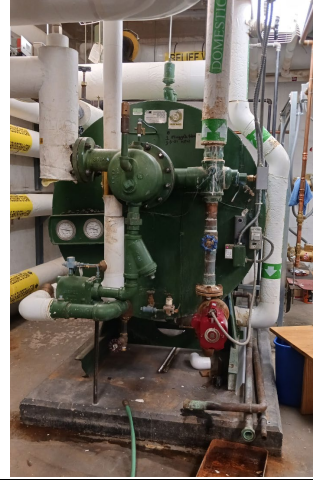
Picture 15: Steam-Fired DHW
Heater

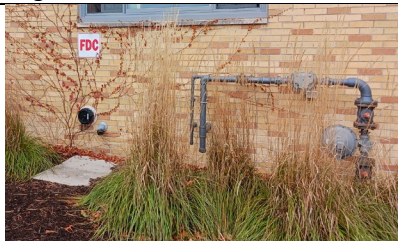
Picture 16: Gas Service with a
Regulator

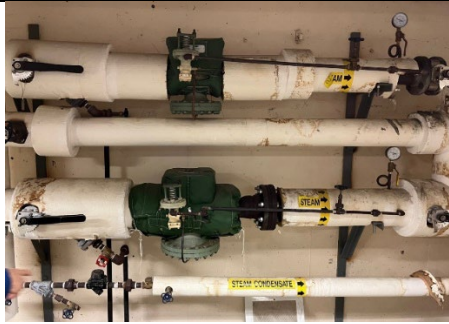
Picture 1: Pressure Reducing Valve Station

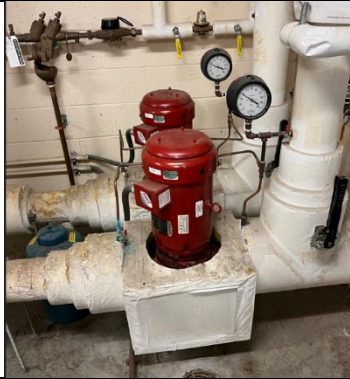
Picture 2: Hot Water Pumps

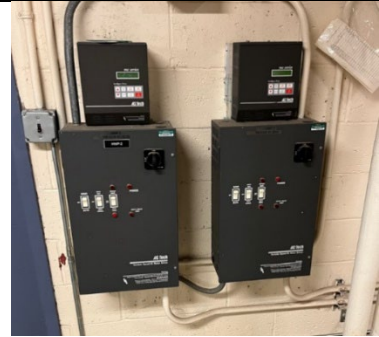
Picture 3: HW Pump VFDs

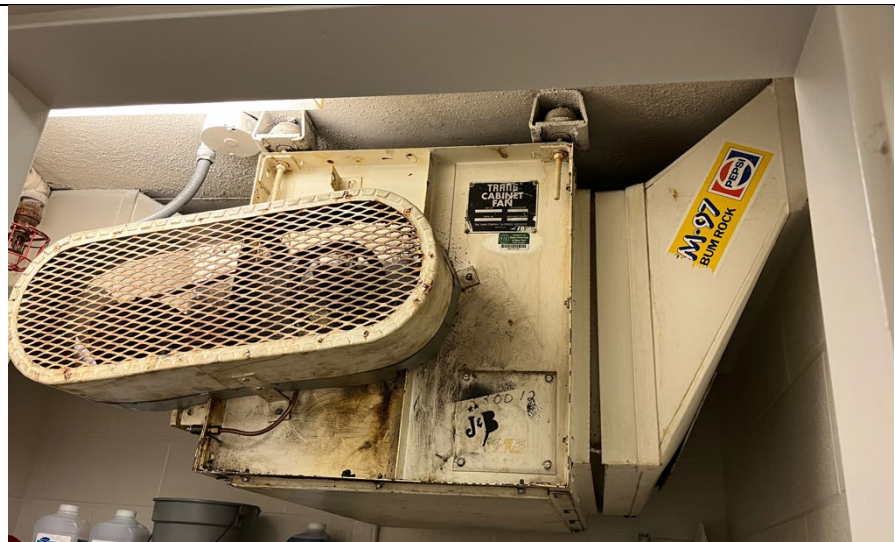
Picture 5: FCU

Concealed fan coil units (FCU-1 through FCU-5) provide heating and cooling to the basement level spaces. One air handling unit (AHU-1) provides heating and cooling to the first floor cafeteria and spaces in tandem with radiant floor heating. One makeup air unit (MUA) provides makeup air to the kitchen. All systems were installed in 2006 and are in good condition.

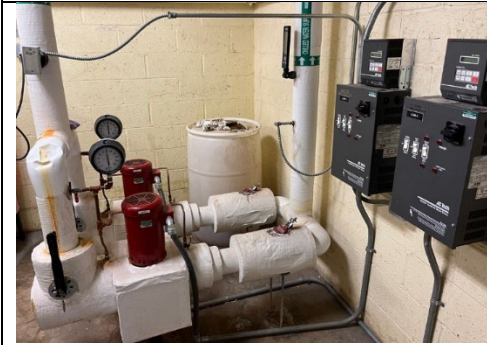
Picture 6: Secondary CHW Pumps (CHW-1 and CHW-2) and VFDs

- Two 355 ton screw chillers (2006) in Lakeside DH mechanical room provide CHW to Lakeside, Johnson, and Riggs.
- Chillers work with Cooling Tower (2006) on Lakeside Roof. Cooling tower motor controlled by VFD.
- CHW pumps PCWP-1 and PCWP-2 are inline centrifugal pumps with 10HP motors. They work on lead/standby serving primary loop for Lakeside DH. CHW pumps have VFDs for motor control based on differential pressure.
- CHW pumps CHW-1 and CHW-2 are inline centrifugal pumps with 1.5HP motors. They serve the secondary loop which provides CHW to Lakeside DH. CHW-1 and CHW-2 have VFDs to control motor, and triple duty valves.
- 3 condenser water pumps. Base mounted, centrifugal pumps operate in lead/standby with constant speed, 15HP motors.
- Glycol Feeder Tank
- AHU-1 and FCUs provide cooling to Lakeside Hall using CHW.

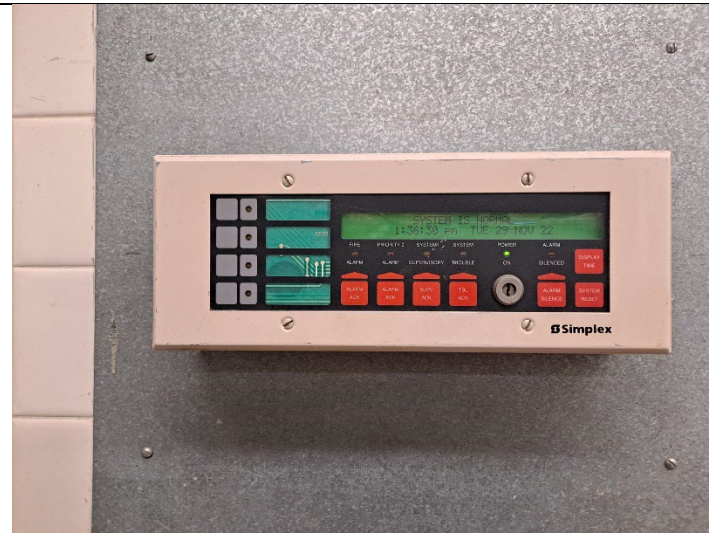
Picture 15: Annunciator Panel

Fire Alarm system for this building was updated back in 1999. The Fire Alarm Control Panel (Simplex 4100-U) contains battery backup and all of the Fire Alarm equipment connected to this system is in operable condition but looks old, should be replaced soon.

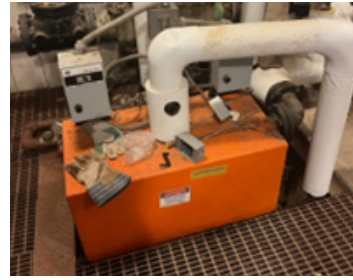
Oneida duplex condensate receiver

- Medium-pressure steam from the central heating plant provides heat to the West Residence Hall community. Heat exchangers, pumps, and dual condensate receivers are very old in all buildings and should be replaced.

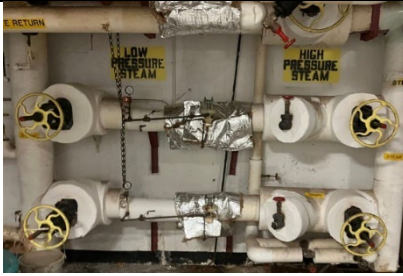
A photograph of a pressure-reducing valve station. It features several white valves with yellow handles, connected by white pipes. Labels include 'RETURN', 'LOW PRESSURE STEAM', and 'HIGH PRESSURE STEAM'.

Picture 1: Pressure Reducing Valve Station	Picture 2: Hot Water Convactor (Shell and Tube Heat Exchanger)	Picture 3: Hot Water Pumps

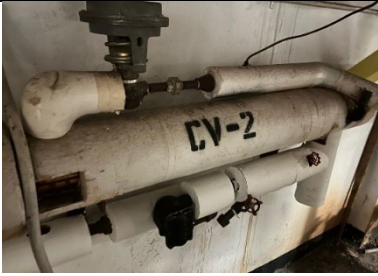
A photograph of a hot water convactor, which is a shell and tube heat exchanger. It is a large, horizontal, cylindrical metal unit with various pipes and valves attached. The label 'CV-2' is visible on the side.

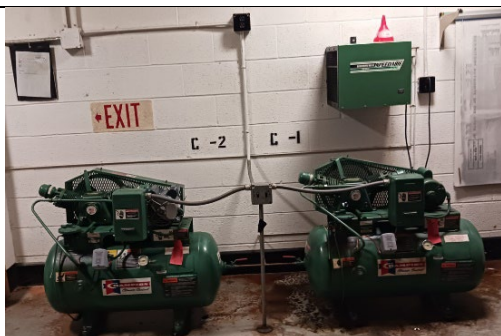
Picture 7: Air Compressors

- Replace pneumatic control system and connect to DDC system on BAS.
- Implement Demand Control Ventilation.
- Implement HW supply temperature reset.
- Install occupancy-based HVAC controls.
- Retro-commissioning of HVAC systems and controls
- Setback equipment during academic breaks

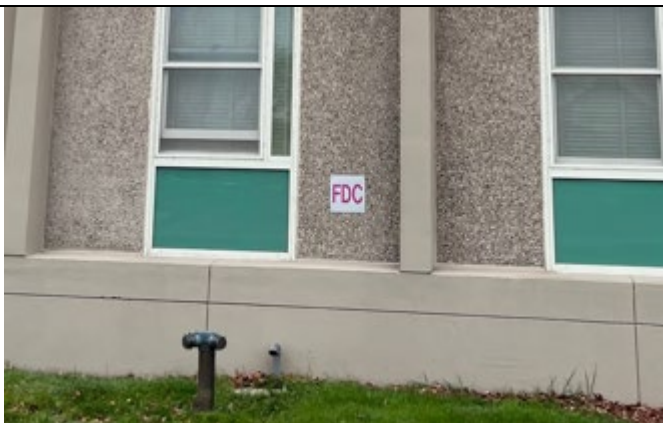
Picture 12: FDC

- Install a Double Check Detector Backflow Prevention Assembly on the incoming 8" fire water service to protect the city water supply from cross contamination caused by backflow from fire water to city supply system. The proposed valve shall comply with ASSE-1048
- Extend sprinkler protection throughout the building.

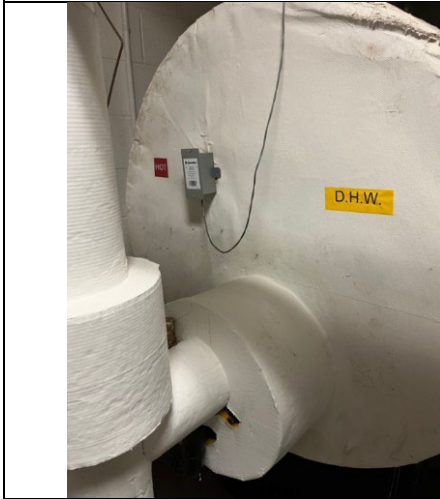
Picture 13: Domestic HW Tank

- Replace heat exchanger and DHW tank.
- Install Low-Flow or Ultra Low-Flow showerheads.

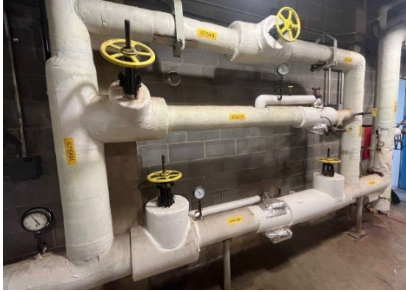
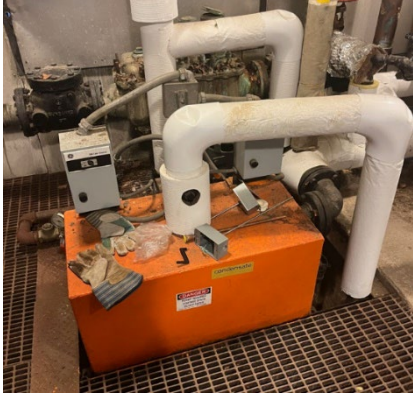
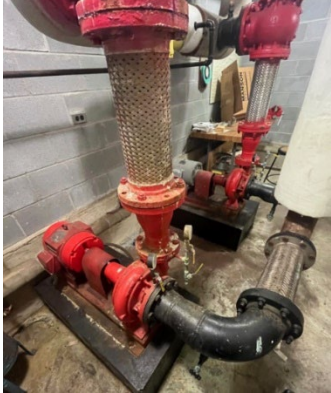
Picture 1: Pressure Reducing Valve Station	Picture 2: Duplex Condensate Receiver	Picture 3: Hot Water Pumps

- The heat exchanger, pumps, and duplex condensate receiver were installed in 1969 and are in poor condition. All are well beyond their useful life and need to be replaced.

- Replace major heating equipment including heat exchangers, condensate receiver, and hot water pumps.
- Install building-level steam submeter.

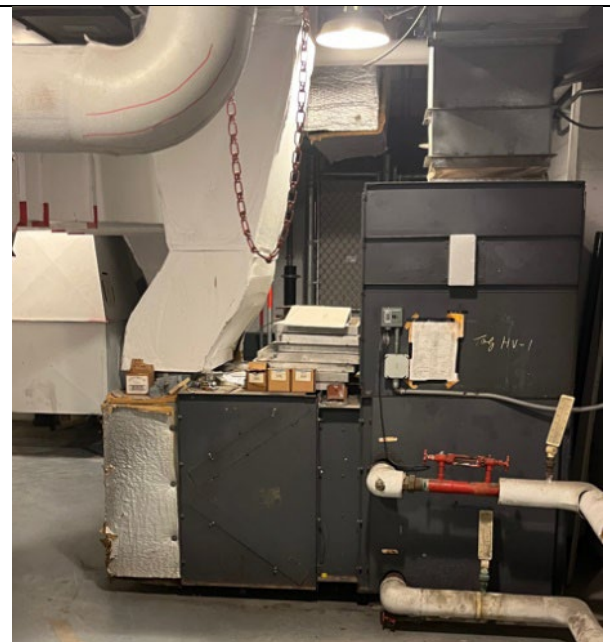
Picture 4: HV-1

- HV-1 and HV-2 were installed in 1969 and require replacement.
