Residence Hall and Academic Facilities Master Plan Update

December 2023

SUNY Oswego

JMZ Architects and Planners, P.C.

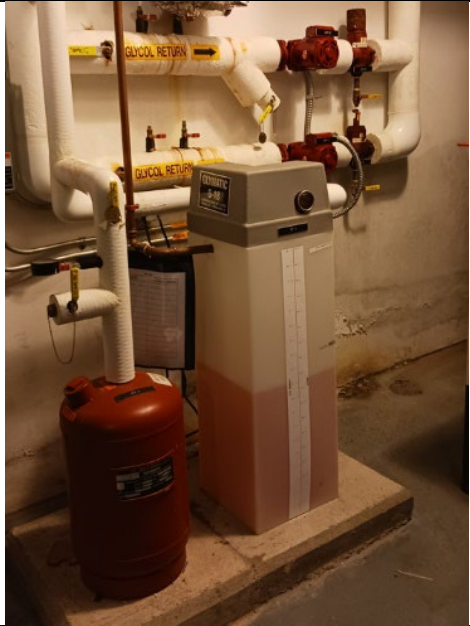
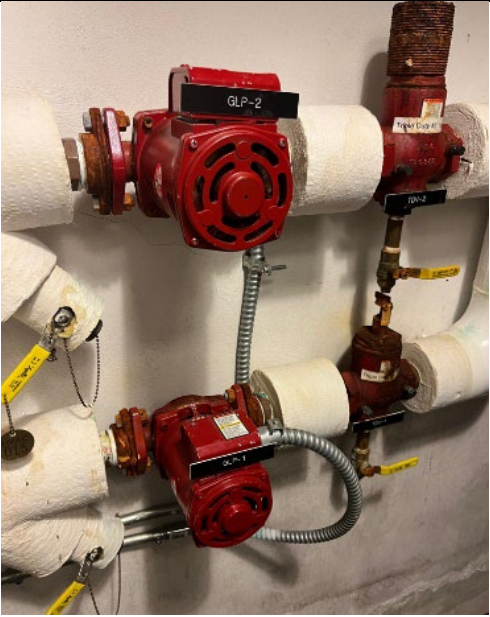
Picture 5: Glycol Feeder Tank	Picture 6: Glycol CHW Inline Pumps

A glycol chilled water system provides CHW to the Oneida IT rooms. Two inline pumps located in the basement mechanical room pump water to the IT closets. The associated fluid cooler, pumps and piping were installed in approximately 2006, are in good condition and are suitable for continued use.

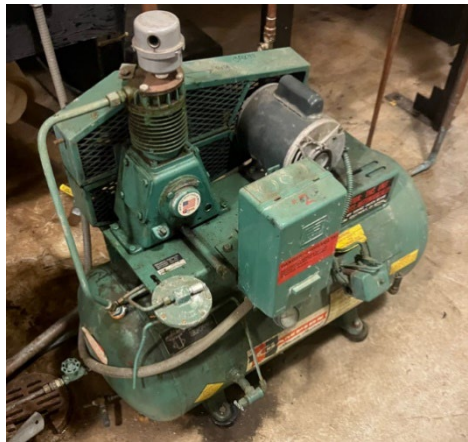
Picture 7: Air Compressor

- Connect building to BAS system.
- Replace pneumatic actuators with electronic controls.
- Retro-commissioning of HVAC systems and Controls
- Setback equipment during academic breaks

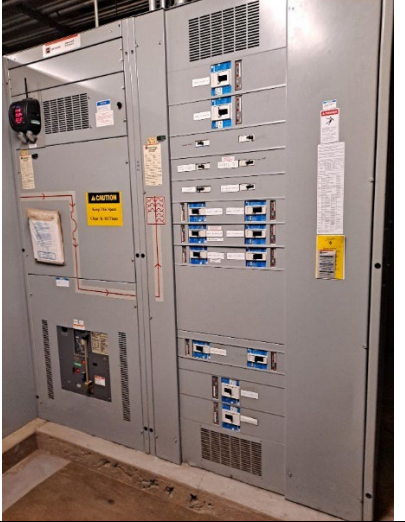
Picture 9: (Emergency Generator):	Picture 10: (Panelboard):	Picture 11: (Switchboard):

Electrically, this building is fed from the 13.2kV campus feeder loops. The 13.2kV feeder feeds a 13.2kV S&C switchgear located inside the electrical room that was installed around 2000 and is still in good condition. There is a 1600A 120/208V 3 phase 4 wire Cutler Hammer switchboard that was also installed around 2000 and located inside the electrical room that is in good condition. The majority of the (120/208V 3 phase 4 wire) electrical panelboards are in good condition except for the few Cutler Hammer panelboards which are old and in poor condition, they should be replaced very soon.

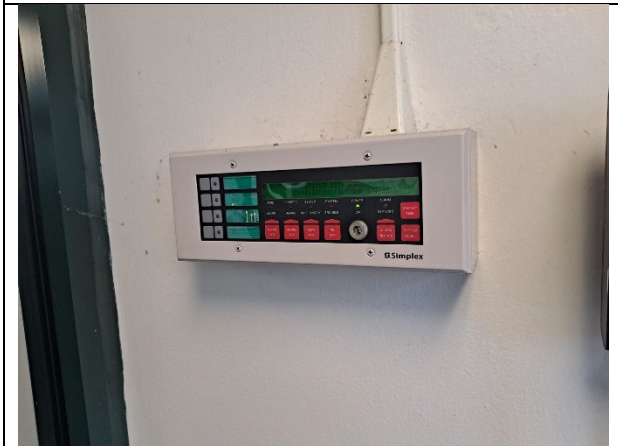
Picture 12: Annunciator Panel

Fire Alarm system for this building was updated back in 2007. The Fire Alarm Control Panel (Simplex 4100-U) contains battery backup and all of the Fire Alarm equipment connected to this system is in good condition.

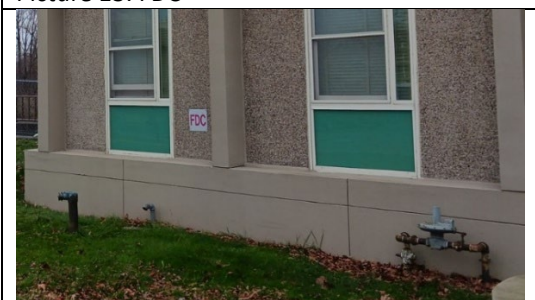
Picture 13: FDC

- Install a Double Check Detector Backflow Prevention Assembly on the incoming 8" fire water service to protect the city water supply from cross contamination caused by backflow from fire water to city supply system. The proposed valve shall comply with ASSE-1048
- Extend sprinkler protection throughout the building.

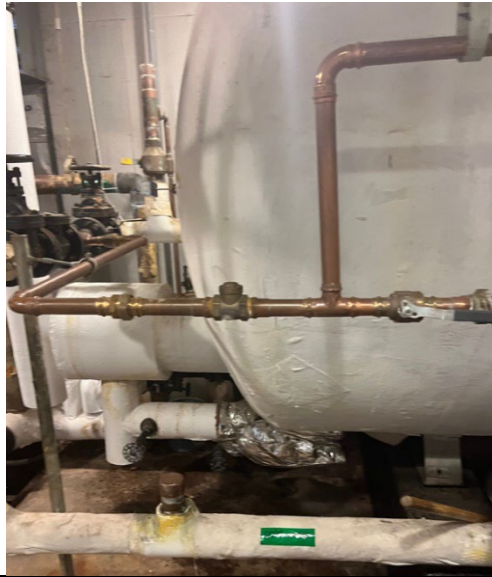
Picture 14: Domestic HW Tank

The domestic hot water is provided by a packaged steam to hot water converter that is located within the hot water storage tank. Two 2 hp base-mounted centrifugal hot water recirculation pumps are used to circulate the hot water throughout the building to prevent cooling off the hot water loop temperature. Two 3-way pneumatically controlled temperature regulating valves are located on the hot water supply line to the building to accurately control and maintain the hot water supply temperature at the desired level. The hot water storage setpoint is at 140°F. The DWH storage tank is original and in fair condition.

- Replace heat exchanger and DHW tank.
- Install Low-Flow or Ultra Low-Flow showerheads.

- Domestic hot water heat exchanger and storage tank (1969)
- Two base mounted centrifugal hot water circulators, 2 hp each
- Two 3-way pneumatic control valves
- Domestic water meter (size could not be verified)
- Electric water heater (size could not be verified)

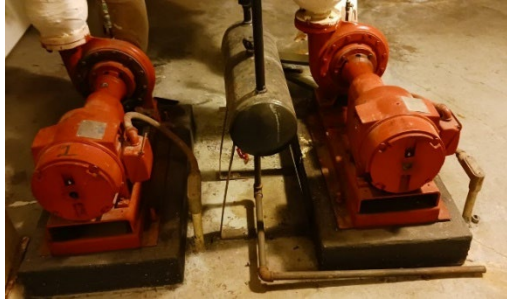
Picture 1: HW Pumps

- Replace major heating equipment, heat exchangers, pumps, condensate receiver.
- Install building-level steam submeter.

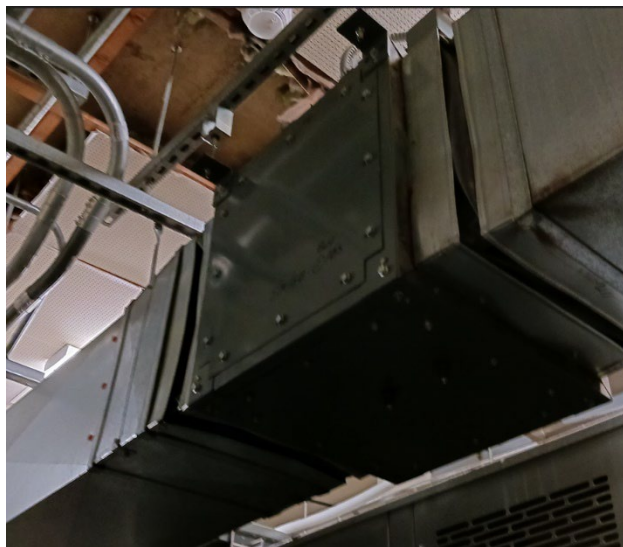
Picture 3: HV Unit

- Replace HV units and convectors.

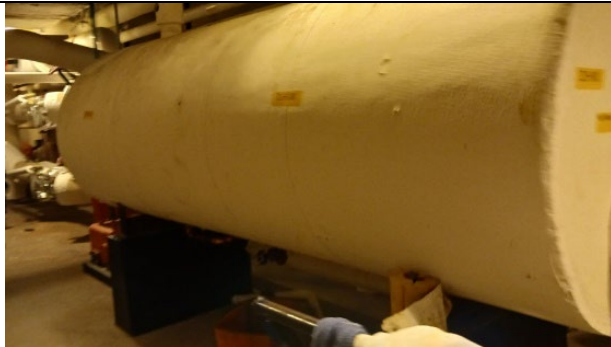
Picture 11: Domestic HW Tank

- Replace DHW tank.
- Install Low-Flow or Ultra Low-Flow showerheads.

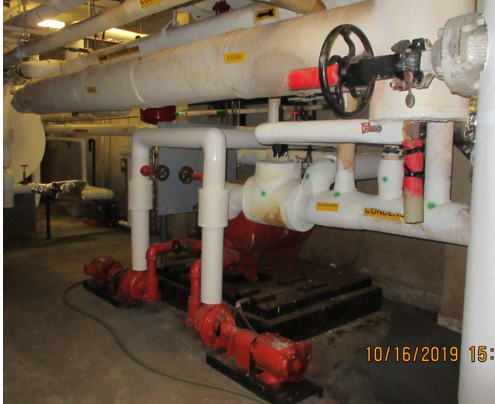
Picture 1: Condensate Pumps	Picture 2: PRV Station

A photograph of a mechanical room showing two red condensate pumps mounted on a black base. Large white pipes with yellow labels are visible. A timestamp '10/16/2019 15:00' is in the bottom right corner.

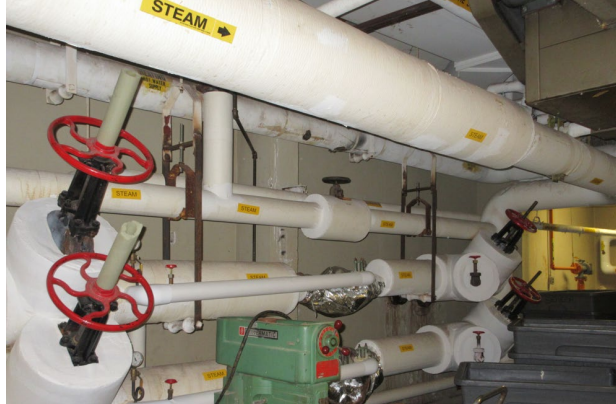
A photograph of a PRV station featuring a large horizontal white pipe with a yellow 'STEAM' label and an arrow. Below it are several red-handled valves and a green control box.

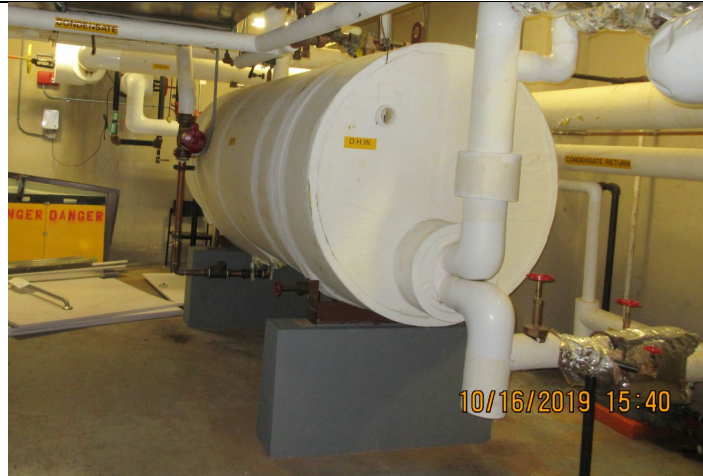
Picture 7: Domestic HW Tank

- Replace heat exchanger and DHW tank.
- Replace all plumbing fixtures and faucets throughout with energy saving products.
- Install Low-Flow or Ultra Low-Flow showerheads.

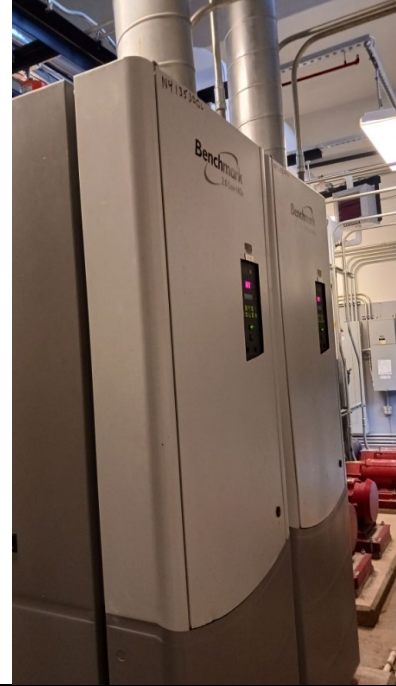
Picture 1: Heating Boilers

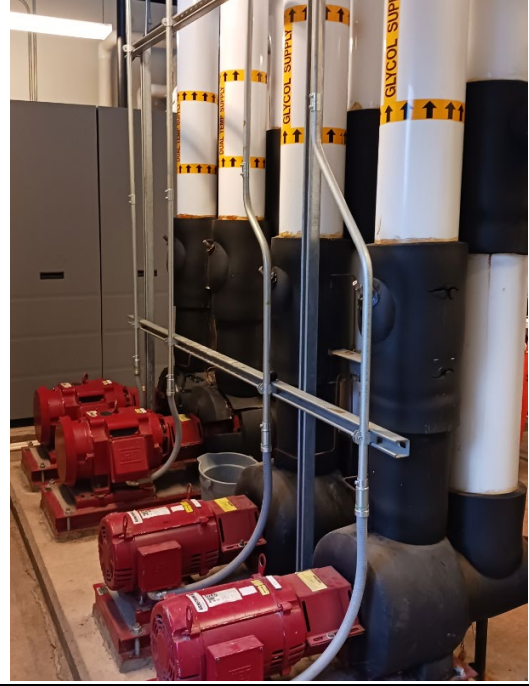
Picture 2: Heating and Cooling Pumps

The chilled water glycol loop is comprised of 4” diameter supply and return chilled water piping. The circulation between the outdoor chiller and the indoor plate & frame heat exchanger is achieved by a set of two base-mounted end-suction centrifugal pumps, at each of the two heating plants, each rated at 210 gpm at 95 ft head, and equipped with a 7.5 hp motors each (original design drawings called for 15 hp pumps). These pumps are constant drive.

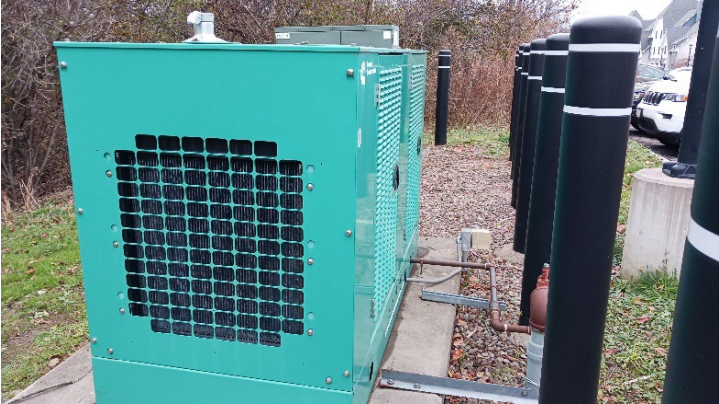
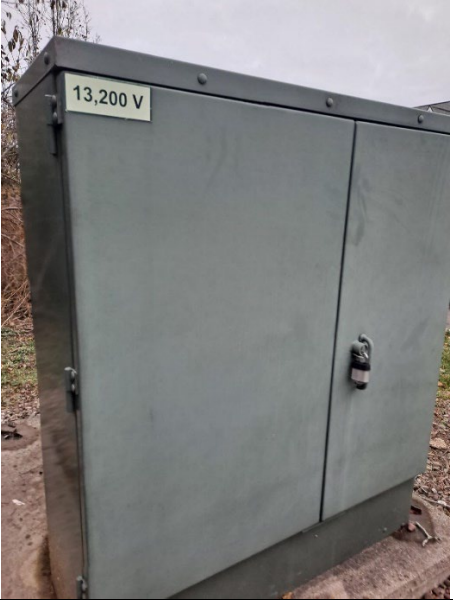
Picture 3: (Emergency Generator):	Picture 4: (Incoming Service):

Electrically, this building is fed from the 13.2kV campus feeder loops. The 13.2kV feeder feeds a 13.2kV S&C switchgear located inside the electrical room that was installed around 2001 and is still in good condition. There is a 1200A 120/208V 3 phase 4 wire switchboard installed around 2010 which is in good condition and located inside the electrical room. The majority of the (120/208V 3 phase 4 wire) electrical panelboards were recently installed around 2010 and is in good condition.

Emergency Power is supplied by a 75kVA 120/208V 3 phase Cummins emergency generator installed in 2010 which is located outside and is in very good condition.

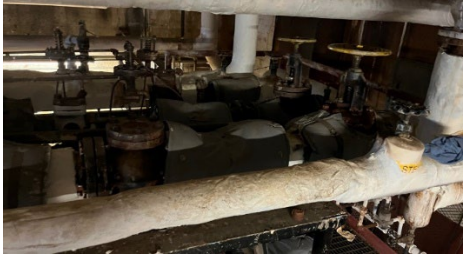
Picture 1: Pressure Reducing Valve Station

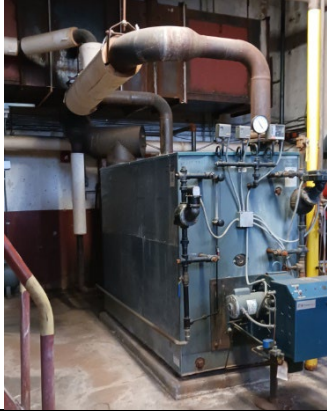
Picture 2: Steam Boiler

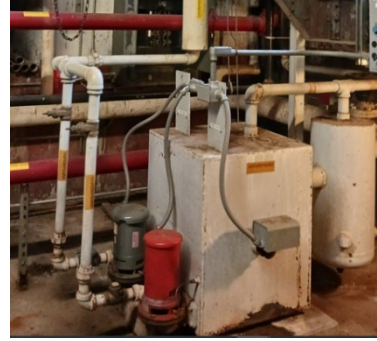
Picture 3: Condensate Receiver

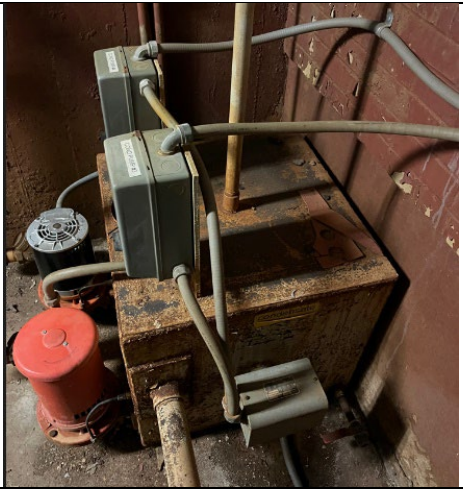
Picture 4: Condensate Receiver

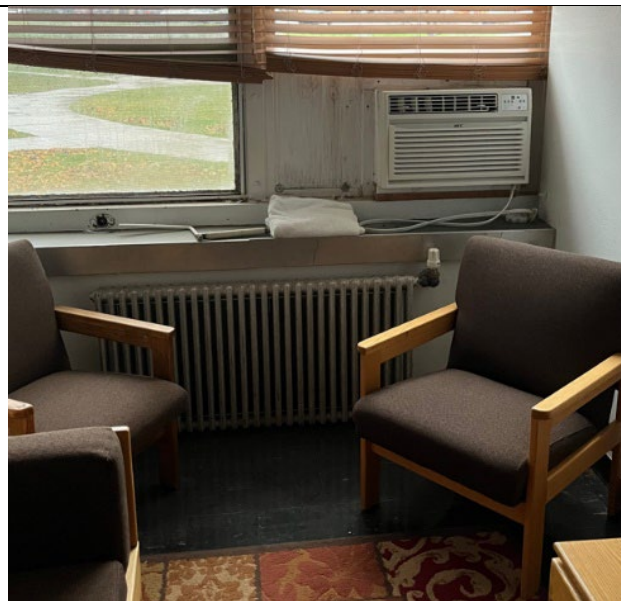
Picture 5: Radiator and Window AC unit

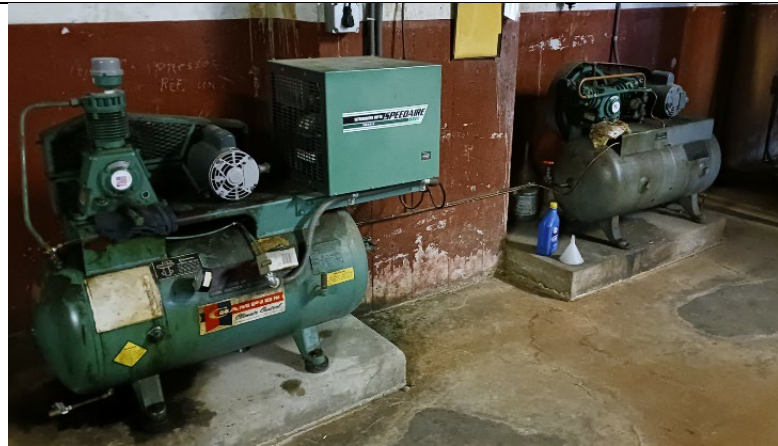
Picture 6: Air Compressors

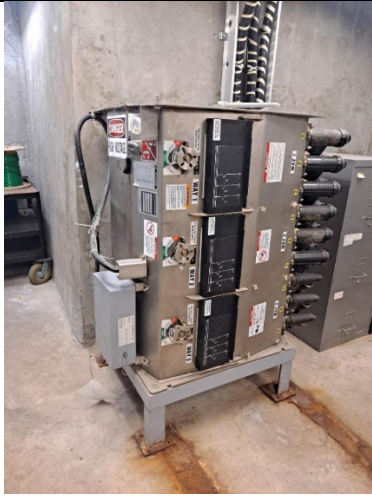
Picture 7: (Switchgear):

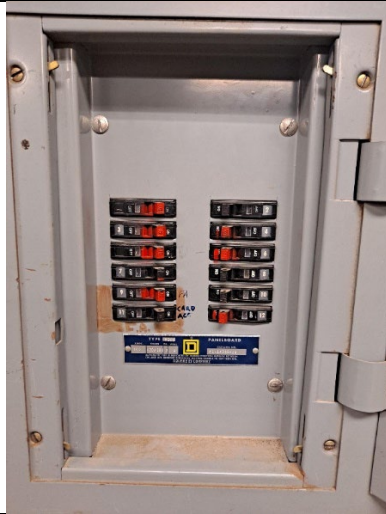
Picture 8: (Panelboard):

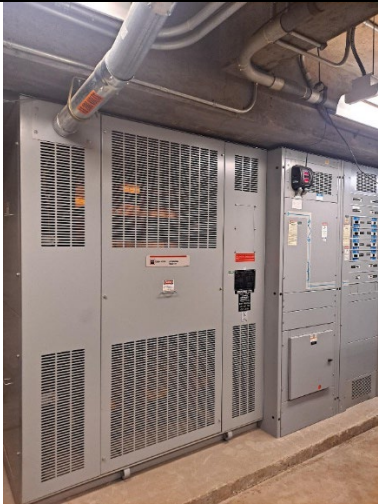
Picture 10: (Switchboard):

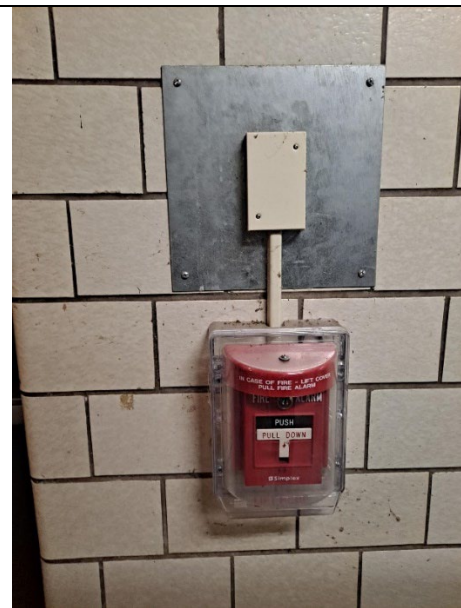
Picture 11: Pull Station

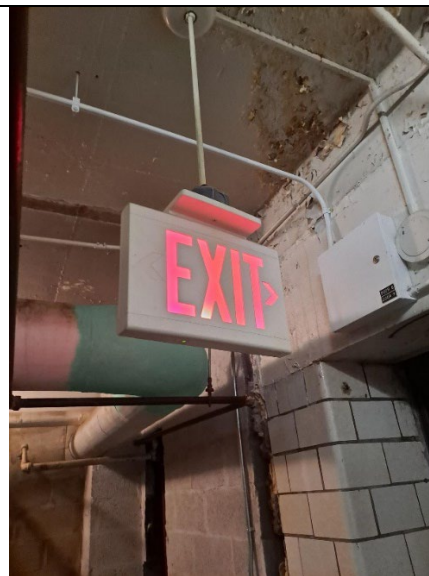
Picture 12: Exit Sign

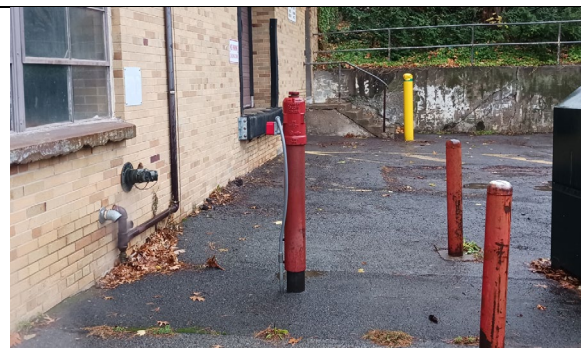
Picture 14: PIV, bollards, and FDC outside the boiler plant:

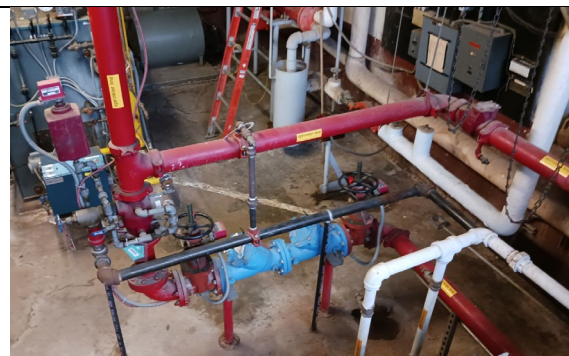
Picture 15: Fire sprinkler BFP and Alarm Check Valve

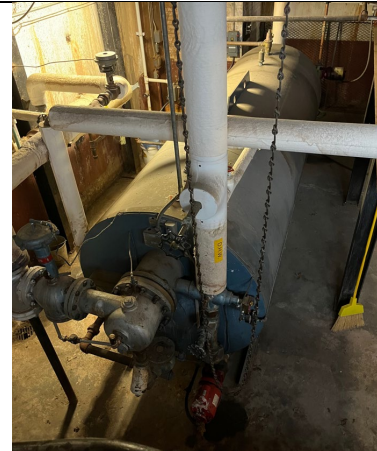
Picture 16: Domestic Hot Water Storage Tank and Steam Heat Exchanger:

- Replace DHW tank and heat exchanger.
- Install Low-Flow or Ultra Low-Flow shower heads.

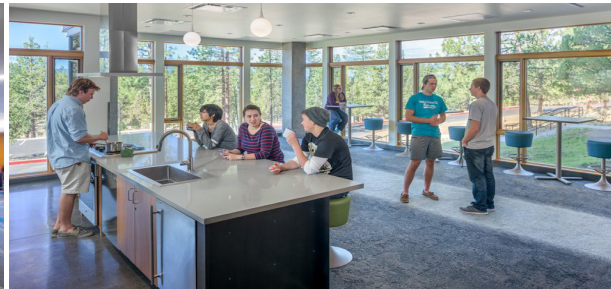
Create community kitchen

Modernize and enclose the existing kitchen to improve exhaust and create a community social space.

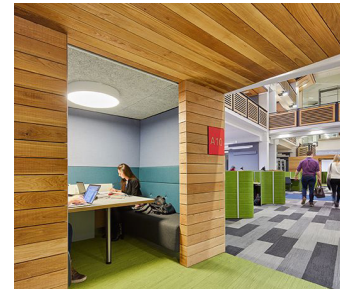
Repurpose floor kitchenettes

Insert a study banquette into the former kitchenette.

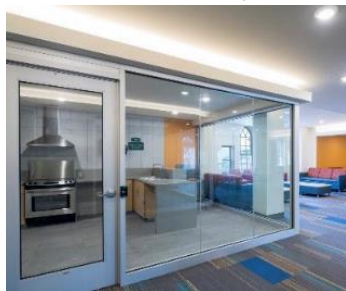
Create community kitchen

Modernize and enclose the existing kitchen to improve exhaust and create a community social space.

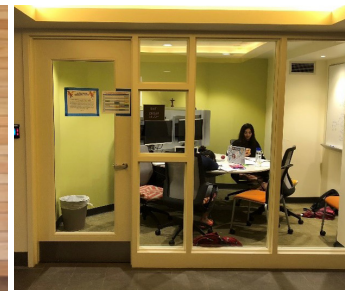
Or, enclose the former kitchenette behind storefront glass and provide study furniture and technology.

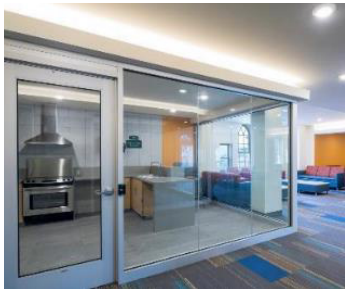
Create community kitchen

Modernize and enclose the existing kitchen to improve exhaust and create a community social space.

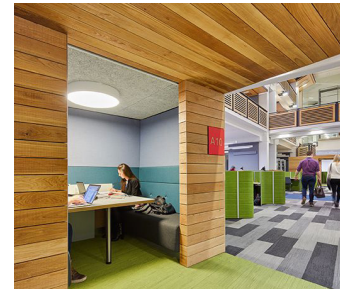
Repurpose floor kitchenettes

Insert a study banquette into the former kitchenette.

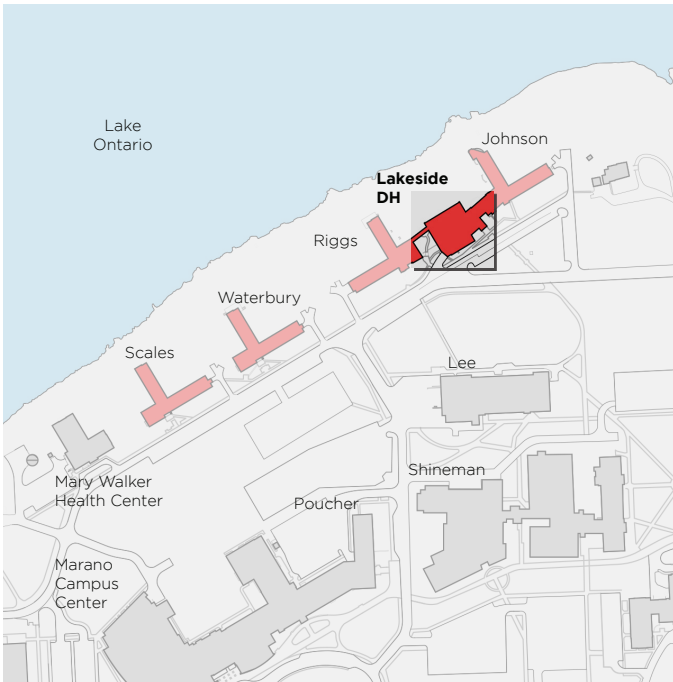
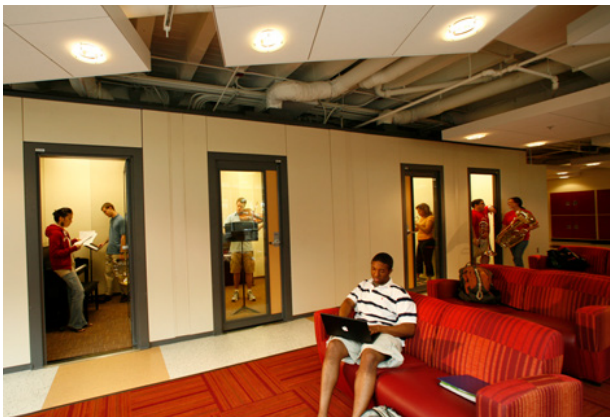
Provide two prefabricated music practice rooms at kitchenette area.

- Remove Kitchenette 016 and create two music practice rooms. Rework door to Janitor Closet 018.
- Renovate Meeting Rooms 005 and 006 to create a multipurpose space for informal music performances and residence hall events. Provide flexible, movable furnishings so the room can function as a training room or meeting room for College use
- Provide access control at Entry 007 to allow re-entry from the porch and lawn.
- Provide ramp and accessible paths to the nearby recreation and leisure areas.

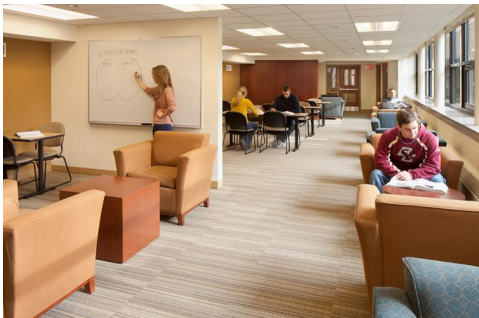
Provide a variety of flexible furnishings in Meeting Rooms 005 and 006.

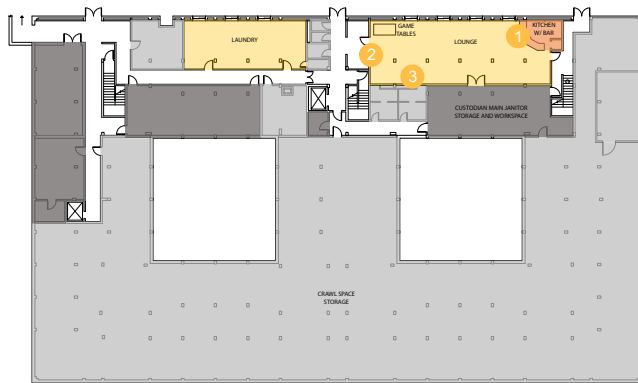
BASEMENT
NTS

Cayuga Hall Existing Floor Plans

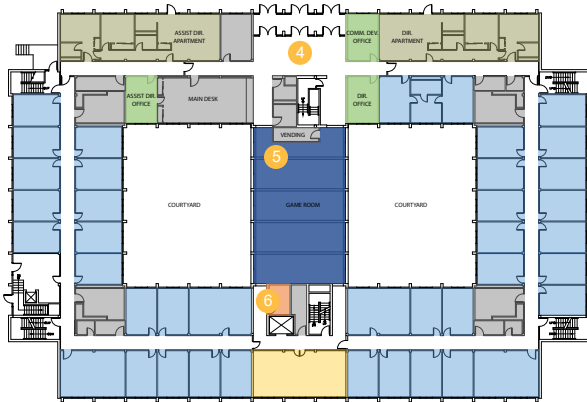
FIRST FLOOR
NTS

- STUDENT LIVING UNIT
- LOUNGE
- KITCHEN
- CLASSROOM / SEMINAR
- ADMIN OFFICE
- STAFF RESIDENCE
- GUEST RESIDENCE
- RECREATION ROOM
- STUDY
- SUPPORT SPACES
- MEP SYSTEMS
- FOOD SERVICE

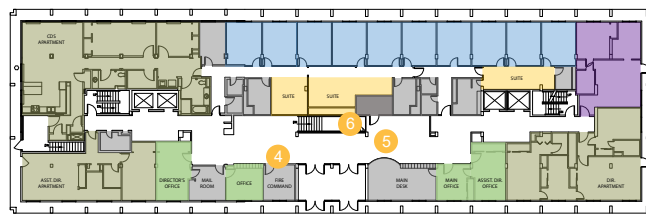
FIRST FLOOR
NTS

- STUDENT LIVING UNIT
- LOUNGE
- KITCHEN
- CLASSROOM / SEMINAR
- ADMIN OFFICE
- STAFF RESIDENCE
- GUEST RESIDENCE
- RECREATION ROOM
- STUDY
- SUPPORT SPACES
- MEP SYSTEMS
- FOOD SERVICE

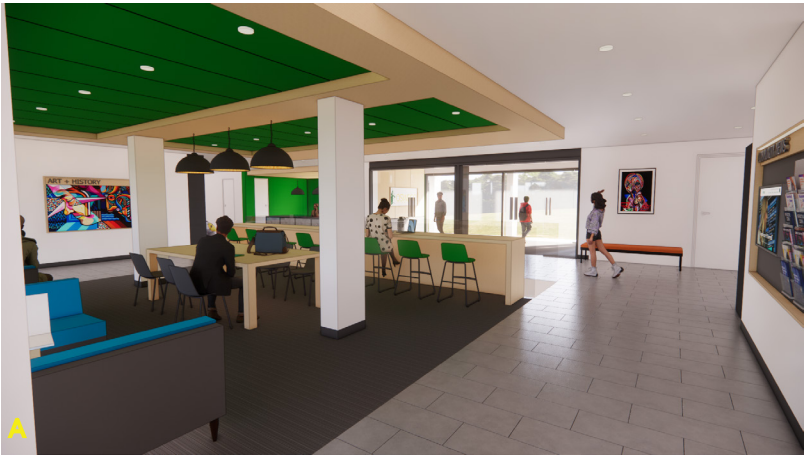
First Floor view looking east toward main entrance.
Two-story area would be to the viewer's left

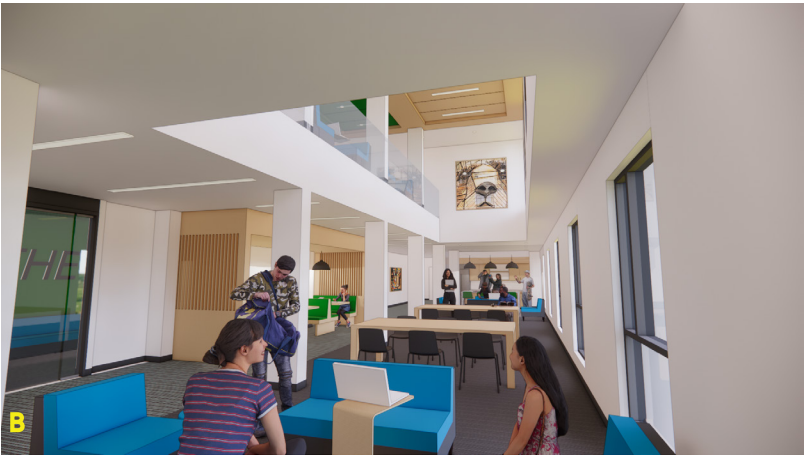
View from basement lounge up toward entrance
lobby and upper lounge.

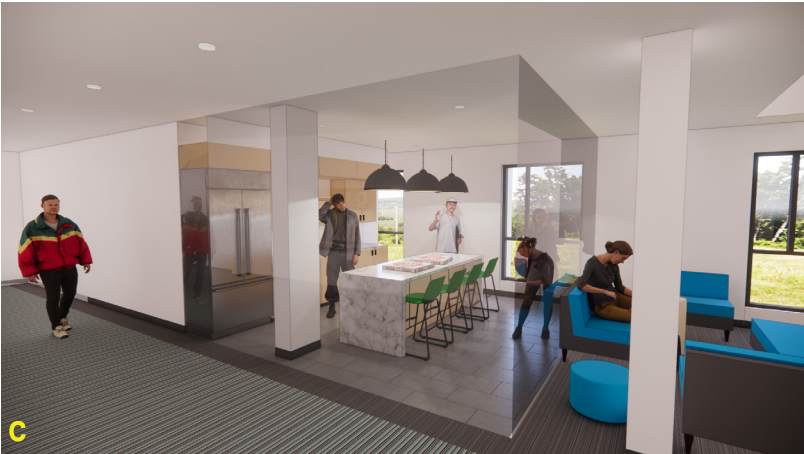
A new community kitchen could be created on the
north side of LOUBC.

Student Experience		
First Steps	Moderate Improvements	Major Improvements
	Upgrade finishes and fixtures in main lounge LOUBC. \$280,000	Reconfigure and renovate LOUBC. Create a community kitchen on the north end of LOUBC. (Existing kitchen would be available for other uses.) Create some enclosed/partitioned spaces for study, meetings, and projects. \$981,000
Remove stored furnishings from HALBC. Remove curtains from study rooms near basement corridor HALBC. No cost	Replace finishes and fixtures HALBC and in study rooms near basement corridor HALBC. \$147,000	Reconfigure and renovate HALBC and study rooms near basement corridor HALBC. \$283,000
Access control to/from the outdoors at basement level (one door) \$8,500	Create a 2,000 sf brick patio outside LOUBC to engage the green quad between West Campus residence halls. Include low walls for seating. allow \$150,000 Add a covered area, allow \$77,600	Widen residence room doors for accessibility and provide ADA clear floor area at all student rooms. \$2,700,000 (one-phase) \$450,000 per 50 doors (if phased)

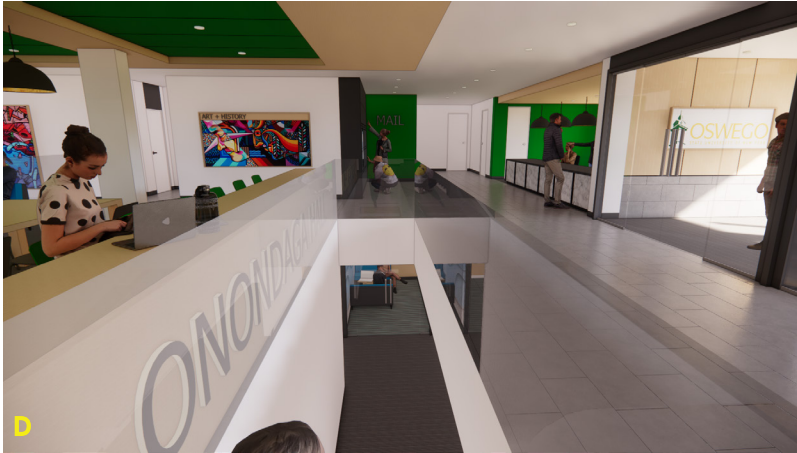
View looking south, with the first floor main entrance to the right and stairs to the basement straight ahead. Upper lounge is to the left.

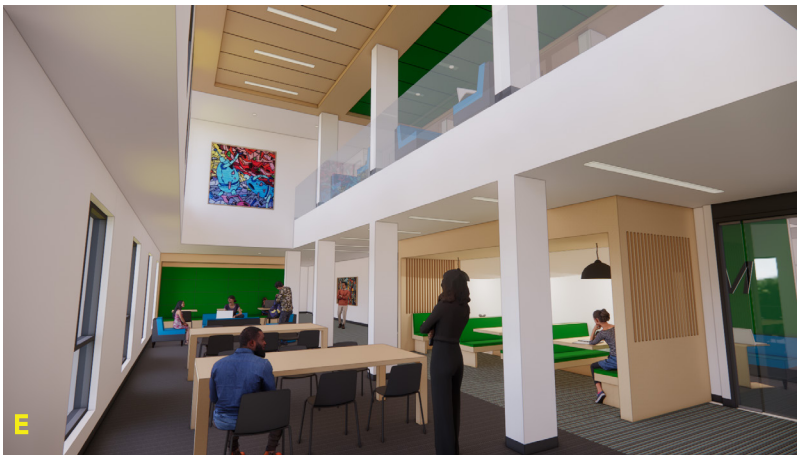
View from basement lounge up toward upper lounge. Viewer is standing just outside the community kitchen.

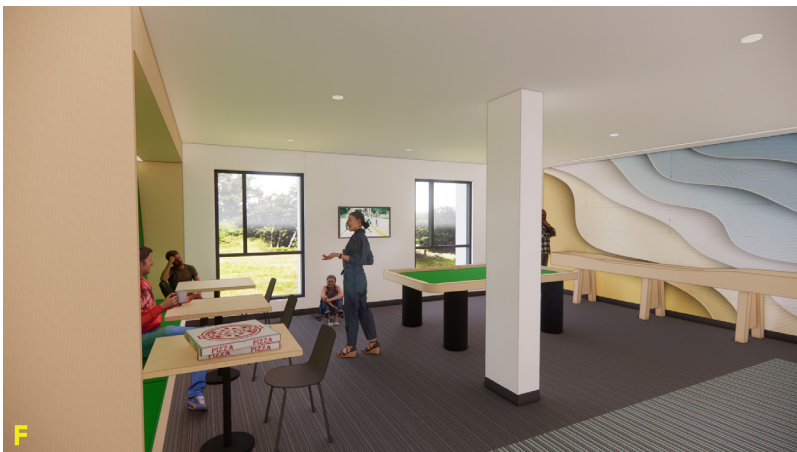
A games zone can be created by adding partitions within LOUBC.

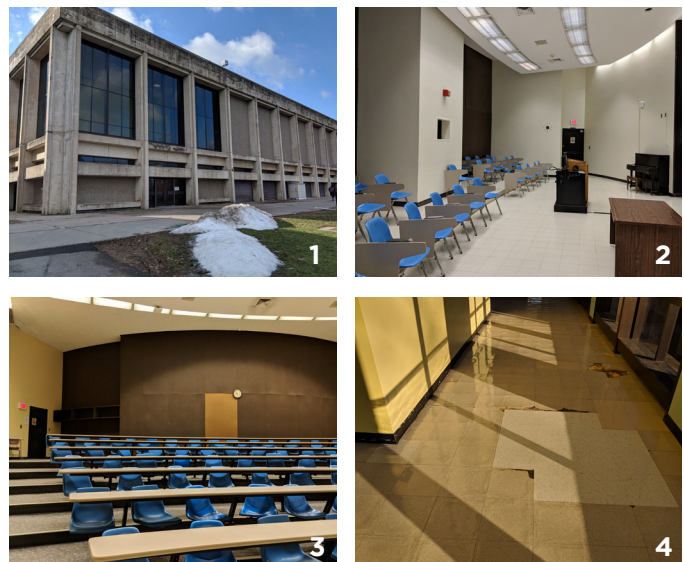
1. The building exterior requires cleaning, repairs, and upgrades. The building entrances are not emphasized in the design.
- 2, 3. Classrooms and lecture halls do not offer an engaging learning environment. Finishes, furnishings, and instructional technology require updates.
4. There are multiple locations where original finishes have failed and can no longer be maintained.

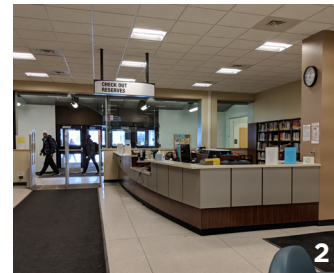
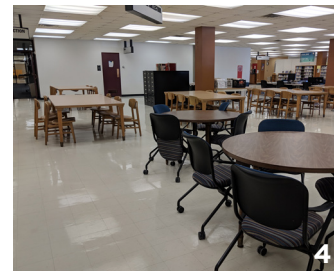
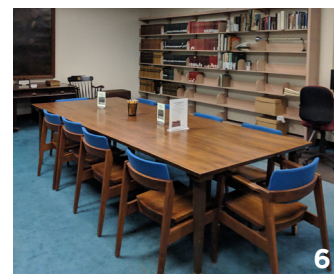
1. The building exterior requires cleaning, repairs, and upgrades. The building entrances are not emphasized in the design.
2. There is little sense of arrival once library users enter the building.
- 3, 4. Floor finishes, ceilings, and lighting have little variation. There are few indications of different zones for different activities. Many parts of the building have no views to the exterior.
- 5, 6. New, movable furnishings have been added to create flexible study areas. In some locations, aging furniture is still in use.

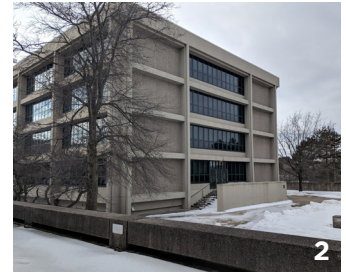
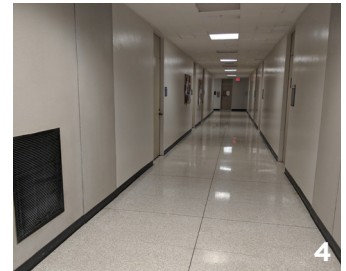
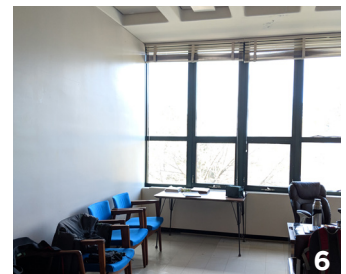
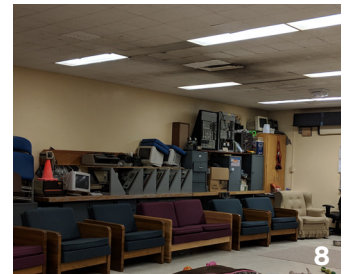
1. Mahar Hall's concrete and glass exterior is in good condition.
2. North and south exits lead to plazas that do not connect to the main paths of campus circulation. This funnels all day-to-day use through one entrance, causing congestion.
3. There is little sense of welcoming or arrival at the building entrance.
4. Corridors have no variation in finishes and no views to the exterior, which can be disorienting. There are no places to sit and wait for a class in the corridors.
5. Many classrooms have tablet armchairs, which are minimally functional for active learning.
6. Glare control is needed at perimeter rooms.
7. The basement houses the Archaeology Dig Lab.
8. Basement spaces, like the former Canine Lab, show evidence of dirty ductwork and dampness.

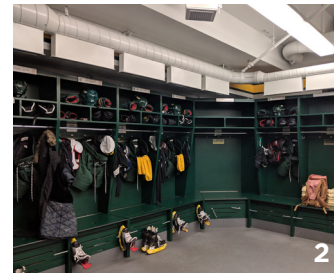
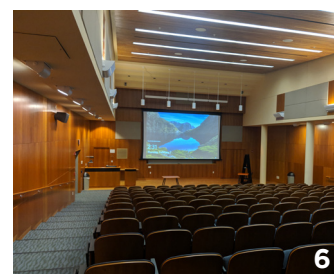
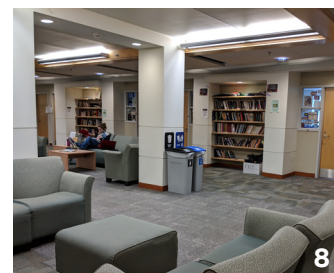
1. A distinguishing feature of Marano Campus Center and Poucher Hall is the enclosed walkway that connects them, providing shelter from the harsh Oswego winter weather.

2. Marano's lower level serves Athletics and is in good condition.

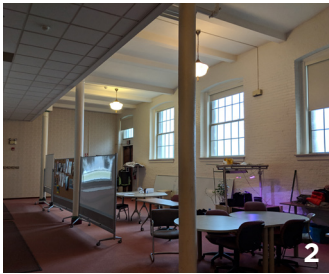
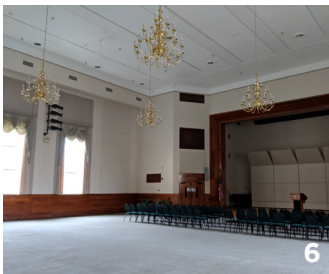
1. Sheldon Hall is a distinctive landmark that has been well maintained.
2. The lower level has underutilized space that could be repurposed.
3. Formal finishes make a good impression on visitors to the Admissions Office and Foundation Office.
4. Third floor classrooms are used as swing space.
5. Bedrooms are now used for offices and the attached bathrooms are used for storage.
6. A ballroom on the second floor is used for campus and community events.
