RE: Shoreline Assessment (draft) FILE: 8705/60224

O'Brien & Gere is pleased to present this report for natural resource assessment services associated with evaluation of the Lake Ontario shoreline at the State University of New York (SUNY) Oswego Campus. The assessment was performed in accordance with our October 31, 2014 proposal and subsequent discussions regarding potential development for the lake-front property owned by SUNY Oswego.

SHORELINE ASSESSMENT

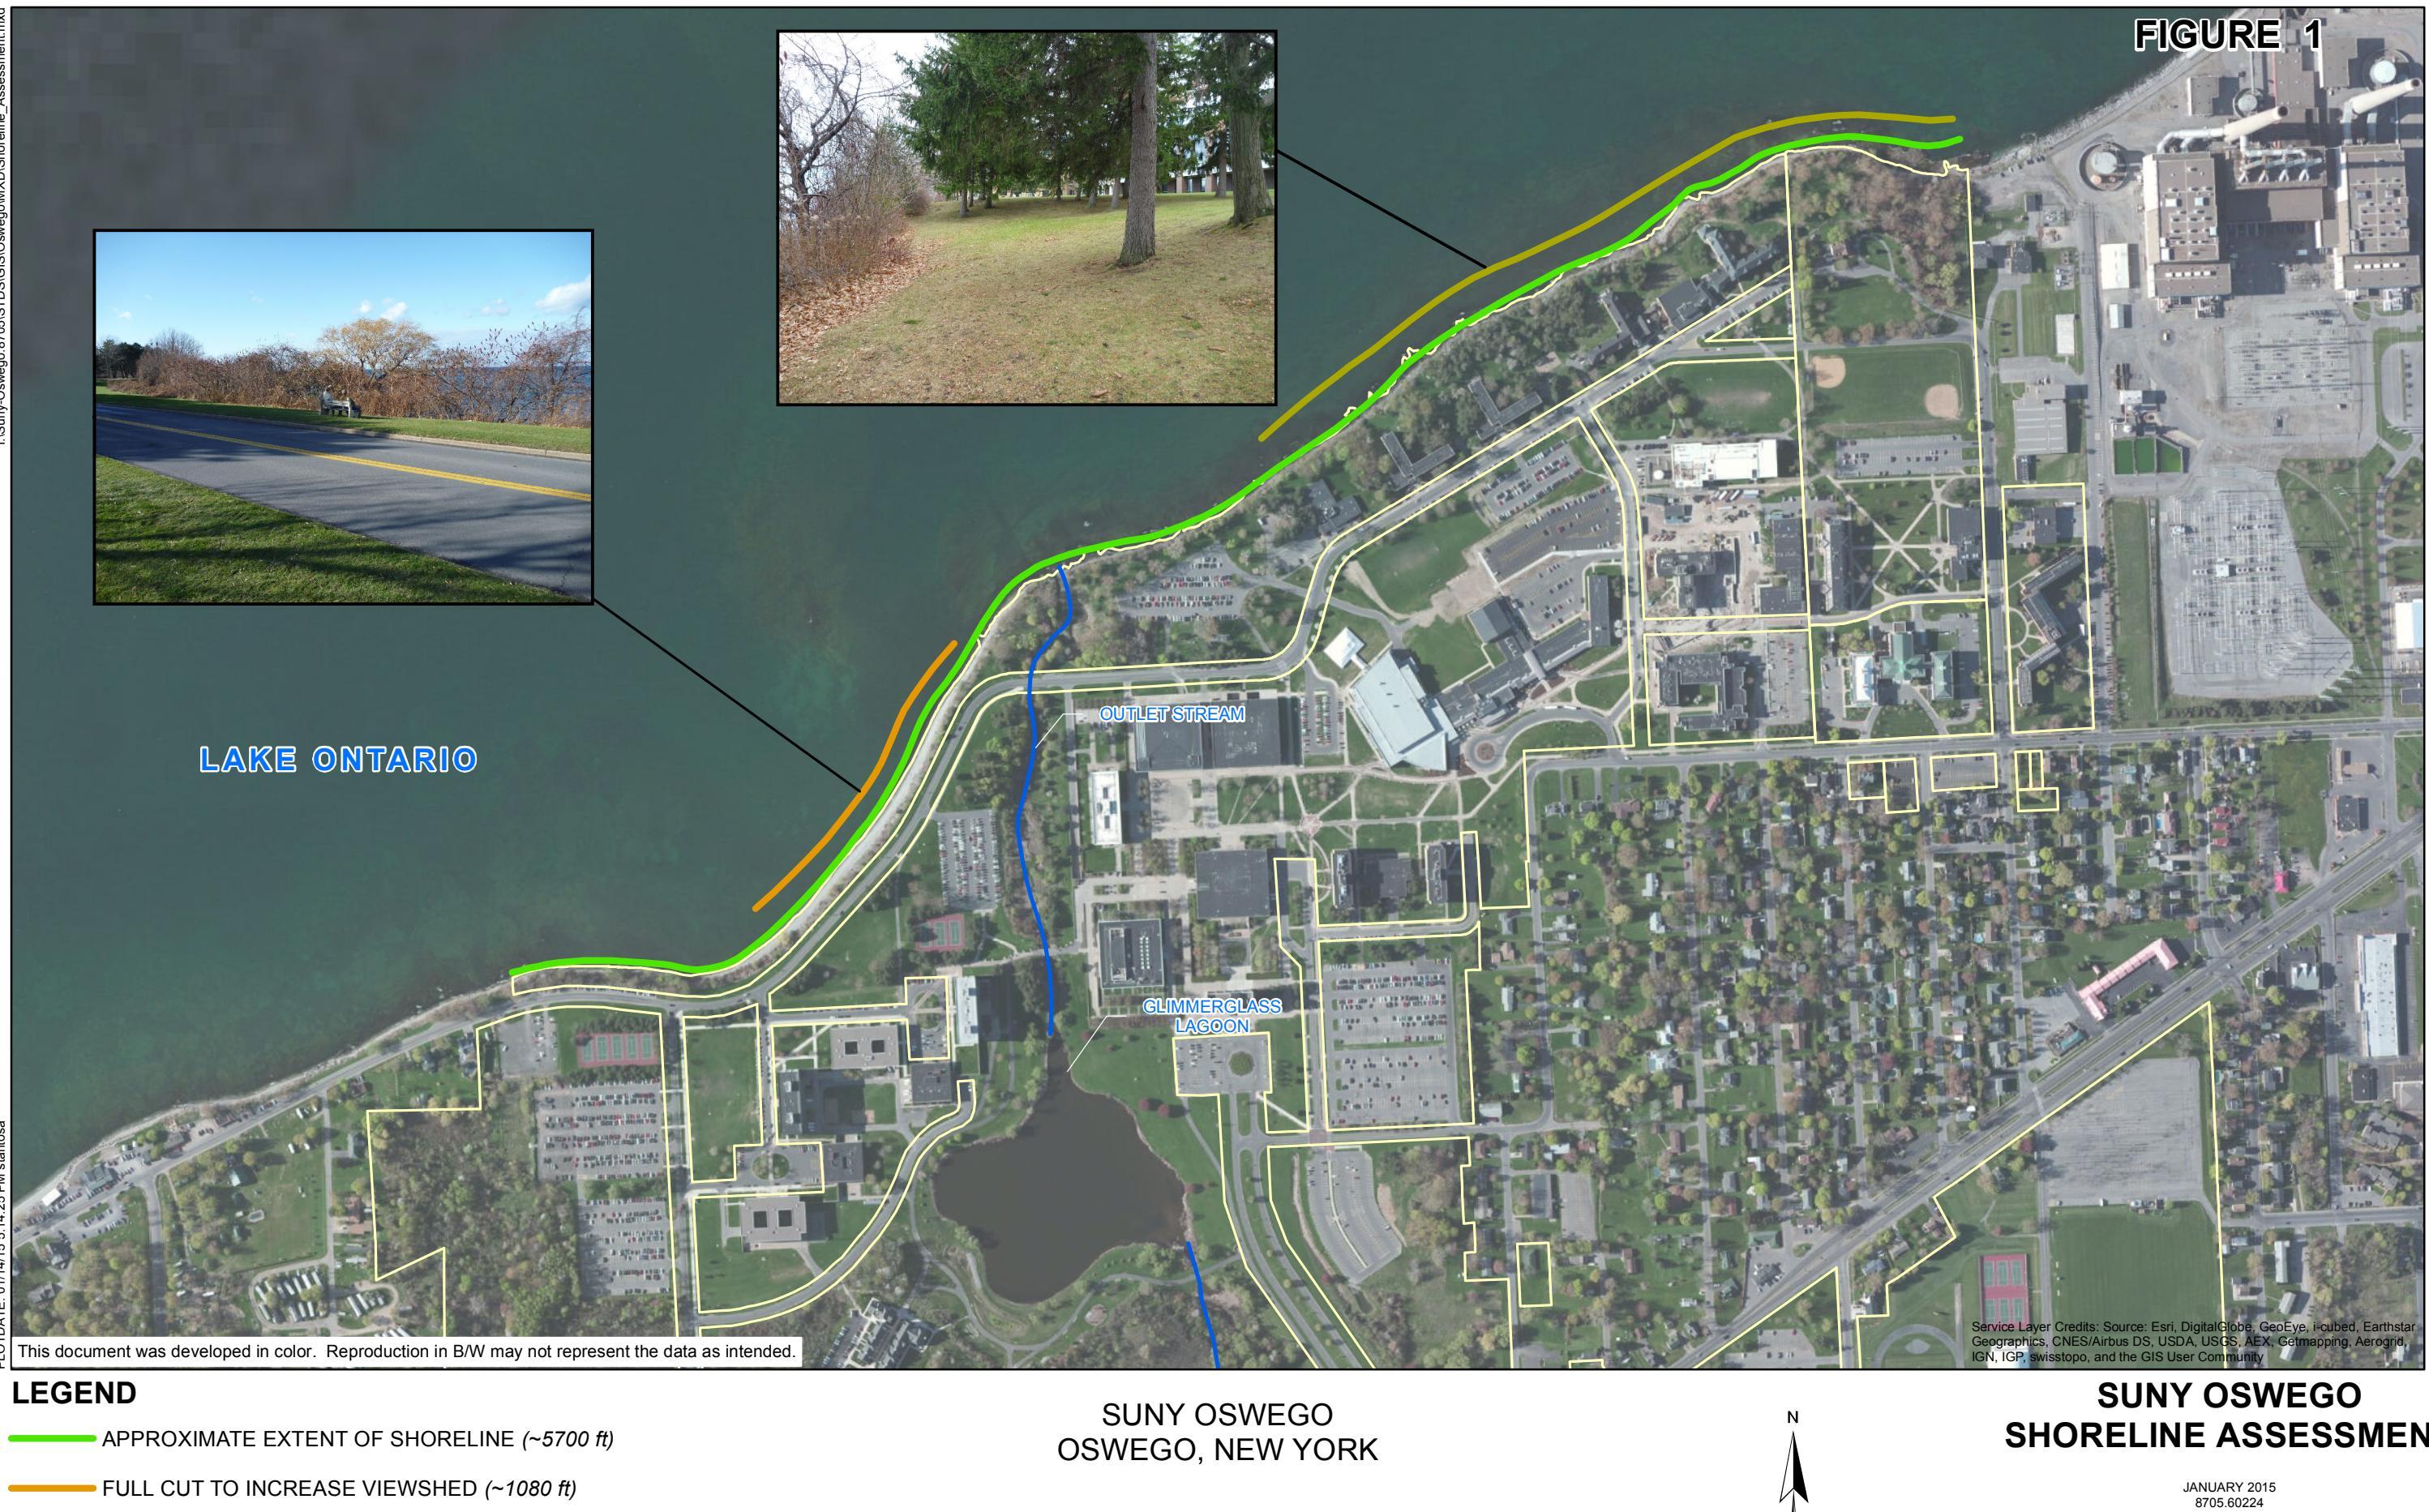
SELECT CUTTING FOR VIEWSHED QUALITY (~2215)	ft
---	----

SUNY OSWEGO PROPERTY

Two viewshed improvement areas have been identified along the eastern and western extremes of the shoreline adjacent to campus. Figure 1 presents the approximate limits of the viewshed improvement areas. The eastern location begins at the eastern end of the property and extends westward for approximately 2,200 feet. Vegetative clearing in this area would consist of the removal of select large trees located on the top and slope of the bank. Taller shrubs that inhibit clear lake views will also be removed.

- Cut standing woody plants at 4-inches above ground surface in areas specified on Figure 1. Where practicable, (such as the western improvement area) utilize an excavator mounted brush hog or 'boom mower' (see following link: http://www.alamo-industrial.com/Products/ProductView.asp?ProductID=70 to extend as far down bank as practicable. Material that cannot be cut in this way (likely along much of the eastern improvement area) shall be manually cut with chain saws and hand tools. No grubbing of stumps or operation of heavy equipment shall occur on the banks to minimize disruption of soil profile and resultant erosion. This approach will maintain the viability of the root systems and allow for resprouting of vegetation. While this may necessitate future vegetative clearing, it maintains the stability of the shoreline banks, thereby avoiding costly engineered erosion control systems (*e.g.*, large rip rapped crib walls) that may be needed if wholesale vegetative clearing and grubbing is pursued. The preferred season for this activity is fall (in part, to minimize impacts to flowering weeds).

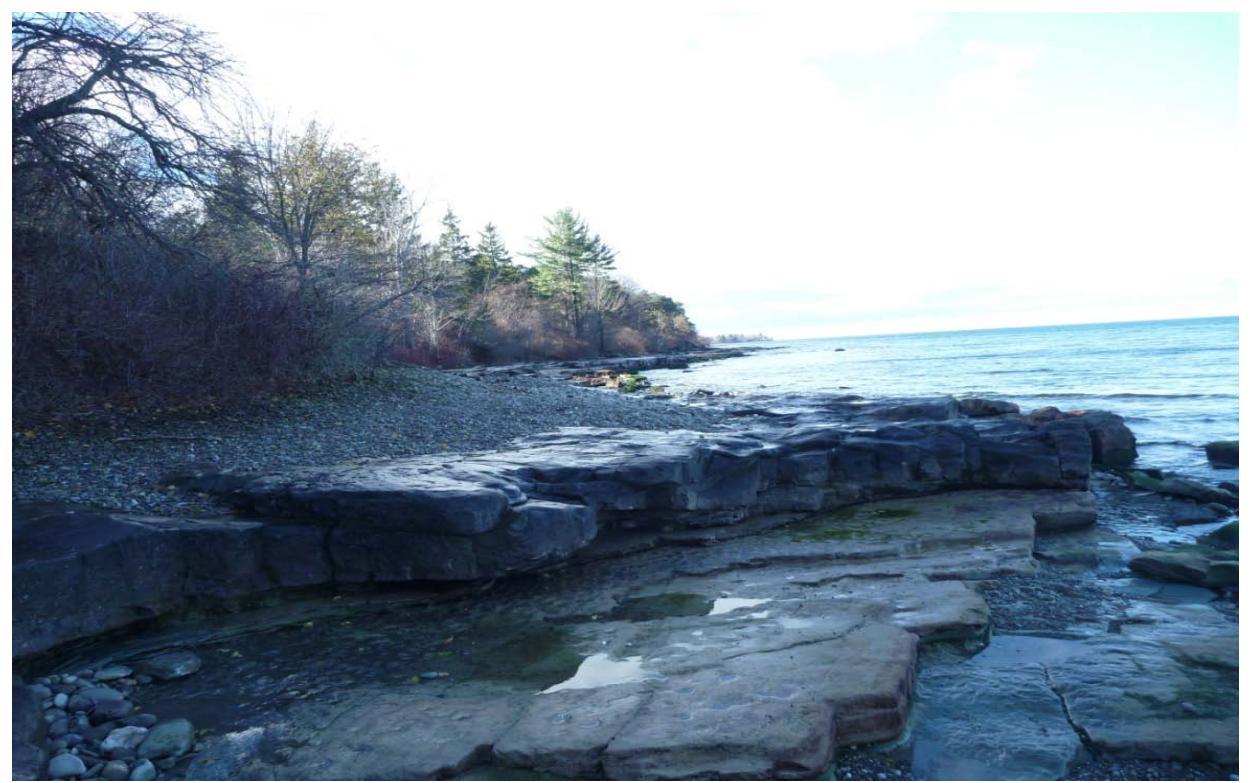
Photo 1. Looking west along shoreline (rocky shore-typical). November 24, 2014

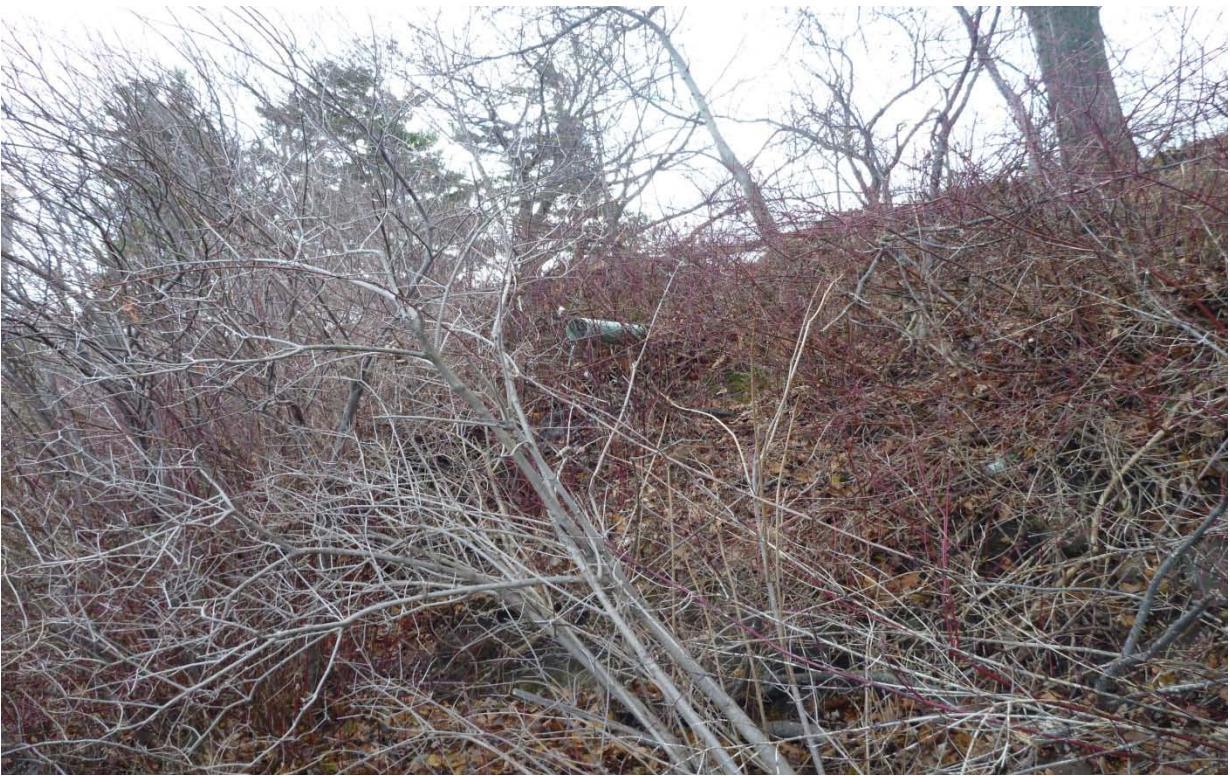
Photo 2. Looking southeast from shoreline at shrub vegetation along bank (typical). Eastern outfall pipe in center of photo. November 24, 2014

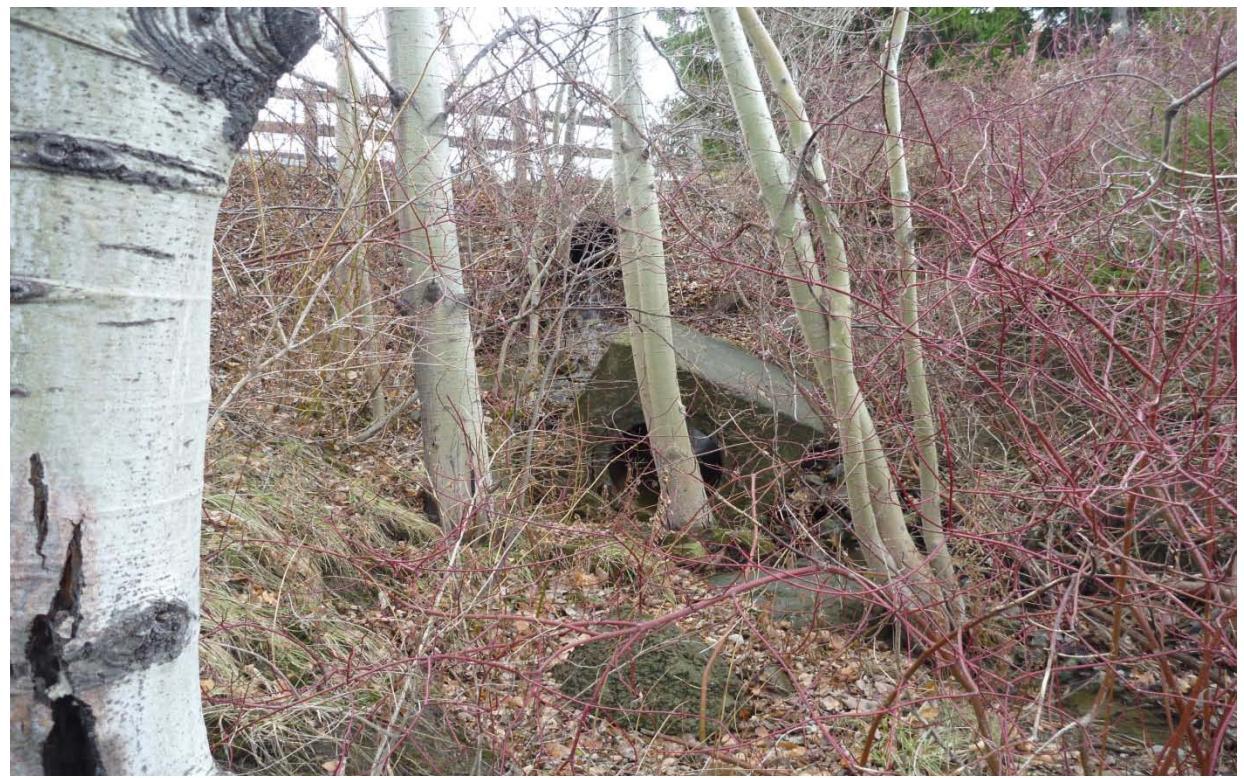
Photo 3. Looking south from shoreline at damaged central-eastern outfall. November 24, 2014

It is assumed that the existing stormwater outfalls are sized appropriately for the design flows that they convey. Therefore, the University should replace failing outfalls with new reinforced facilities while maintaining existing invert elevations.

- Replacement of outfalls and placement of riprap outlet protection should occur during dry months when flows are minimal. The upstream inlet should be blocked and bypass pumps and hoses placed to convey flow around the rock area until facility installation is completed.
- The area below the outfall should be stabilized with placement of erosion control fabric and appropriately sized riprap
- If desired, live stakes could be installed in gaps within the riprap to further stabilize the outlet and increase the ecological function of the facility by providing shade against thermal impacts and shrub habitat
- Recommended timeframe = July through August

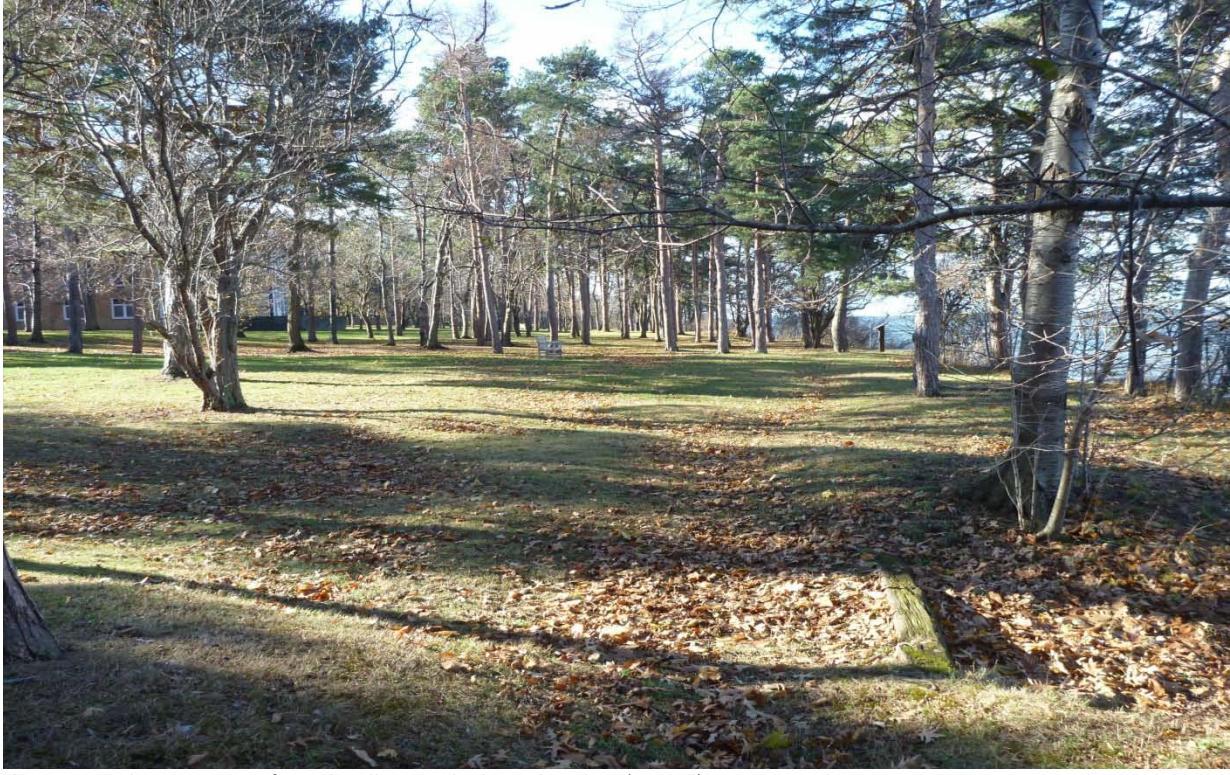
Photo 4. Looking west at informal walking path along shoreline (typical). November 24, 2014

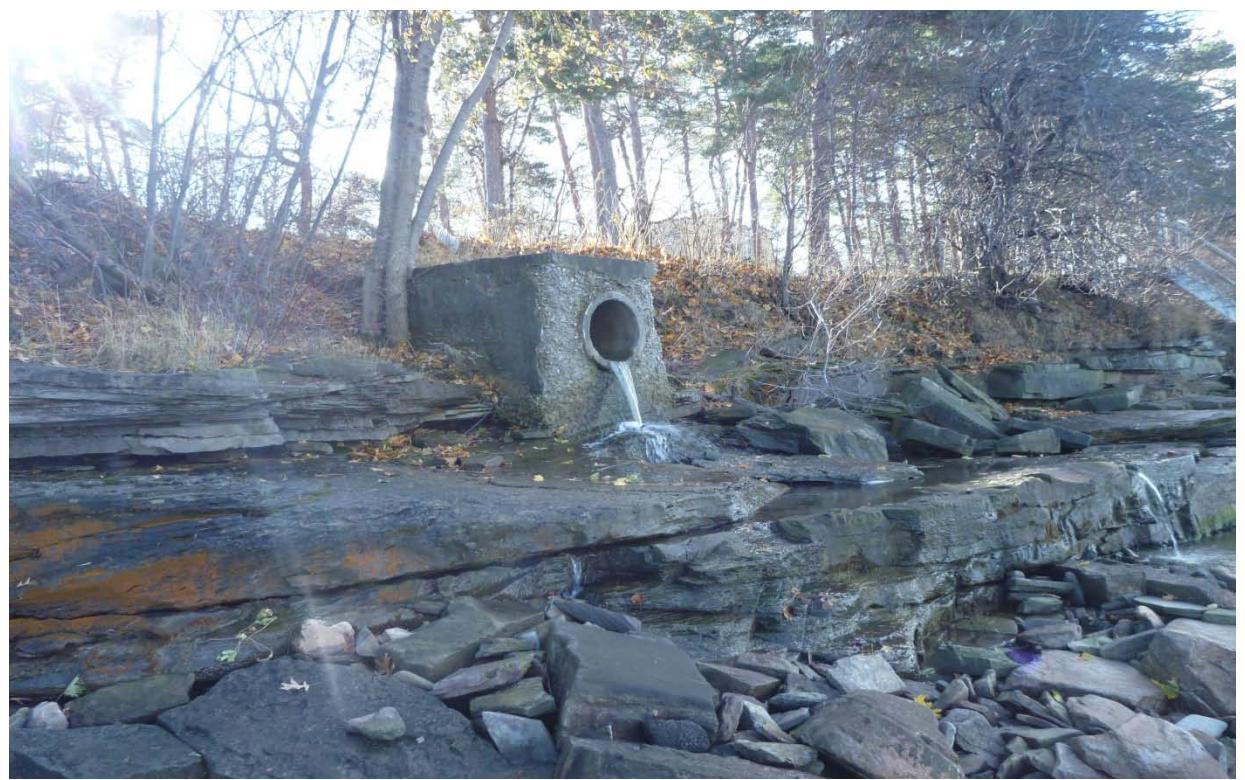
Photo 5. Looking southwest from shoreline at central-western outfall. November 24, 2014

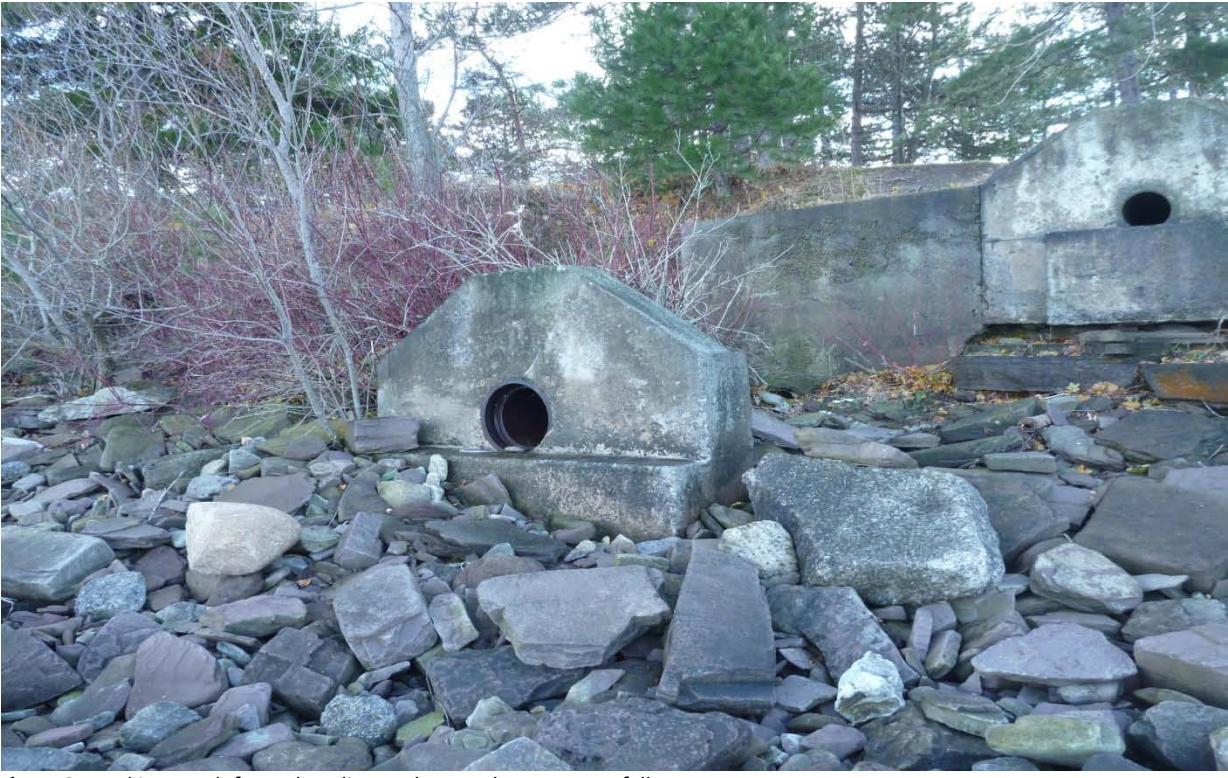
Photo 6. Looking south from shoreline at damaged western outfall. November 24, 2014

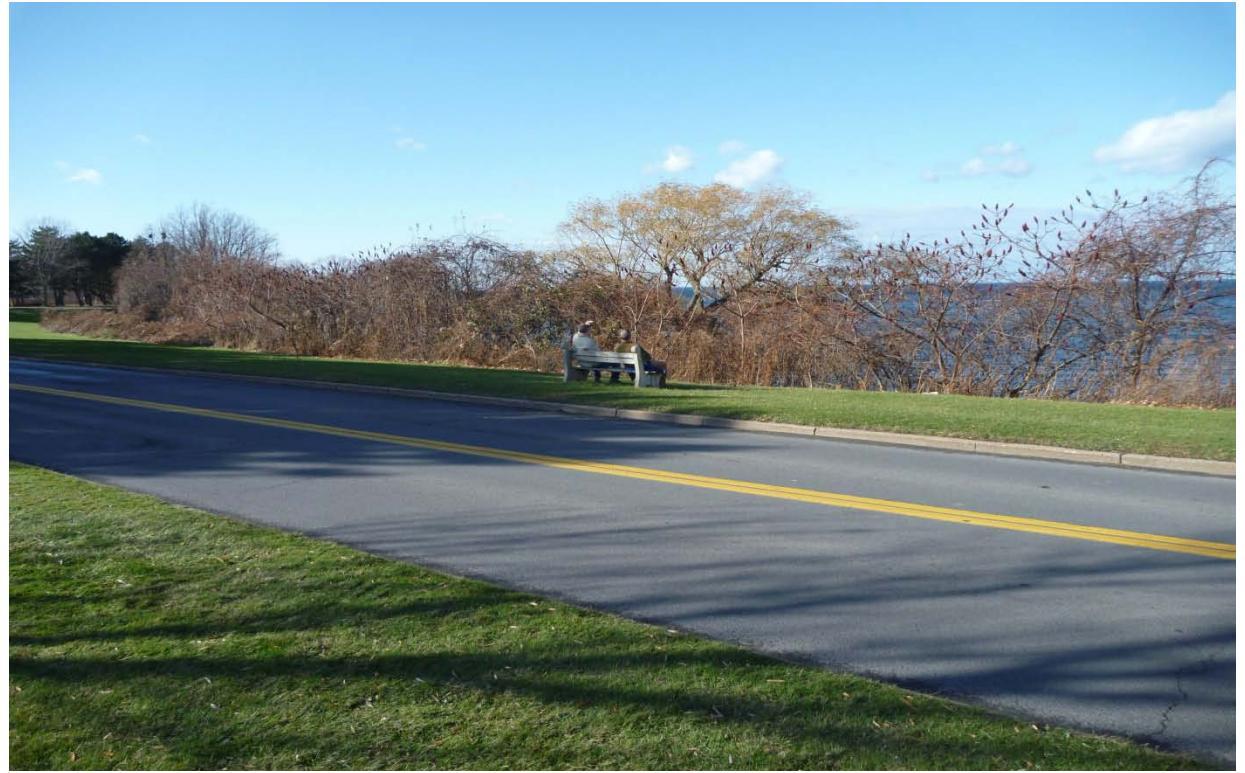
Photo 7. Looking northwest at western viewshed opportunity along Rudolph Road. November 24, 2014

The western viewshed improvement area extends approximately 1,000 feet along the western shoreline parallel to Randolph Road. Vegetation in this area consists primarily of large shrubs that can be cut and or trimmed to provide exceptional views of the lake for walkers and drivers utilizing Randolph Road. It is critical to employ best management practices while performing vegetative clearing to avoid erosion of the bank and shoreline habitats. In most instances it will likely be required to leave the root mass of larger plants in place to minimize disturbance of the substrate. Additional details concerning the vegetative clearing are presented below.

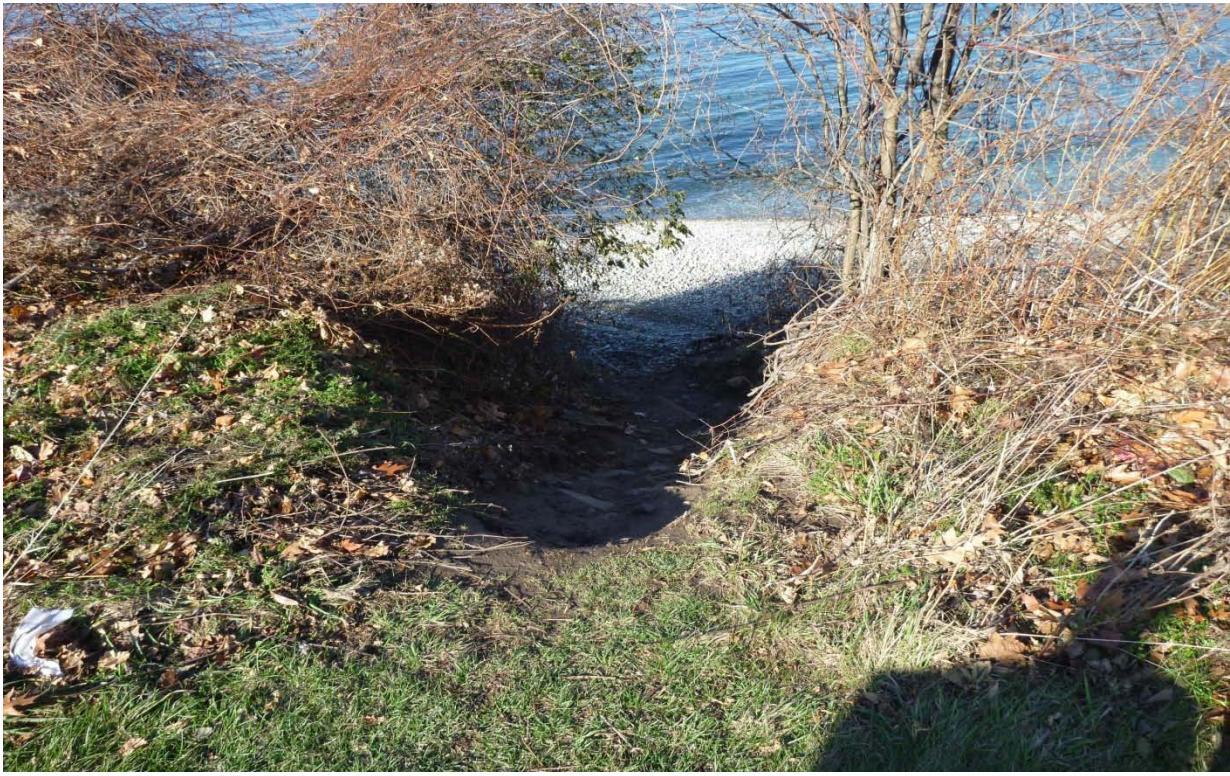
The swales observed (*e.g.*, Photo 8 of Attachment 1) are likely to degrade over time due to continued use by pedestrians and/or erosion during significant runoff events. In an effort to avoid unsightly discouragement features (*e.g.*, gates, obstacles) and/or encourage use of alternative, potentially less safe access points, it is recommended that these areas be stabilized with the following:

Photo 8. Erosion swale (typical) along western bank. November 24, 2014

- Placement of erosion control fabric that is toed-in on all sides a minimum of 1-foot beyond the limits of existing erosion
- Placement of a minimum of 6-inches of washed stone over the fabric
- In areas where the swale location is adjacent to existing stormwater outfalls, the University should incorporate additional grading and stabilization measures of these areas into the design of the outfalls
- If there are specific access points that the University wants to discourage from future use, they could be identified with the GPS and they can be blocked by strategic placement of vegetative plantings or educational kiosks
- Recommended timeframe = May through September
